Project Name:	Mountain Valley Pipeline	Inspector:	Matthew Grant
Inspection Date:	Monday, October 31, 2022	Project Contact:	Brian Clauto
Spread I: Franklin	ATWS 619, 350 LY 047, 034, 032, 033 AR FR32/312, 313	Weather:	Rainy

FIELD INSPECTION PHOTO LOG

Project Name: Mountain Valley Pipeline

Date: Monday, October 31, 2022

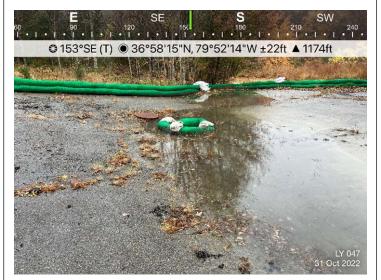
Figure 1: ECD's in place and functioning at LY047.

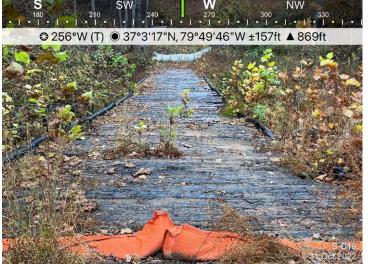
3. Areas of offsite sediment deposition observed?										\boxtimes				
 <u>Comments:</u> Inspected the following resources: S-C19 ECD's were in place and functioning at the designated crossing.]			
Routine Maintenance: (<u>72-Hour Deadline</u> from Notification) - N/A														
Ineffective Controls: (24-Hour Deadline from Notification) - N/A														
Recommended Corrective Action: N/A														
													╛

Figure 2: Designated crossing S-C19, ESC controls were in place.

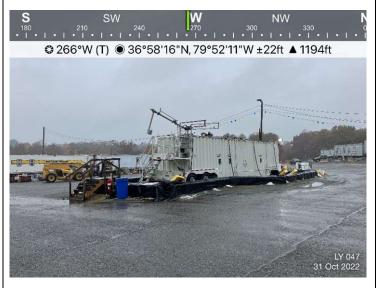
<u>Figure 3</u>: Pollution prevention controls in place and functioning at LY047.

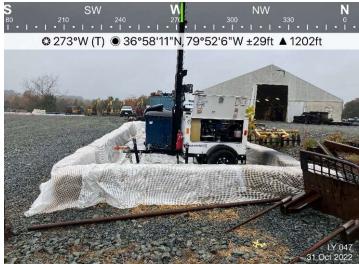
<u>Figure 4</u>: Pollution prevention controls in place and functioning at LY047.
