FIELD INSPECTION REPORT

Project Name:	Mountain Valley Pipeline	Inspector:	Marshall Willis
Inspection Date:	Tuesday, October 18, 2022	Project Contact:	Brian Clauto, Cory Chalmers
Spread I: Franklin County	STA 14270+00 – 14333+27 MVP-FR-313	Weather:	Dry

FIELD INSPECTION PHOTO LOG

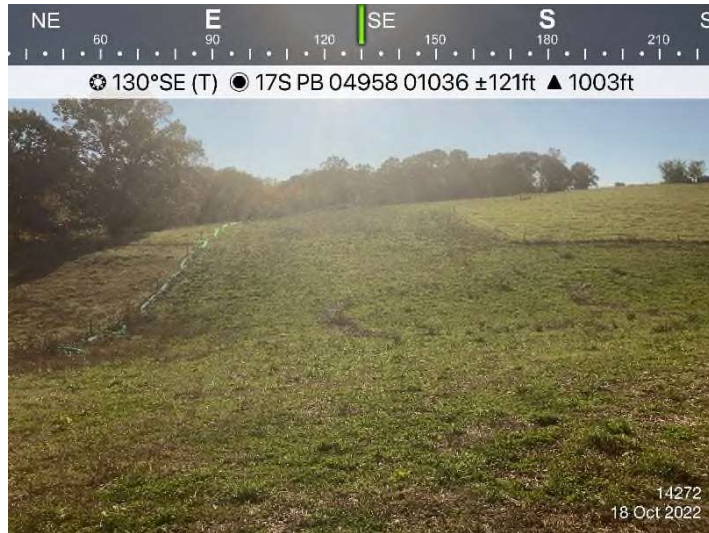
Figure 1: STA 14272+00 – Controls in place and functioning properly.

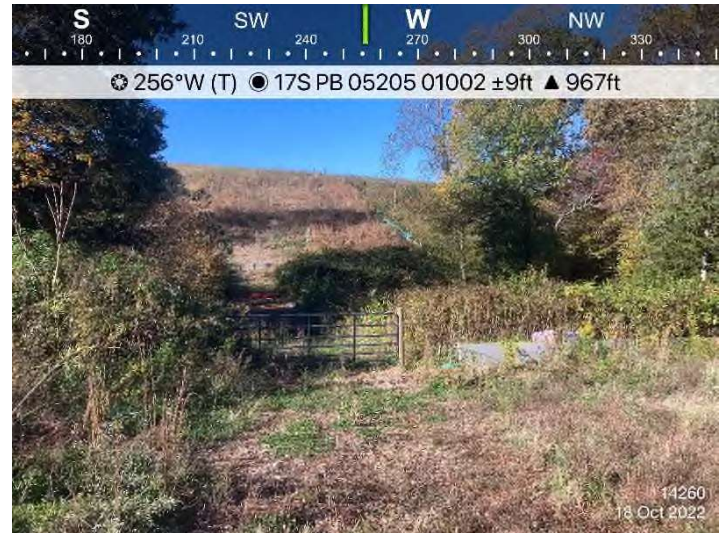
Figure 2: STA 14260+00 – Controls in place and functioning properly.

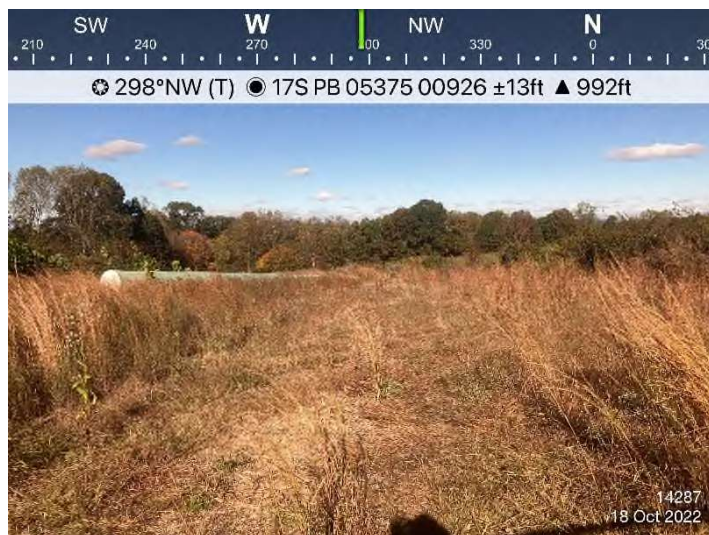
Figure 3: STA 14287+00 – Controls in place and functioning properly.

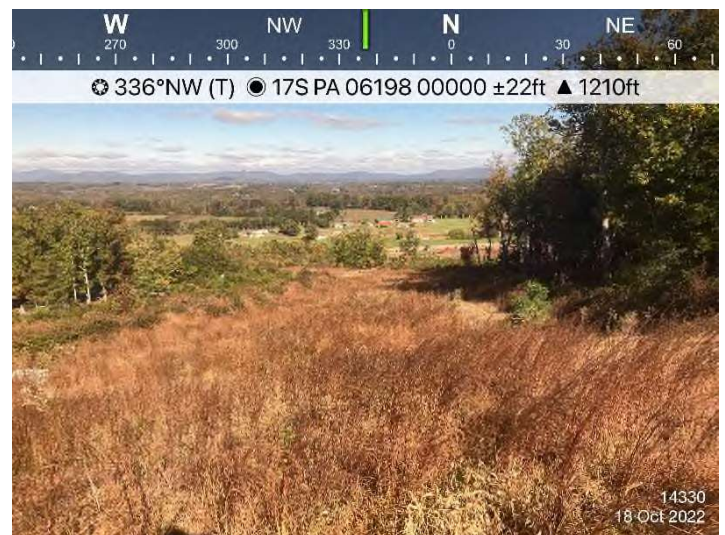
Figure 4: STA 14330+00 – Controls in place and functioning properly.
