FIELD INSPECTION REPORT

Project Name:	Mountain Valley Pipeline	Inspector:	Marshall Willis
Inspection Date:	Thursday, October 13, 2022	Project Contact:	Brian Clauto, Cory Chalmers
Spread I: Pittsylvania County	STA 15760+89 – 15826+77 MVP-PI-338.01	Weather:	Dry

FIELD INSPECTION PHOTO LOG

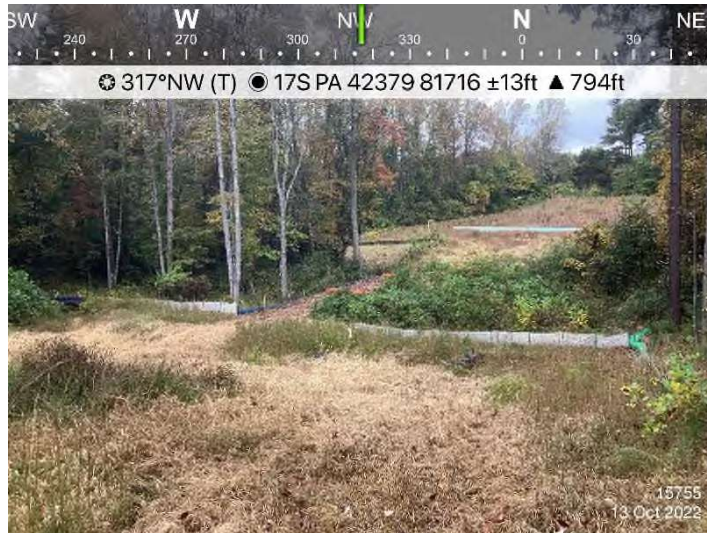
Figure 1: STA 15755+00 – Controls in place and functioning properly.

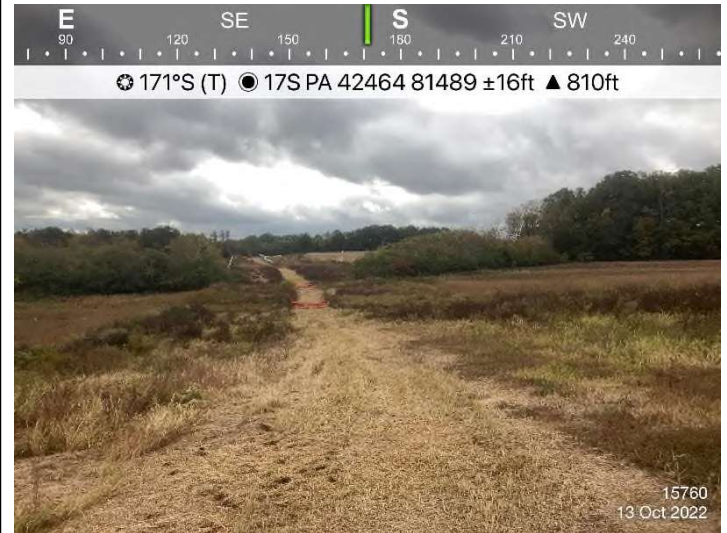
Figure 2: STA 15760+00 – Controls in place and functioning properly.

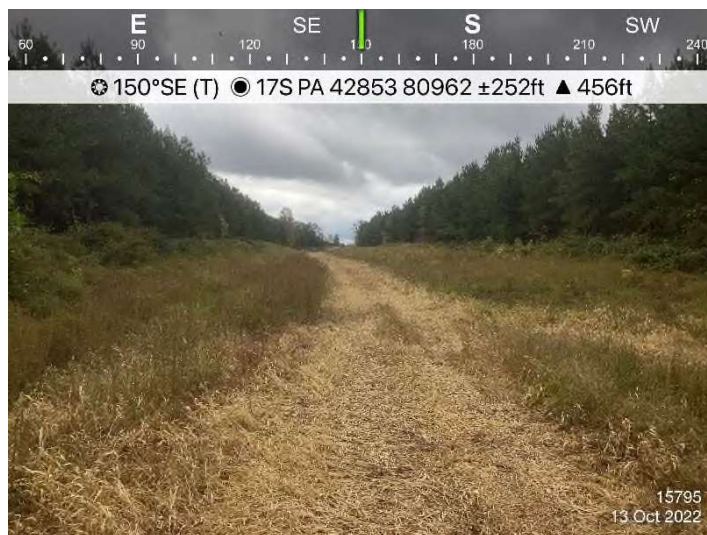
Figure 3: STA 15795+00 – Controls in place and functioning properly.

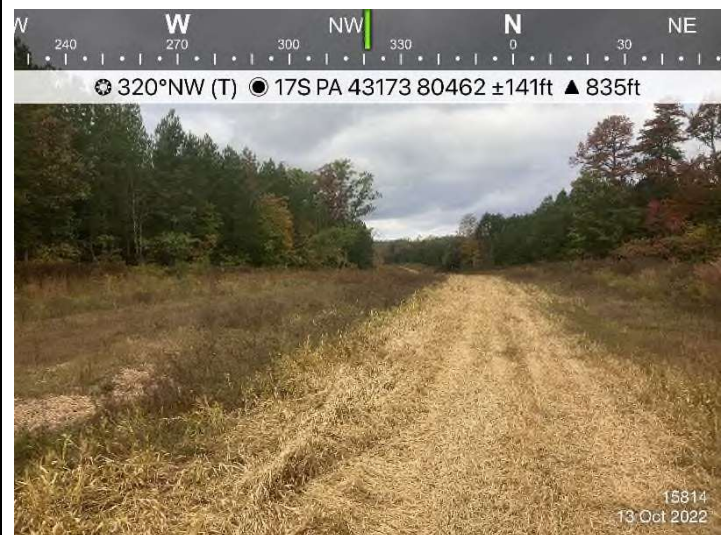
Figure 4: STA 15814+00 – Controls in place and functioning properly.
