FIELD INSPECTION REPORT

Project Name:	Mountain Valley Pipeline	Inspector:	Marshall Willis
Inspection Date:	Wednesday, September 28, 2022	Project Contact:	Brian Clauto, Cory Chalmers
Spread I: Franklin County	STA 14454+22 – 14546+75 MVP-FR-258.01	Weather:	Dry

FIELD INSPECTION PHOTO LOG

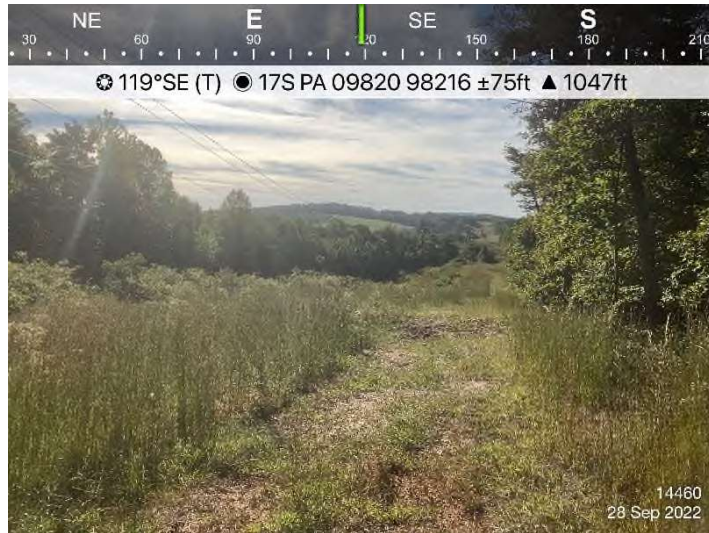
Figure 1: STA 14460+00 – Controls in place and functioning properly.

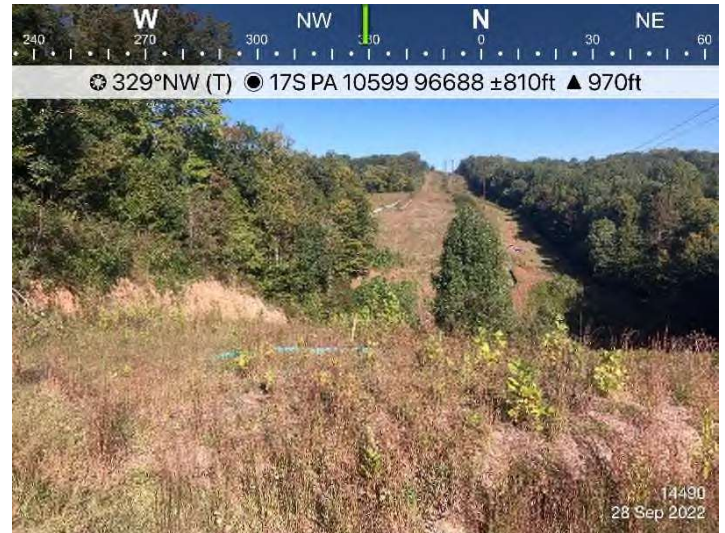
Figure 2: STA 14490+00 – Controls in place and functioning properly.

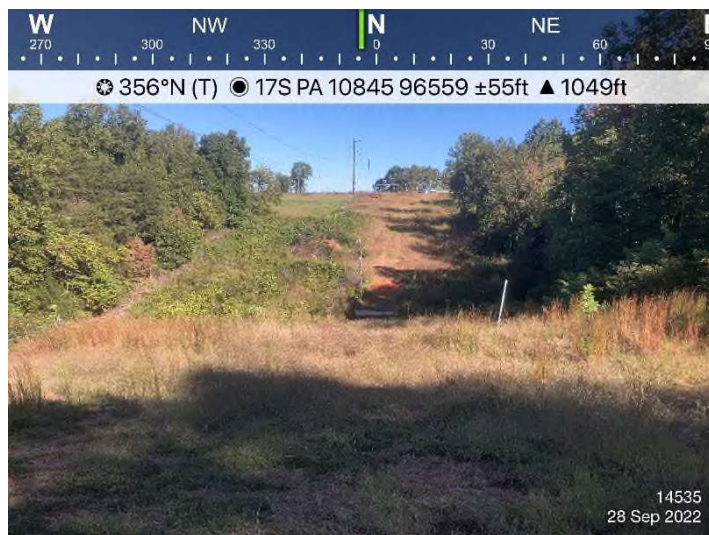
Figure 3: STA 14535+00 – Controls in place and functioning properly.

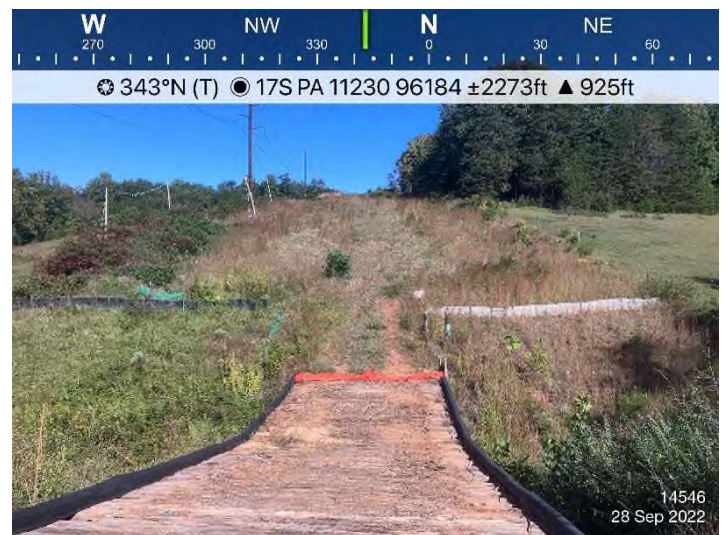
Figure 4: STA 14546+00 – Controls in place and functioning properly.
