Project Name:	Mountain Valley Pipeline	Inspector:	Matthew Grant
Inspection Date:	Tuesday, September 13, 2022	Project Contact:	Brian Clauto
Spread I: Franklin	St 13786-13854 ATWS1040, 1041, 569A, 346, 347, 516, 516A, 515 AR 300, 303,01	Weather:	Dry

FIELD INSPECTION PHOTO LOG

Project Name: Mountain Valley Pipeline <u>Date</u>: Tuesday, September 13, 2022

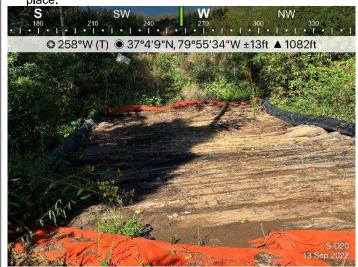
Figure 1: Designated crossing S-D20, ESC controls were in place.

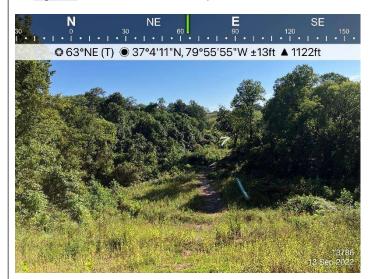
Figure 2: St13786, ECD's are in place and stabilized.

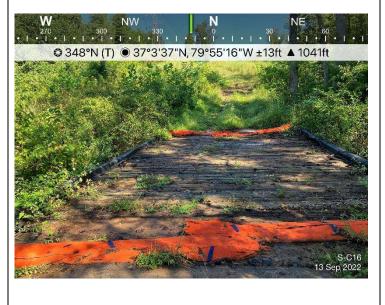
Figure 3: Designated crossing S-C16, ESC controls were in place.

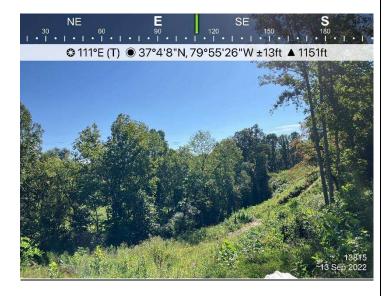
Figure 4: St13815, ECD's are in place and stabilized.
