## FIELD INSPECTION REPORT

<b>Project Name:</b>	Mountain Valley Pipeline	<b>Inspector:</b>	Matthew Grant
<b>Inspection Date:</b>	Wednesday, March 1, 2023	<b>Project Contact:</b>	Brian Clauto
<b>Spread H: Roanoke</b>	AR RO282 Sta 12776-12795+31	<b>Weather:</b>	Dry

# FIELD INSPECTION PHOTO LOG

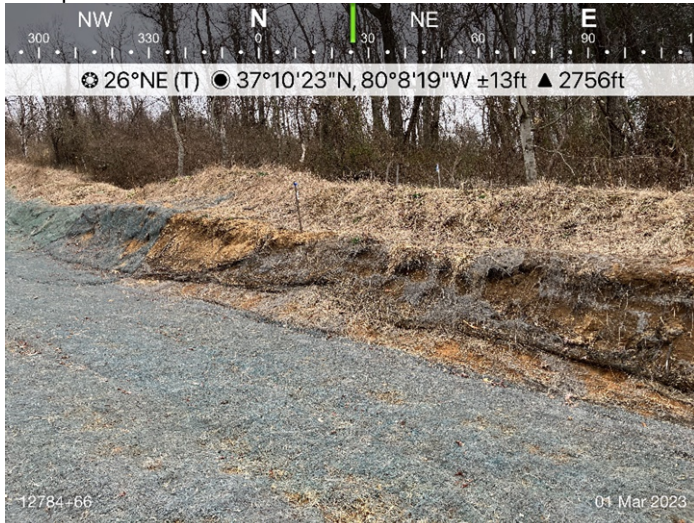
- Sta 12784+66 Row cut requires erosion control matting repair.
- Sta 12779 Row cut requires erosion control matting repair.

- Figure 1: Sta 12784+66 erosion control matting requires repair.

**Recommended Corrective Action:** Maintain and install all controls per the approved PSS&S.

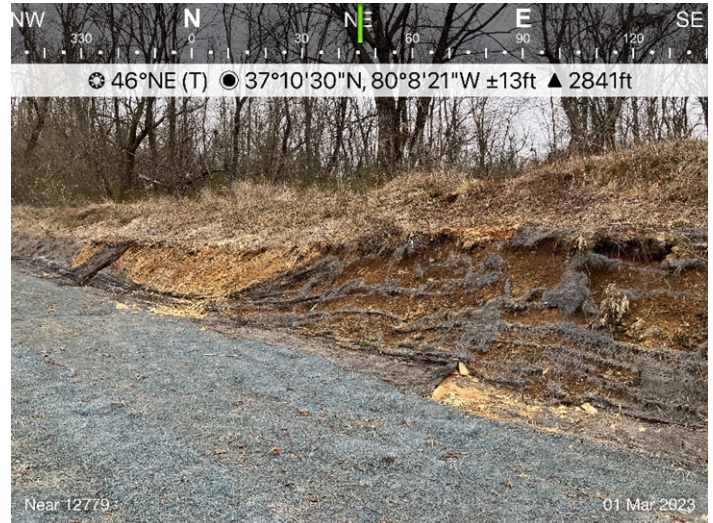
- Figure 2: Sta 12779 erosion control matting requires repair.

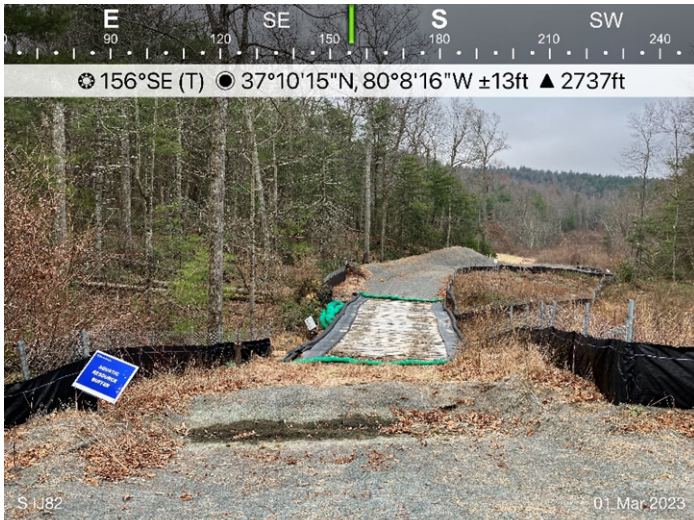
- Figure 3: Designated crossing S-IJ 82, ESC in place.

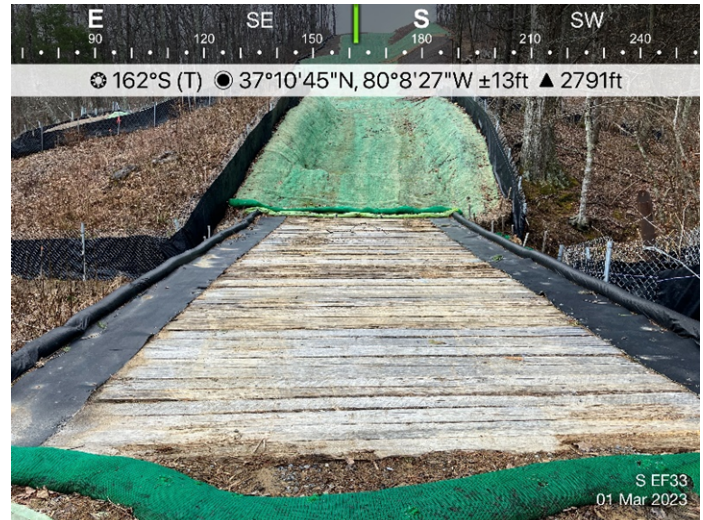
- Figure 4: Designated crossing S-EF33, ESC in place.
