FIELD INSPECTION REPORT

Project Name:	Mountain Valley Pipeline	Inspector:	Matthew Grant
Inspection Date:	Thursday, February 23, 2023	Project Contact:	Brian Clauto
Spread H: Roanoke Montgomery	PY 006 LY049	Weather:	Dry

FIELD INSPECTION PHOTO LOG

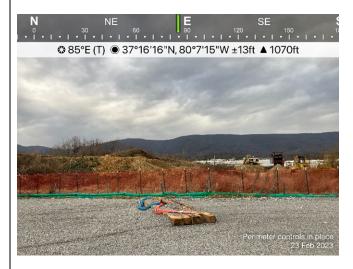
Figure 1: LY049, ECD's are in place and functioning.

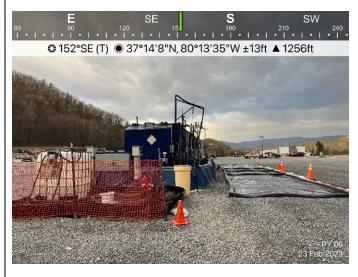
Figure 3: PY 006, pollution prevention controls are in place and functioning.

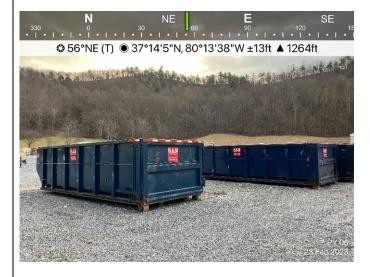
Figure 4: PY 006, pollution prevention controls are in place and functioning.
