FIELD INSPECTION REPORT

Project Name:	Mountain Valley Pipeline	Inspector:	Matthew Grant
Inspection Date:	Wednesday, January 25, 2023	Project Contact:	Brian Clauto
Spread H: Montgomery	PY 006	Weather:	Wet

FIELD INSPECTION PHOTO LOG

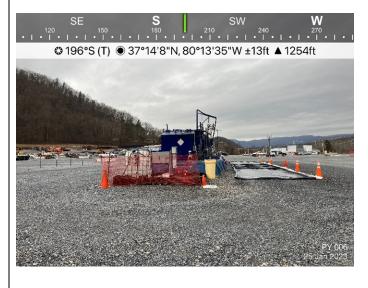
Figure 4: PY 006, pollution prevention controls are in place and functioning.

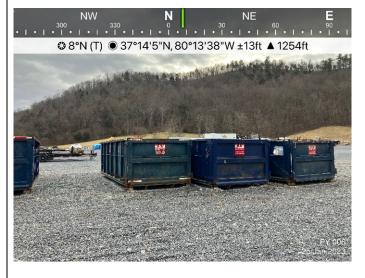
Figure 3: PY 006, pollution prevention controls are in place and functioning.
