## FIELD INSPECTION REPORT

| Project Name: | Mountain Valley Pipeline | Inspector: | Marshall Willis |
| Spread H:<br>Roanoke County | STA 12964+64 - 12982+00<br>MVP-RO-288 | Weather: | Wet |

FIELD INSPECTION PHOTO LOG

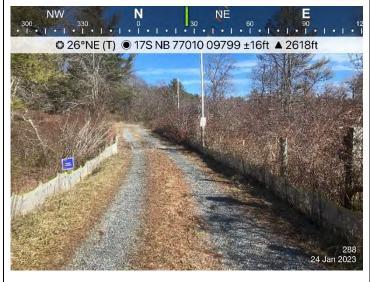
<u>Figure 1</u>: **Stream S-KL4** – Controls in place and functioning properly along access road crossing.

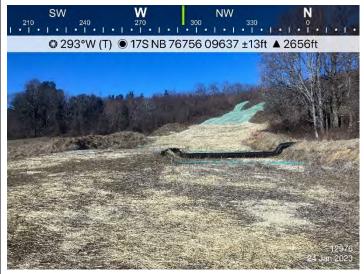
<u>Figure 2:</u> **STA 12976+00** – Controls in place and functioning properly.

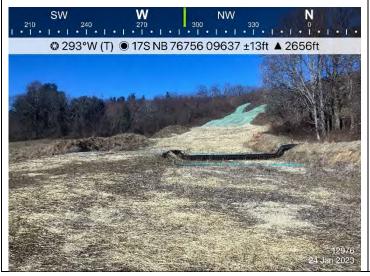
<u>Figure 3</u>: **STA 12976+00** – Controls in place and functioning properly.

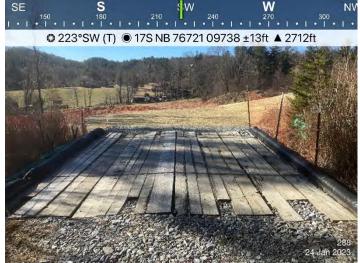
Figure 4: MVP-R0-288 – Controls in place and functioning properly.
