FIELD INSPECTION REPORT

Project Name:	Mountain Valley Pipeline	Inspector:	Marshall Willis	
Inspection Date:	Monday, January 23, 2023	Project Contact:	Brian Clauto, Cory Chalmers	
Spread H: Franklin County	STA 13136+00 - 13196+71 MVP-FR-292/.02 MVP-MLV-AR-29	Weather:	Wet

FIELD INSPECTION PHOTO LOG

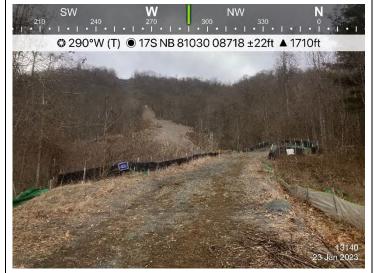
Figure 1: **STA 13140+00** – Controls in place and functioning properly.

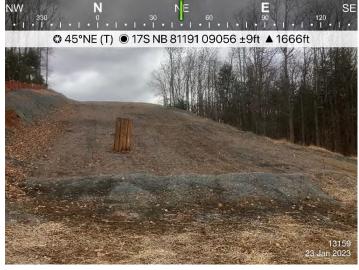
Figure 2: STA 13159+00 – Controls in place and functioning properly.

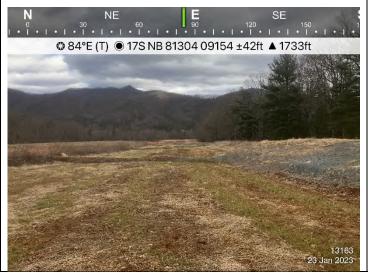
<u>Figure 3</u>: **STA 13163+00** – Controls in place and functioning properly.

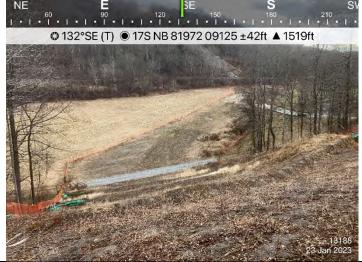
<u>Figure 4</u>: **STA 13188+00** – Controls in place and functioning properly.
