FIELD INSPECTION REPORT

Project Name:	Mountain Valley Pipeline	Inspector:	Matthew Grant
Inspection Date:	Wednesday, December 7, 2022	Project Contact:	Brian Clauto
Spread H: Montgomery	ATWS 645, 645a, 727, 725, 1222 LY049 AR MN 279	Weather:	Rainy

FIELD INSPECTION PHOTO LOG

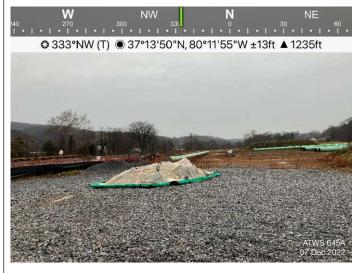
Figure 1: Controls remain in place at ATWS 645A.

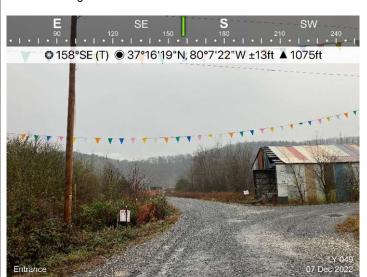
Figure 2: LY 049 construction entrance remains in place and functioning.

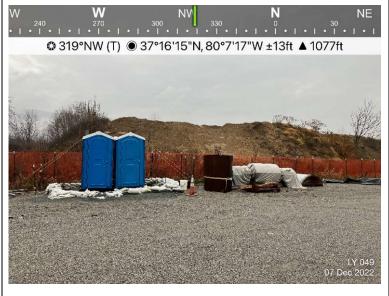
Figure 3: LY049, pollution prevention remains in place and functioning.

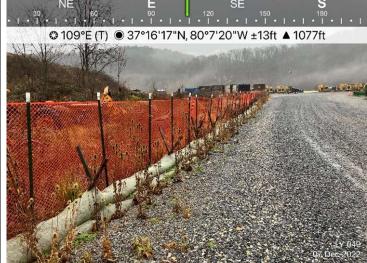
Figure 4: ECD remains in place and functioning at LY049.
