FIELD INSPECTION REPORT

Project Name:	Mountain Valley Pipeline	Inspector:	Matthew Grant
Inspection Date:	Tuesday, November 29, 2022	Project Contact:	Brian Clauto
Spread H: Roanoke	ATWS1227, 1226, 1228 AR RO 281, 282 ST 12730-12760	Weather:	Dry

FIELD INSPECTION PHOTO LOG

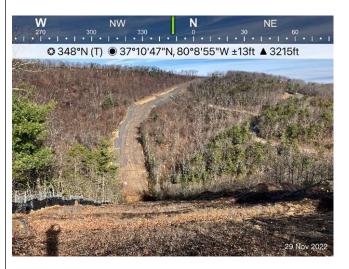
Figure 3: Near St 12748, ECB requires repair.

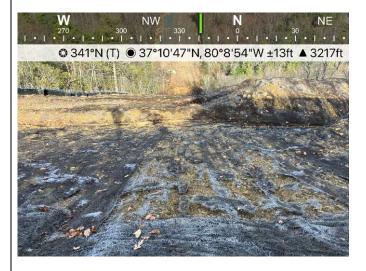
• Figure 4: Designated crossing S- EF33, controls remain in place.
