FIELD INSPECTION REPORT

Project Name:	Mountain Valley Pipeline	Inspector:	Matthew Grant	
Inspection Date:	Wednesday, November 16, 2022	Project Contact:	Brian Clauto	
Spread H: Roanoke	ATWS 1307, 1308, 1309, 1310, 1306, 1305 AR RO 288, 287 ST 12980-12940	Weather:	Wet

FIELD INSPECTION PHOTO LOG

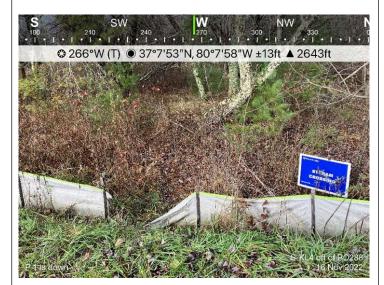
Figure 1: Designated crossing S-KL4, P1 fencing is down.

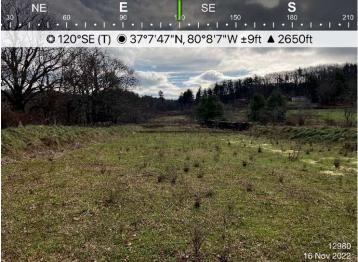
Figure 2: St12980, ECD's are in place and functioning.

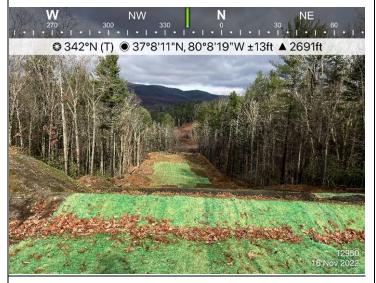
Figure 3: St12950, ECD's are in place and functioning.

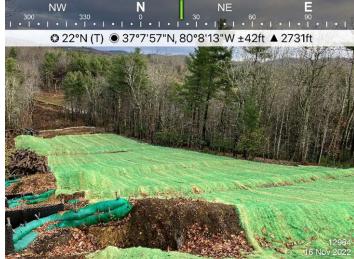
Figure 4: St12964, ECD's are in place and functioning.
