FIELD INSPECTION REPORT

Project Name:	Mountain Valley Pipeline	Inspector:	Marshall Willis
Inspection Date:	Tuesday, November 15, 2022	Project Contact:	Brian Clauto, Cory Chalmers
Spread H: Franklin County	STA 13135+00 – 13150+00 MVP-FR-292	Weather:	Rainy

FIELD INSPECTION PHOTO LOG

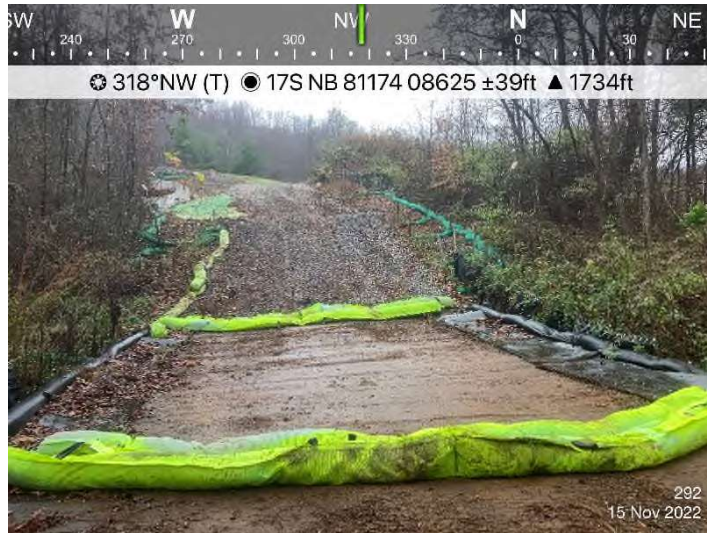
Figure 1: MVP-FR-292 – Controls in place and functioning properly along Access Road 292.

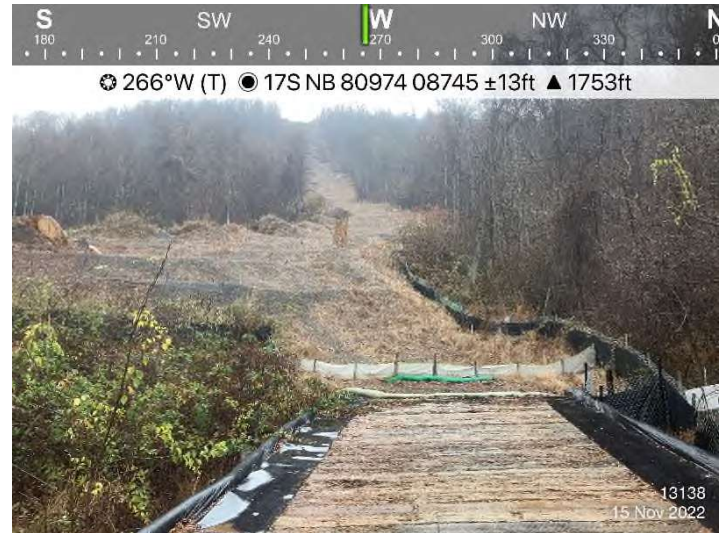
Figure 2: STA 13138+00 – Controls in place and functioning properly.

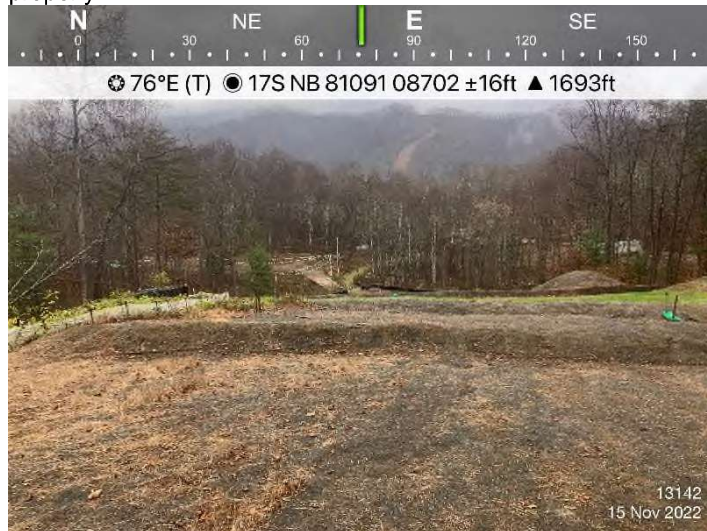
Figure 3: STA 13142+00 – Controls in place and functioning properly.

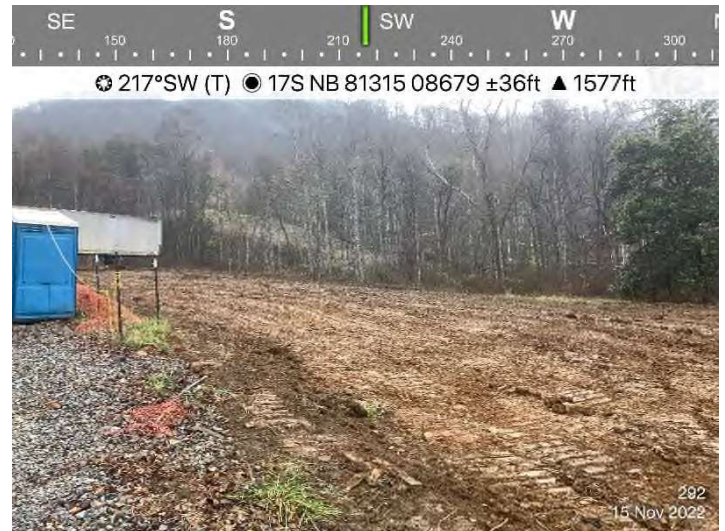
Figure 4: MVP-FR-292 – Off-site LDA from property owner.
