FIELD INSPECTION REPORT

Project Name:	Mountain Valley Pipeline	Inspector:	Matthew Grant
Inspection Date:	Tuesday, October 25, 2022	Project Contact:	Brian Clauto
Spread H: Montgomery	ATWS 1163, 1162 AR MN 270 ST 12073-12020	Weather:	Dry

FIELD INSPECTION PHOTO LOG

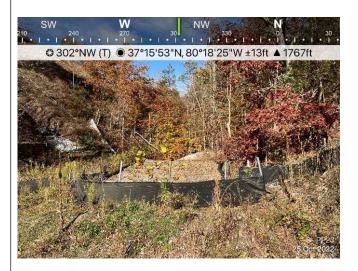
Figure 1: Designated crossing S-PP23, ECD's are in place.

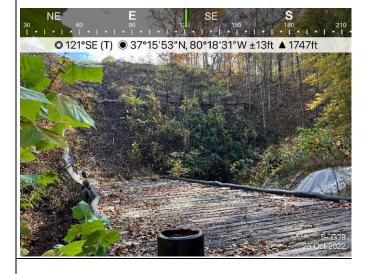
Figure 3: Designated crossing S-G39, ECD's are in place.

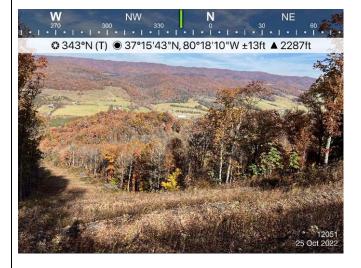
Figure 4: St 10251, ECD's are in place and functioning.
