FIELD INSPECTION REPORT

Project Name:	Mountain Valley Pipeline	Inspector:	Marshall Willis
Inspection Date:	Thursday, October 20, 2022	Project Contact:	Brian Clauto, Cory Chalmers
Spread H: Franklin County	STA 13115+95 – 13141+53 MVP-FR-292/291	Weather:	Dry

FIELD INSPECTION PHOTO LOG

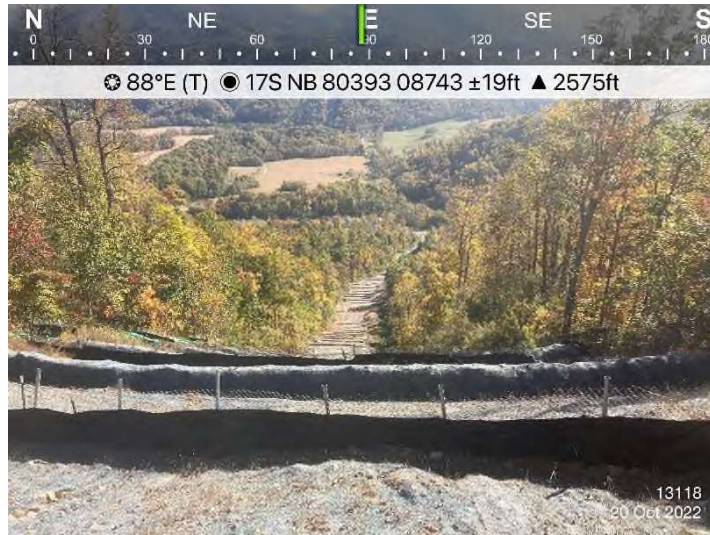
Figure 1: STA 13118+00 – Controls in place and functioning properly.

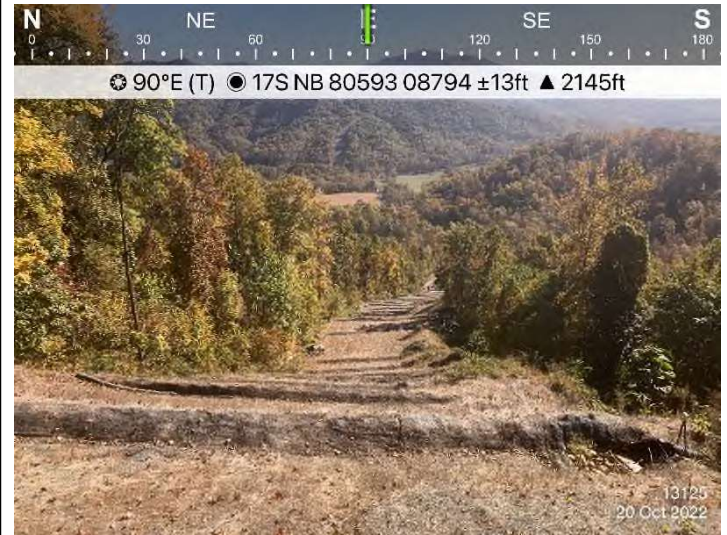
Figure 2: STA 13125+00 – Controls in place and functioning properly.

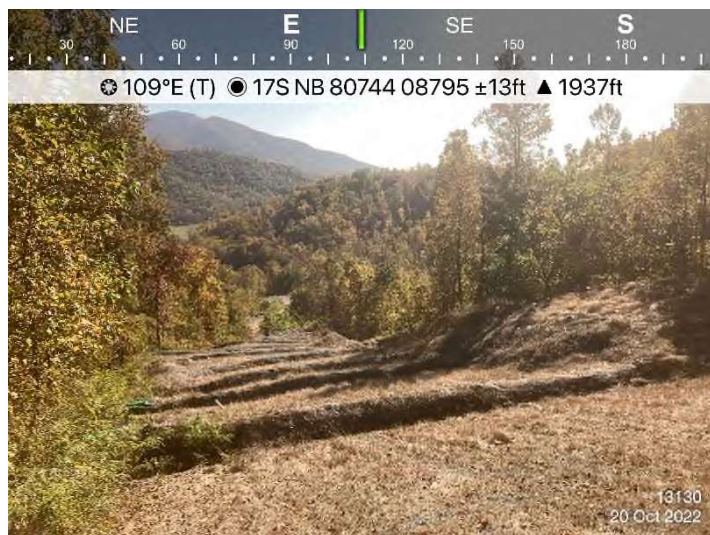
Figure 3: STA 13130+00 – Controls in place and functioning properly.

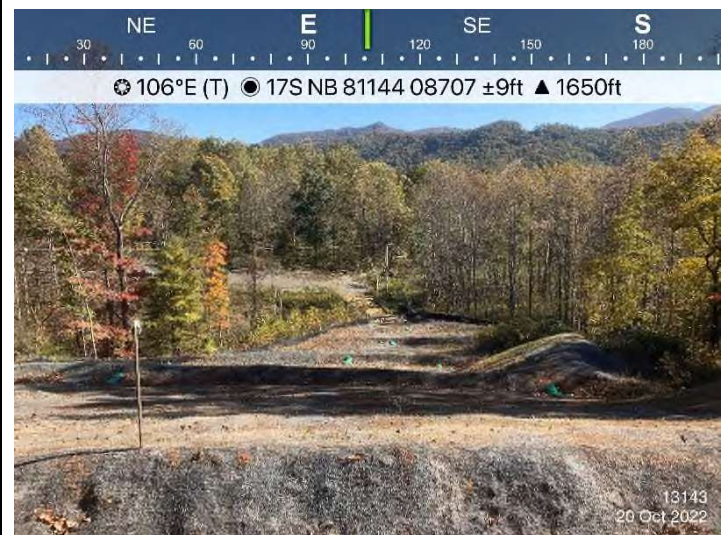
Figure 4: STA 13143+00 – Controls in place and functioning properly.
