FIELD INSPECTION REPORT

Project Name:	Mountain Valley Pipeline	Inspector:	Marshall Willis
Inspection Date:	Monday, October 17, 2022	Project Contact:	Brian Clauto, Cory Chalmers
Spread H: Franklin County	STA 13342+67 – 13415+51	Weather:	Wet

FIELD INSPECTION PHOTO LOG

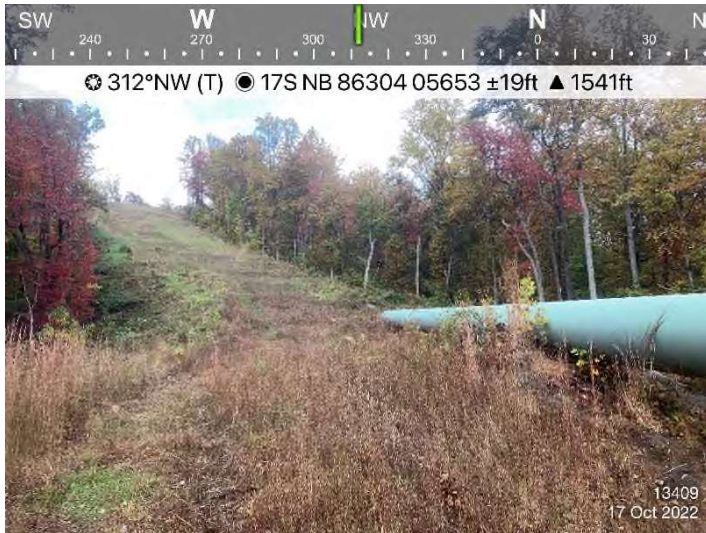
Figure 1: STA 13409+00 – Controls in place and functioning properly.

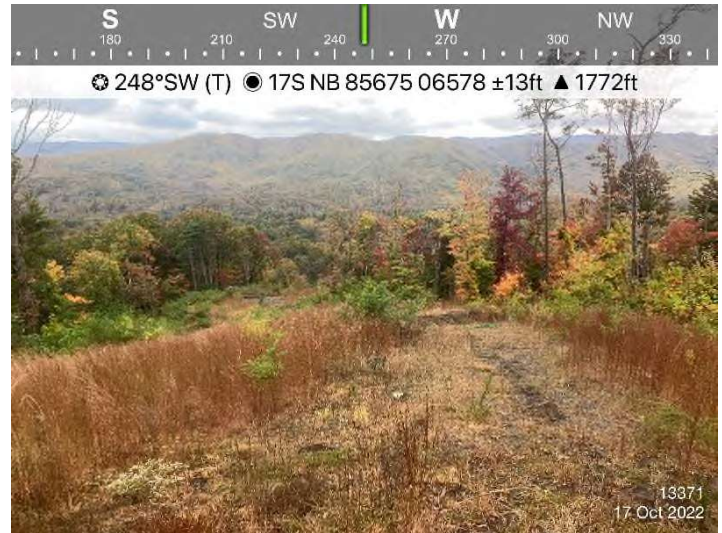
Figure 2: STA 13371+00 – Controls in place and functioning properly.

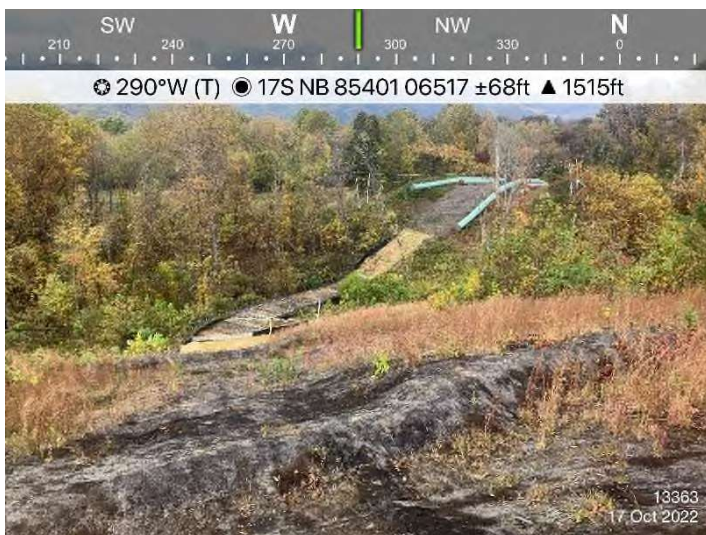
Figure 3: STA 13363+00 – Controls in place and functioning properly.

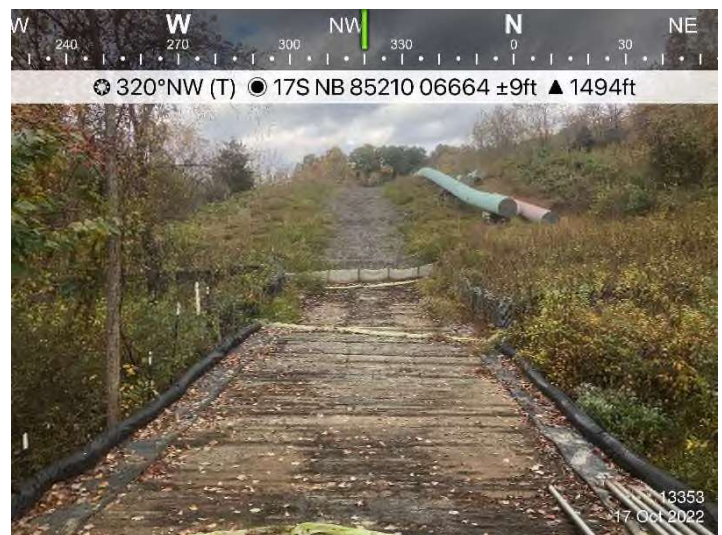
Figure 4: STA 13353+00 – Controls in place and functioning properly.
