FIELD INSPECTION REPORT

Project Name:	Mountain Valley Pipeline	Inspector:	Marshall Willis
Inspection Date:	Monday, October 3, 2022	Project Contact:	Brian Clauto, Cory Chalmers
Spread H: Roanoke County	STA 12601+00 – 12637+00 MVP-RO-279.01/.02	Weather:	Wet

FIELD INSPECTION PHOTO LOG

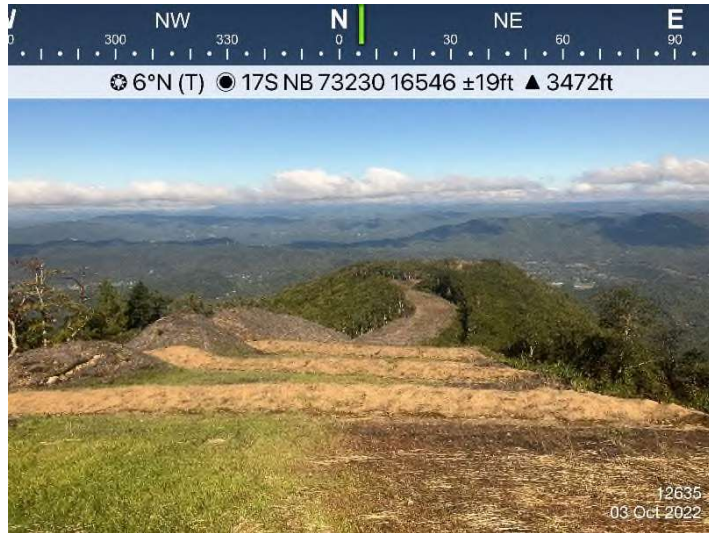
Figure 1: STA 12635+00 – Controls in place and functioning properly.

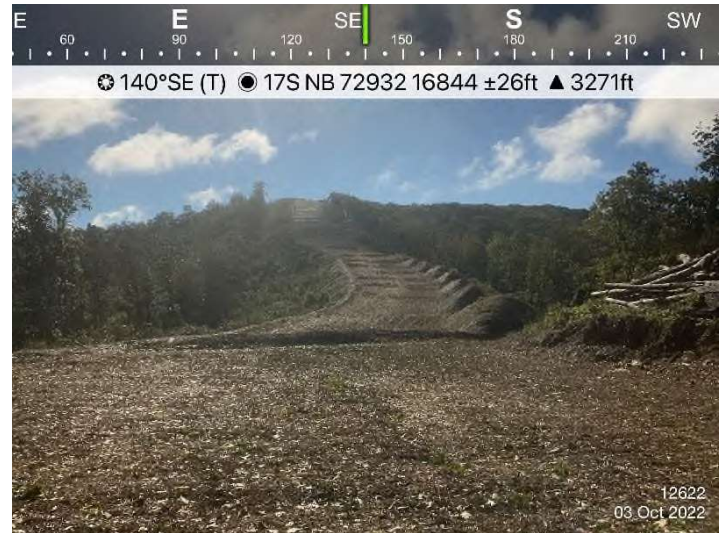
Figure 2: STA 12622+00 – Controls in place and functioning properly.

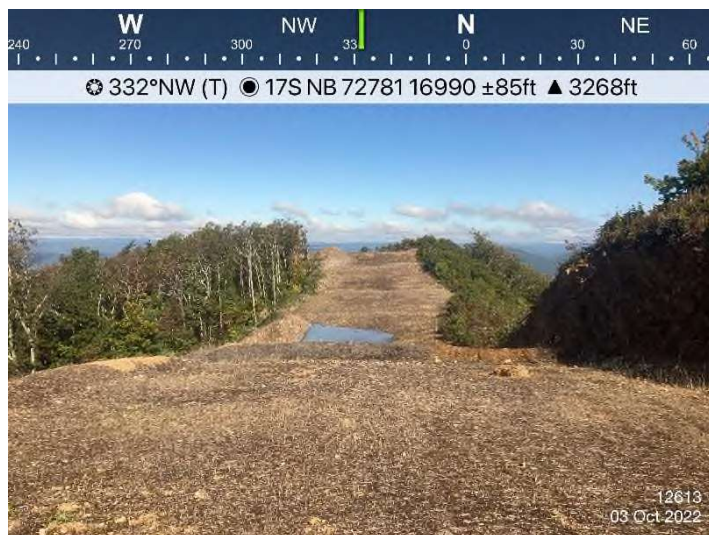
Figure 3: STA 12613+00 – Controls in place and functioning properly.

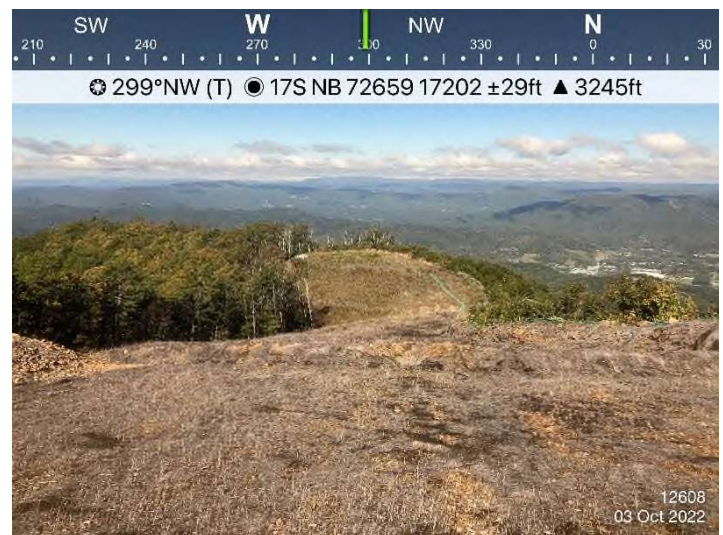
Figure 4: STA 12608+00 – Controls in place and functioning properly.
