FIELD INSPECTION REPORT

Project Name:	Mountain Valley Pipeline	Inspector:	Marshall Willis
Inspection Date:	Thursday, September 29, 2022	Project Contact:	Brian Clauto, Cory Chalmers
Spread H: Montgomery County	STA 12424+73 – 12445+19 MVP-MN-279.02	Weather:	Dry

FIELD INSPECTION PHOTO LOG

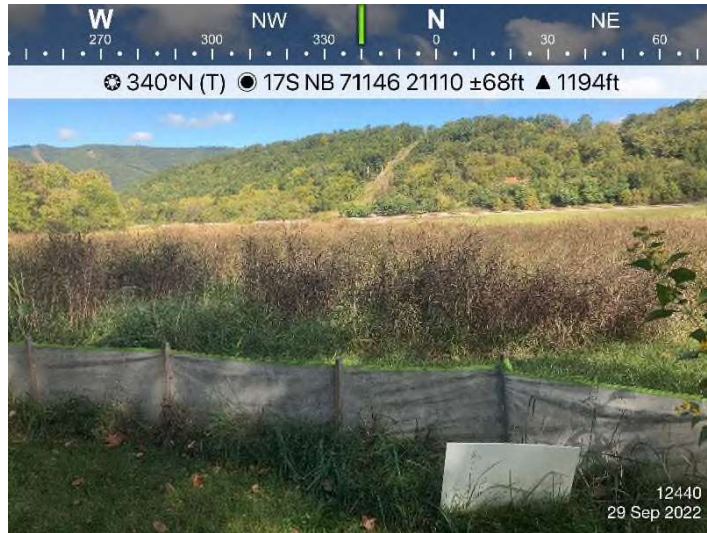
Figure 1: STA 12440+00 – Controls in place and functioning properly.

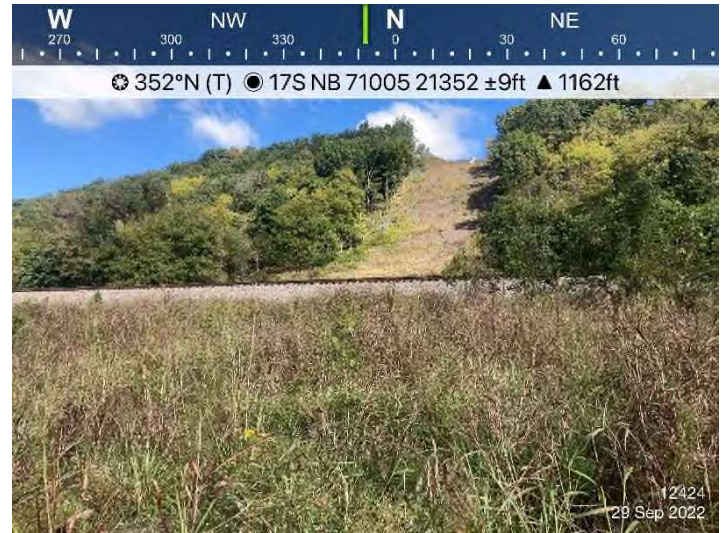
Figure 2: STA 12424+00 – Controls in place and functioning properly.

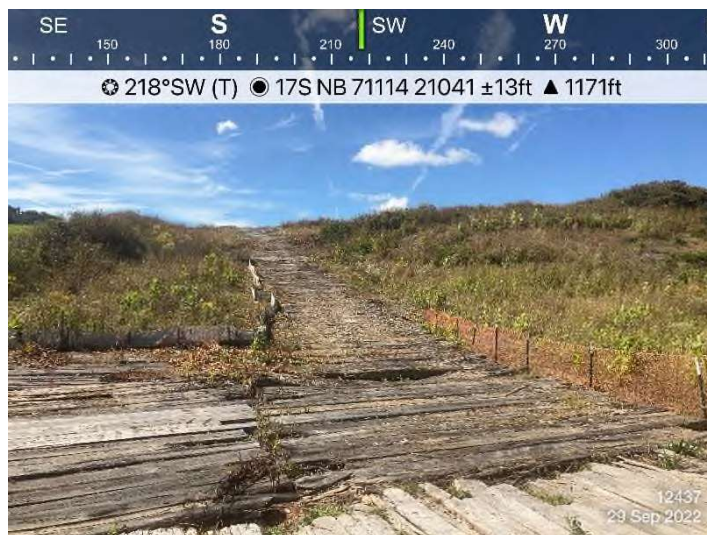
Figure 3: STA 12437+00 – Controls in place and functioning properly.

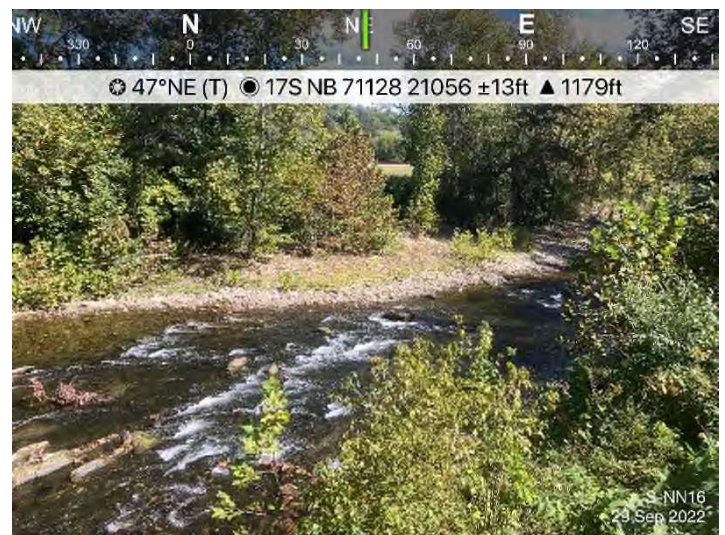
Figure 4: Stream S-NN16 – Controls in place and functioning properly around Roanoke River crossing.
