## FIELD INSPECTION REPORT

<b>Project Name:</b>	Mountain Valley Pipeline	<b>Inspector:</b>	Matthew Grant
<b>Inspection Date:</b>	Wednesday, March 15, 2023	<b>Project Contact:</b>	Brian Clauto
<b>Spread H: Franklin</b>	AR FR306.03, 306.02 Sta 13900-13890, 13990-14010, 14020-14040 ATWS 697, 696, 1466, 1470 MLV 31	<b>Weather:</b>	Dry

## FIELD INSPECTION PHOTO LOG

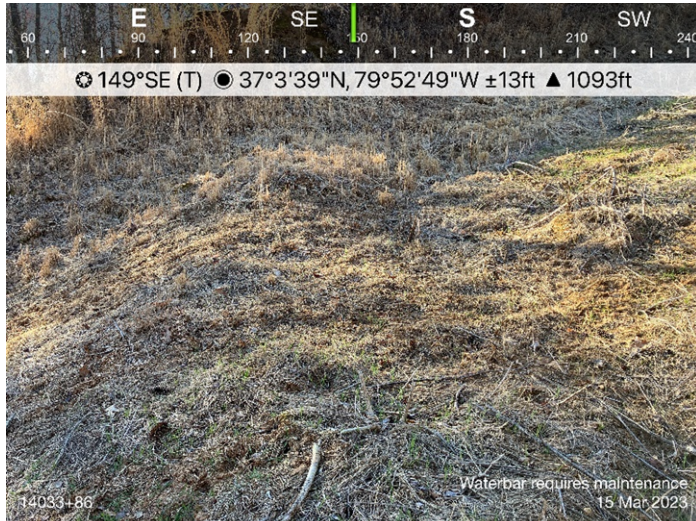
- Sta 14033+86 waterbar requires maintenance due to waterbar height.

Figure 1: Sta 14033+86 waterbar requires maintenance.

**Recommended Corrective Action:** Maintain and install all controls per the approved PSS&S.

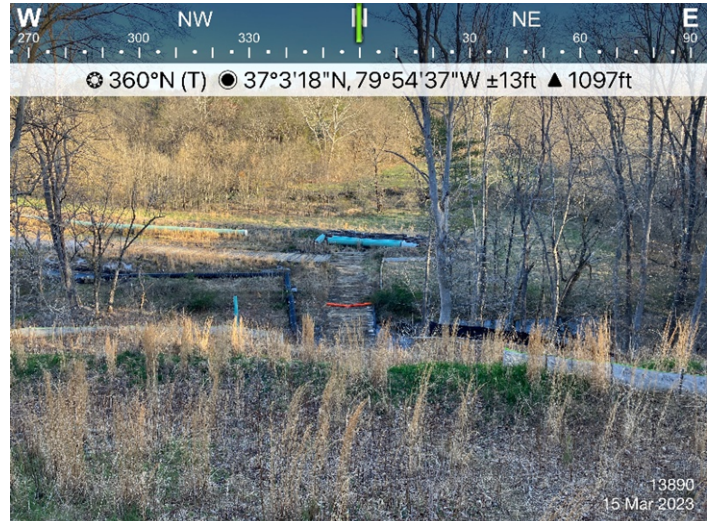
Figure 2: Sta 13890, ESC in place.

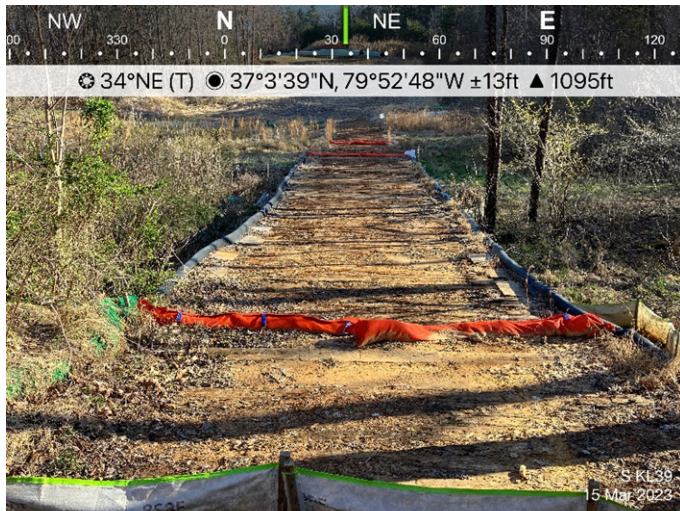
Figure 3: Designated crossing S-KL39, ESC in place.

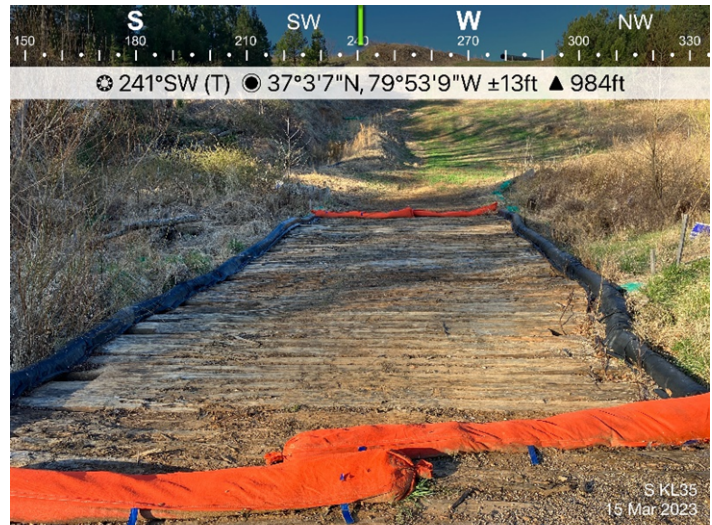
Figure 4: Designated crossing S-KL35, ESC in place.
