## FIELD INSPECTION REPORT

| <b>Project Name:</b> | Mountain Valley Pipeline | <b>Inspector:</b> | Marshall Willis |
| <b>Inspection Date:</b> | Friday, March 17, 2023 | <b>Project Contact:</b> | Brian Clauto, Cory Chalmers |
| <b>Spread I:<br/>Franklin County</b> | STA 13965+00 – 13937+00<br>STA 13435+00 – 13442+00<br>MVP-FR-303.01<br>MVP-FR-293.02 | <b>Weather:</b> | Rainy |

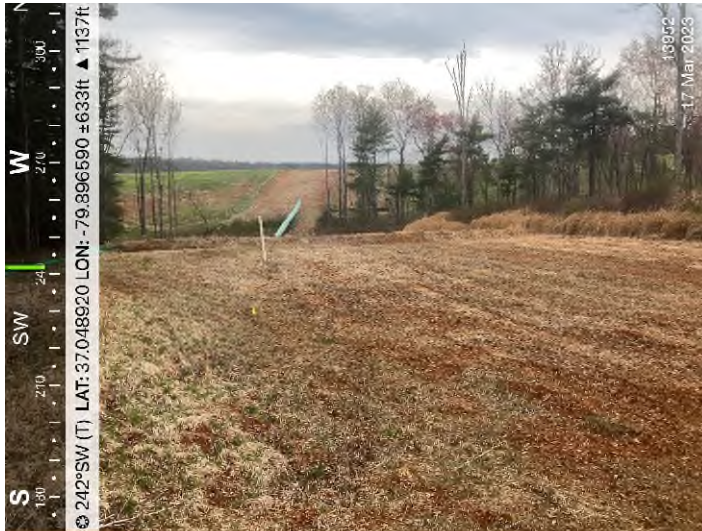
**Figure 1: STA 13952+00** – Controls in place and functioning properly.

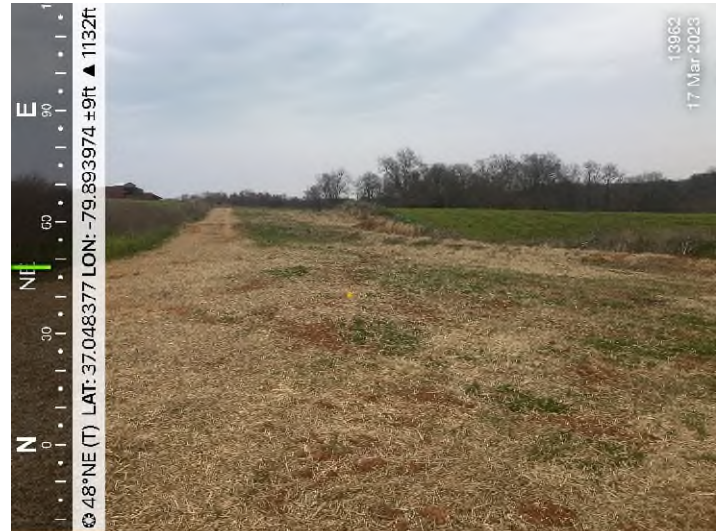
**Figure 2: STA 13962+00** – Controls in place and functioning properly.

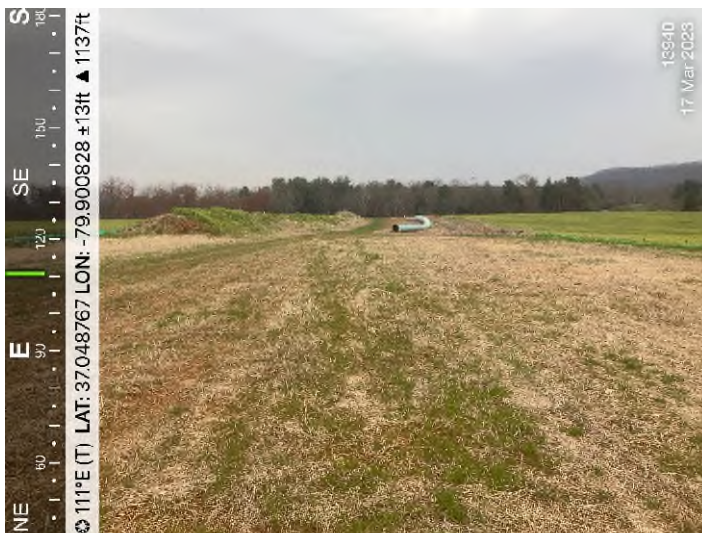
**Figure 3: STA 13940+00** – Controls in place and functioning properly.

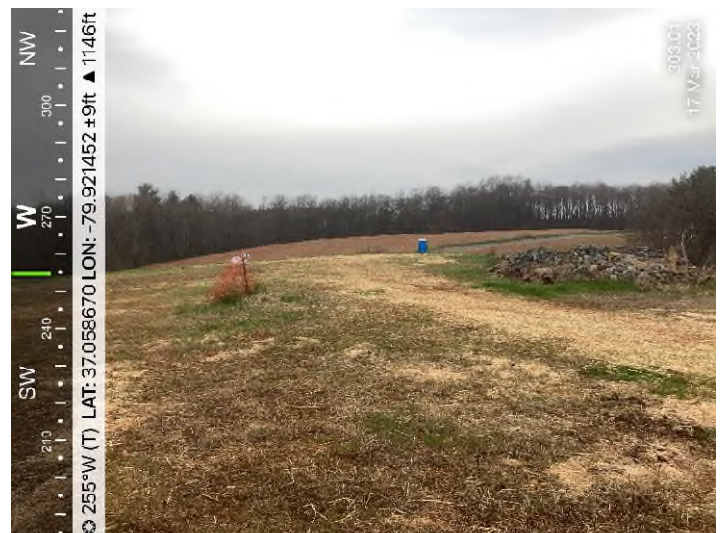
**Figure 4: MVP-FR-303.01** – Controls in place and functioning properly.
