## FIELD INSPECTION REPORT

| Project Name: | Mountain Valley Pipeline | Inspector: | Marshall Willis |
| Spread H:<br>Roanoke County | STA 12724+88 – 12742+82<br>MVP-RO-281/281.02/281.03 | Weather: | Dry |

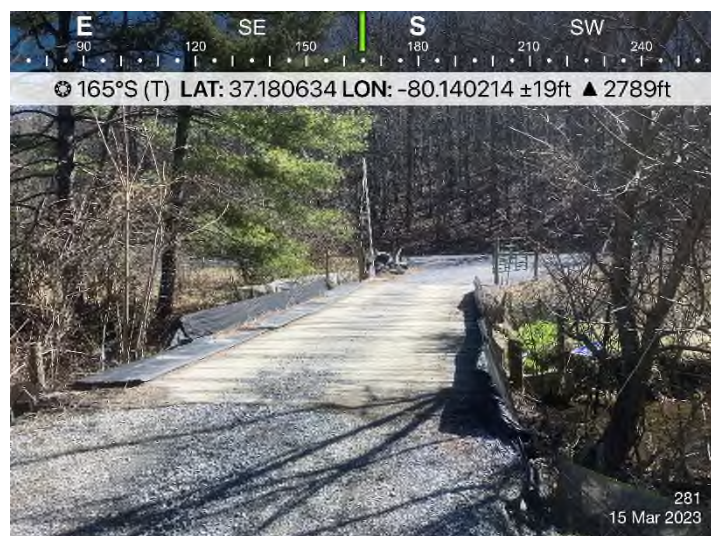
**Figure 1: Stream S-EF32** – Controls in place and functioning properly along FR-281.

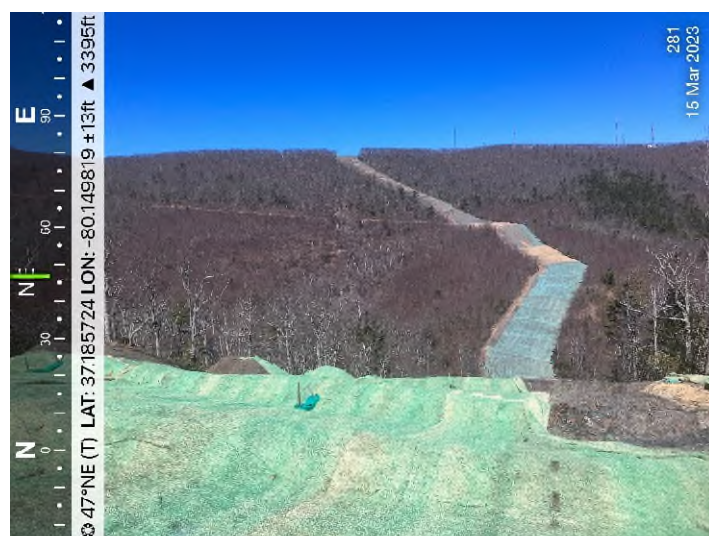
**Figure 2: STA 12724+00** – Controls in place and functioning properly.

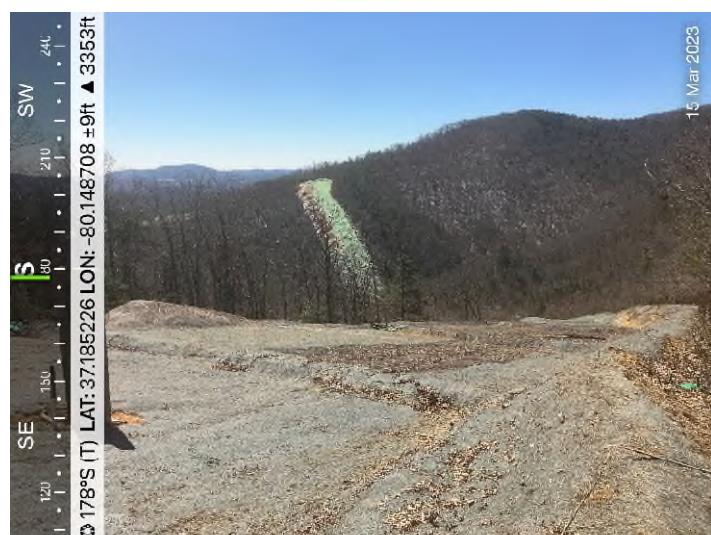
**Figure 3: STA 12729+00** – Controls in place and functioning properly.

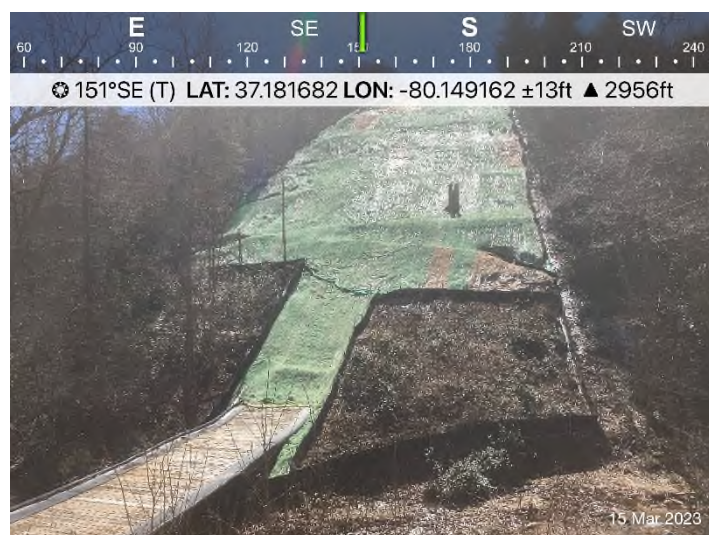
**Figure 4: Stream S-EF56** – Controls in place and functioning properly.
