## FIELD INSPECTION REPORT

| Project Name: | Mountain Valley Pipeline | Inspector: | Marshall Willis |
| Inspection Date: | Wednesday, March 1, 2023 | Project Contact: | Brian Clauto, Cory Chalmers |
| Spread H:<br>Roanoke County | STA 12601+00 – 12637+00<br>MVP-RO-279.01/02 | Weather: | Wet |

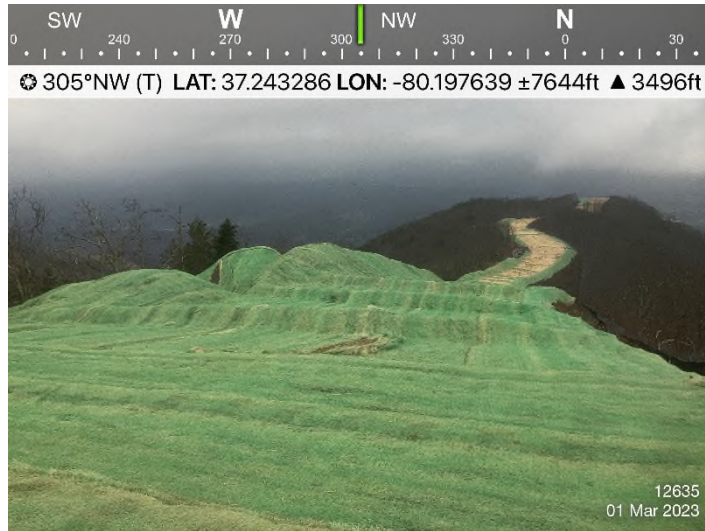
**Figure 1: STA 12635+00** – Controls in place and functioning properly.

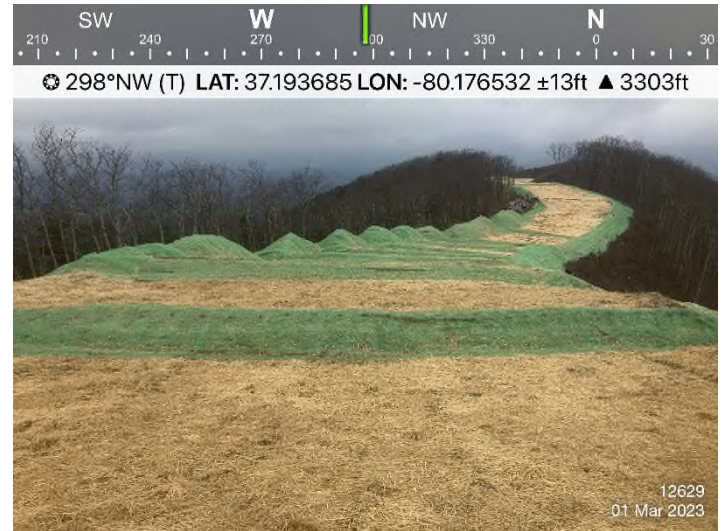
**Figure 2: STA 12629+00** – Controls in place and functioning properly.

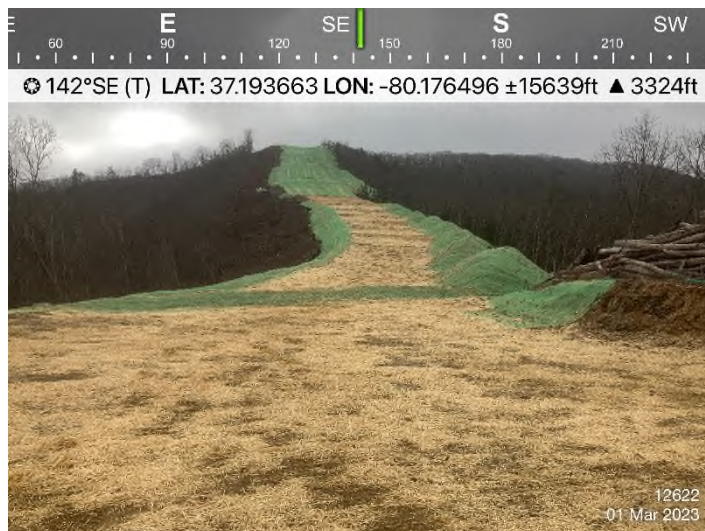
**Figure 3: STA 12622+00** – Controls in place and functioning properly.

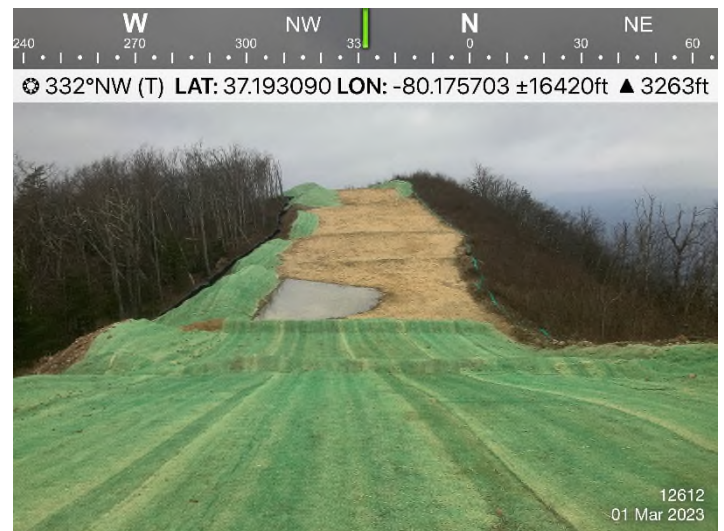
**Figure 4: STA 12612+00** – Controls in place and functioning properly.
