## **FIELD INSPECTION REPORT**

Project Name:	Mountain Valley Pipeline	Inspector:	Matthew Grant
Inspection Date:	Wednesday, March 22, 2023	Project Contact:	Brian Clauto
Spread H: Montgomery	AR MN 276.03 Sta 12233-12190 ATWS 1217, 1216, 275, 1446, 704A	Weather:	Dry

## FIELD INSPECTION PHOTO LOG

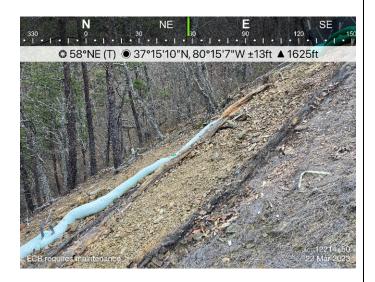
Figure 1: Sta 12214+50 erosion control matting requires repair.

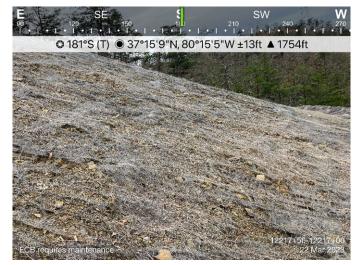
Figure 2: Sta 12217+50-12217, erosion control matting requires repair.

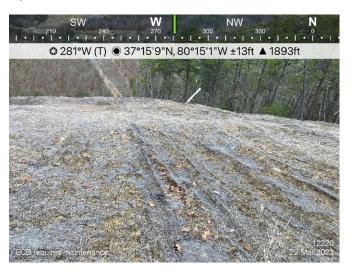
<u>Figure 3:</u> Sta 12219+50-12220 erosion control matting requires repair.

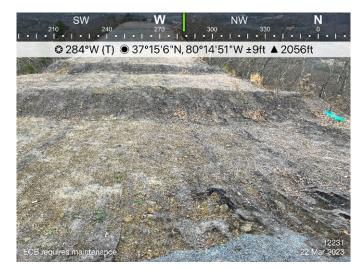
Figure 4: Sta 12231+00-1228 erosion control matting requires repair.
