## FIELD INSPECTION REPORT

| Project Name: | Mountain Valley Pipeline | Inspector: | Marshall Willis |
| Spread I:<br>Franklin County | STA 13690+91 – 13785+00<br>MVP-FR-300 | Weather: | Dry |

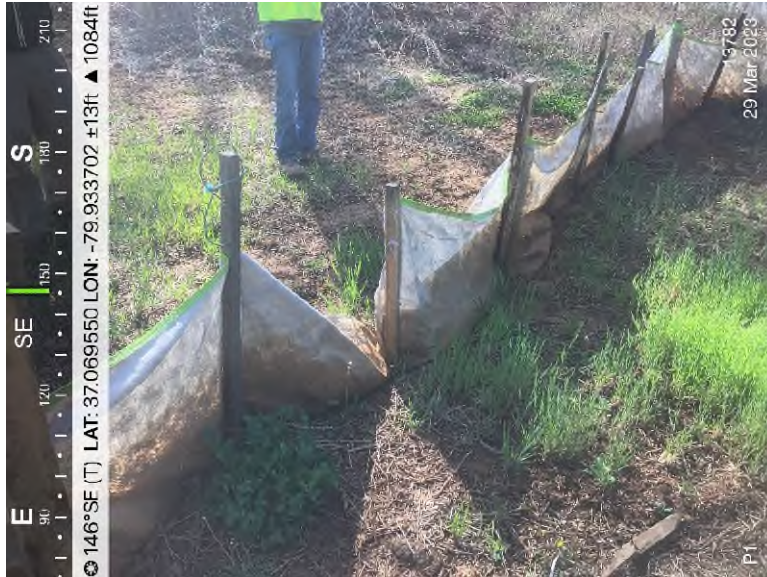
- STA 13782+00: P1 maintenance needed.

**Figure 1: STA 13782+00 – P1 maintenance needed.**

**Recommended Corrective Action:** Maintain and install all controls per the approved PSS&S.

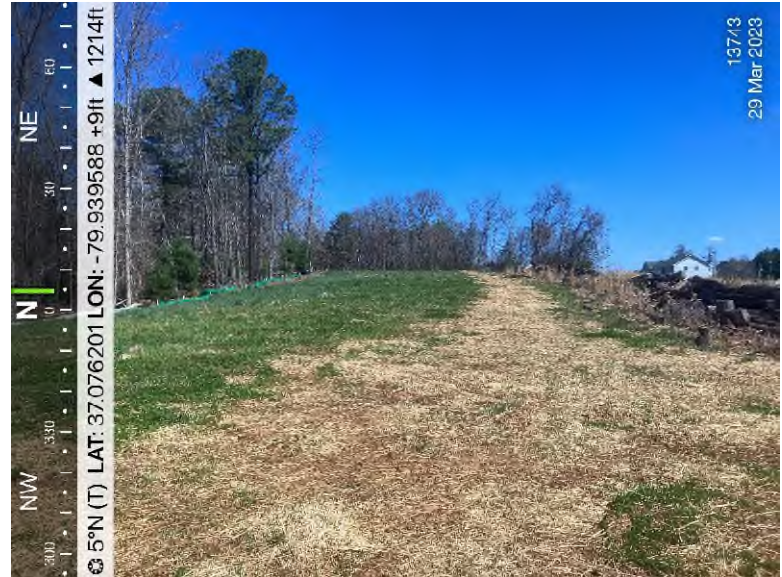
**Figure 2: STA 13743+00 – Controls in place and functioning properly.**

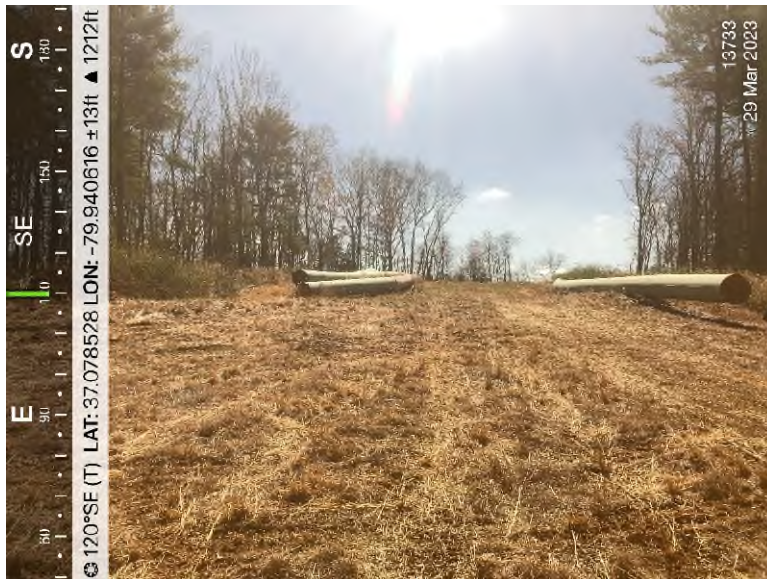
**Figure 3: STA 13733+00 – Controls in place and functioning properly.**

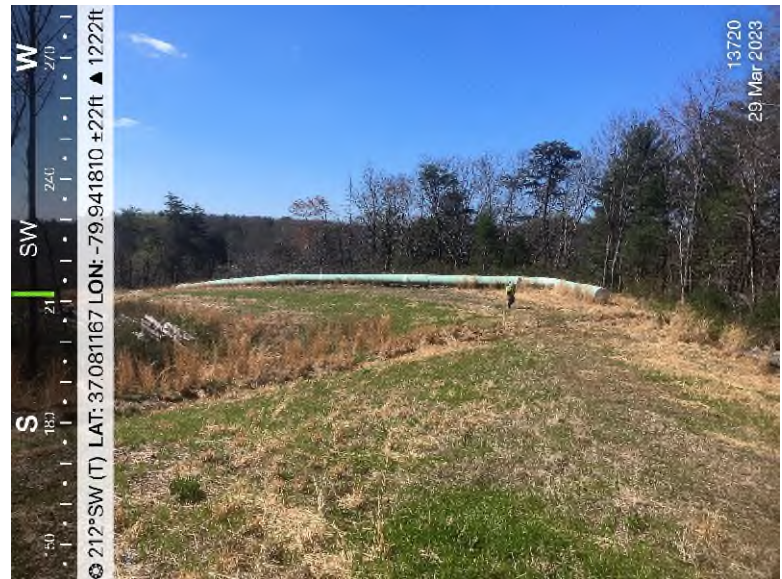
**Figure 4: STA 13720+00 – Controls in place and functioning properly.**
