## FIELD INSPECTION REPORT

| Project Name: | Mountain Valley Pipeline | Inspector: | Marshall Willis |
| Spread I:<br>Franklin County | STA 13575+21 – 13644+82 | Weather: | Dry |

## FIELD INSPECTION PHOTO LOG

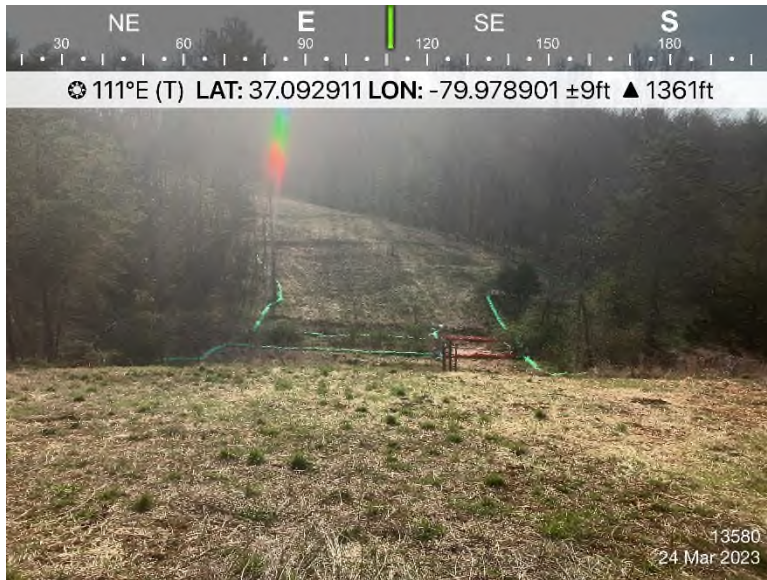
**Figure 1: STA 13580+00** – Controls in place and functioning properly.

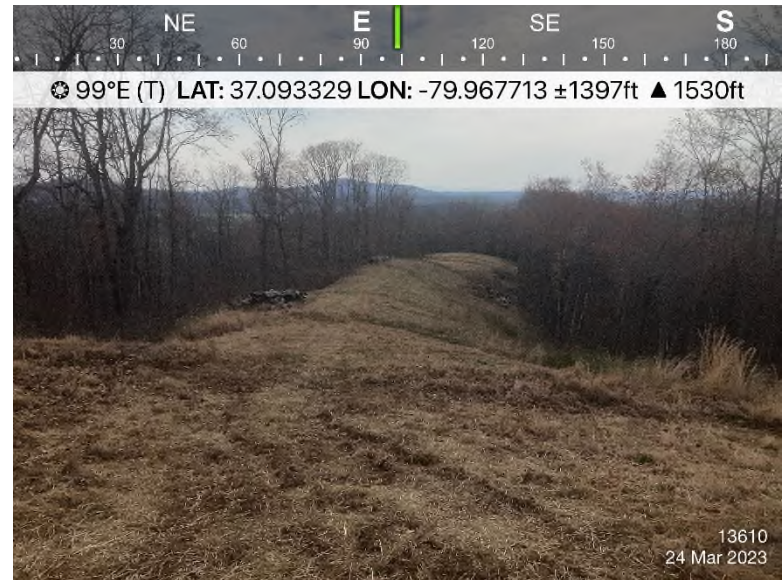
**Figure 2: STA 13610+00** – Controls in place and functioning properly.

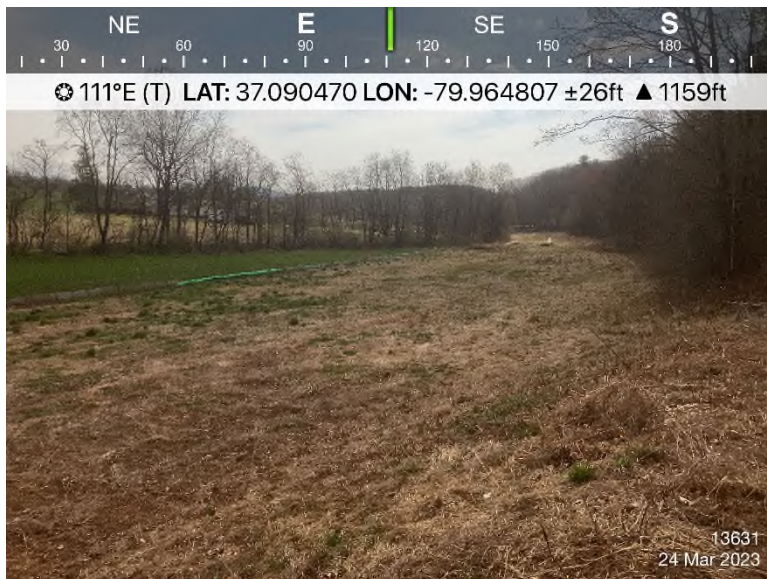
**Figure 3: STA 13631+00** – Controls in place and functioning properly.

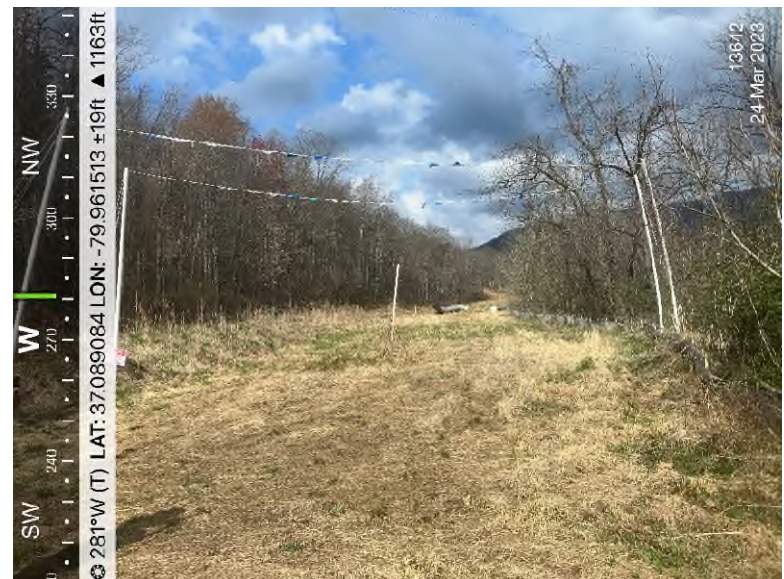
**Figure 4: STA 13642+00** – Controls in place and functioning properly.
