FIELD INSPECTION REPORT

Project Name:	Mountain Valley Pipeline	Inspector:	Marshall Willis
Inspection Date:	Wednesday, March 22, 2023	Project Contact:	Brian Clauto, Cory Chalmers
Spread I: Franklin County	STA 13437+75 – 13496+87 MVP-FR-293.02	Weather:	Rainy

FIELD INSPECTION PHOTO LOG

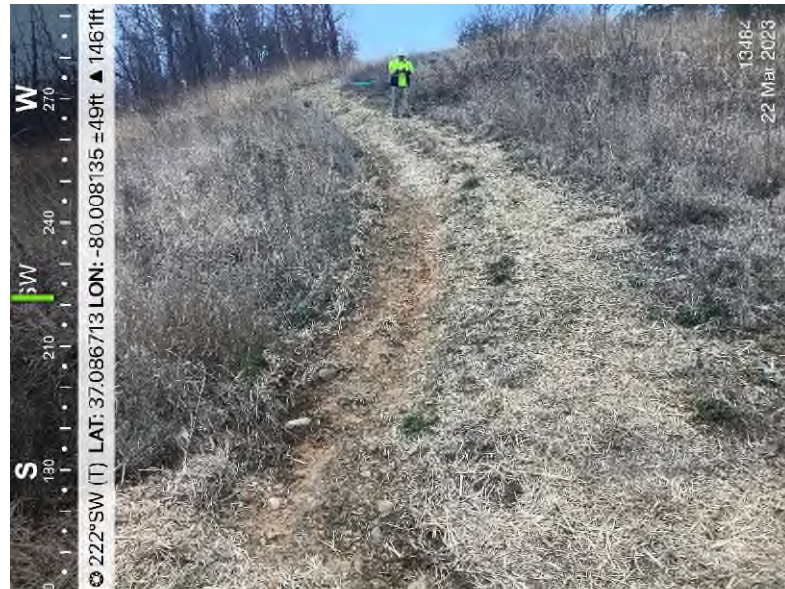
- STA 13484+00: Repair and restabilize scour.

Figure 1: STA 13484+00 – Repair and restabilize scour.

Recommended Corrective Action: Repair and restabilize scour.

Deadline: Within 72-Hour of Notification

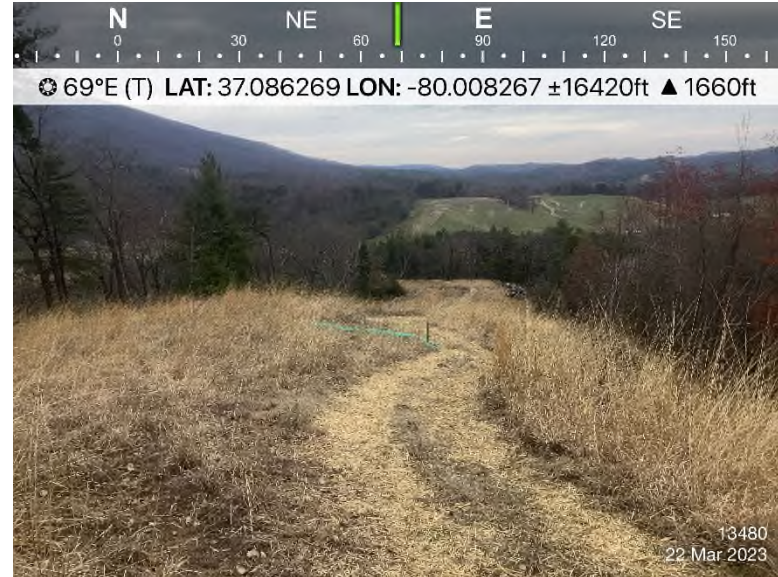
Figure 2: STA 13480+00 – Controls in place and functioning properly.

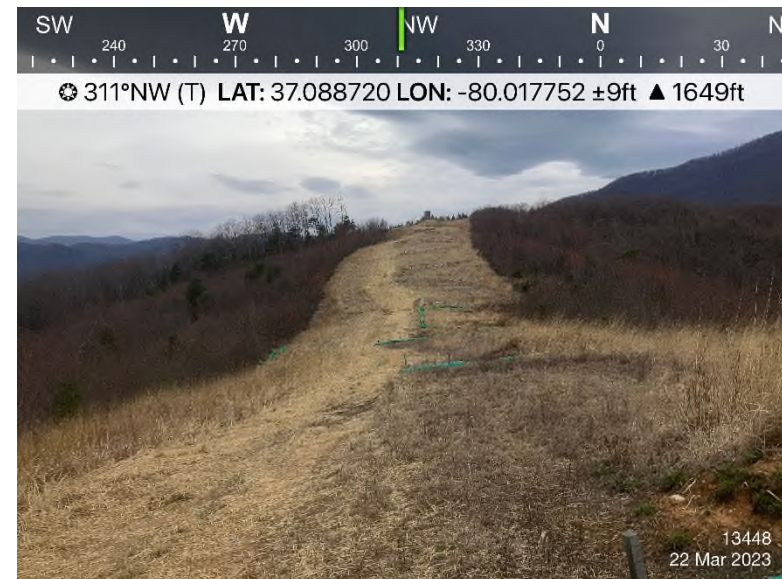
Figure 3: STA 13448+00 – Controls in place and functioning properly.

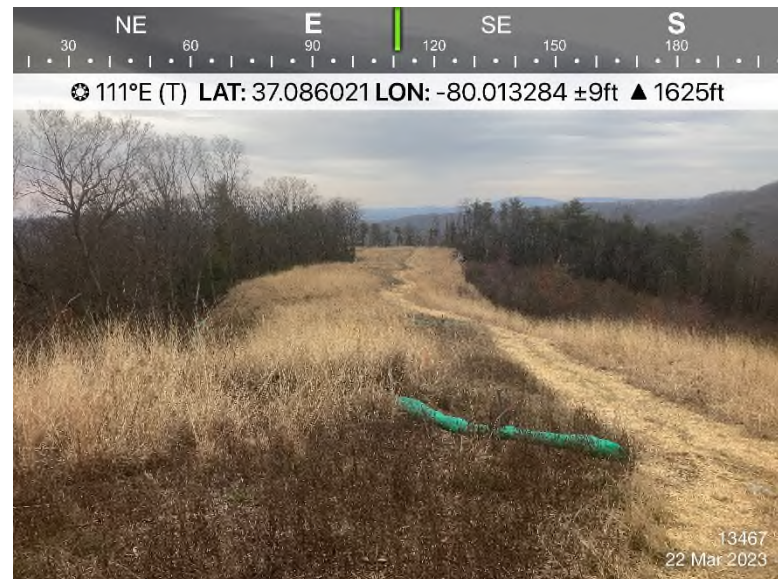
Figure 4: STA 13467+00 – Controls in place and functioning properly.
