FIELD INSPECTION REPORT

Project Name:	Mountain Valley Pipeline	Inspector:	Matthew Grant
Inspection Date:	Tuesday, April 25, 2023	Project Contact:	Brian Clauto
Spread H: Franklin	AR FR 290 Sta 12995-13067 ATWS 954, 344	Weather:	Dry

FIELD INSPECTION PHOTO LOG

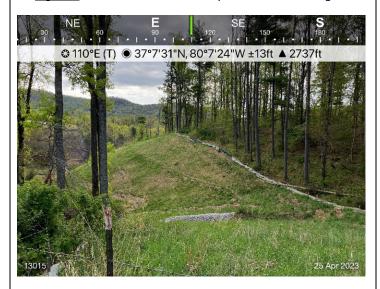
Figure 1: Sta 13015, ECD's are in place and functioning.

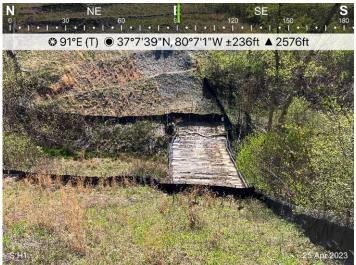
Figure 2: Designated crossings S-H1, ESC measures in place.

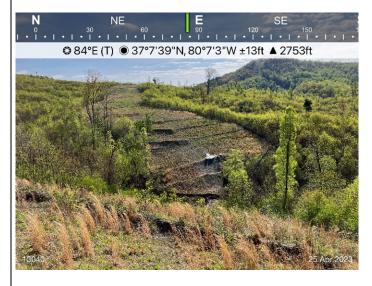
Figure 3: Sta 13040, ECD's are in place and functioning.

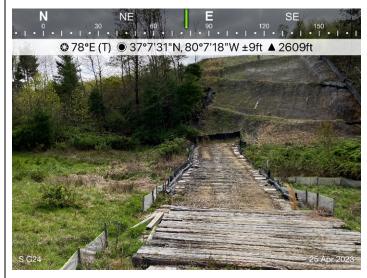
Figure 4: Designated crossing S-G24, ESC measures in place.
