## FIELD INSPECTION REPORT

| Project Name: | Mountain Valley Pipeline | Inspector: | Marshall Willis |
| Spread I:<br>Franklin County | STA 14928+52 – 14981+55<br>MVP-MLV-AR-33 | Weather: | Rainy |

# FIELD INSPECTION PHOTO LOG

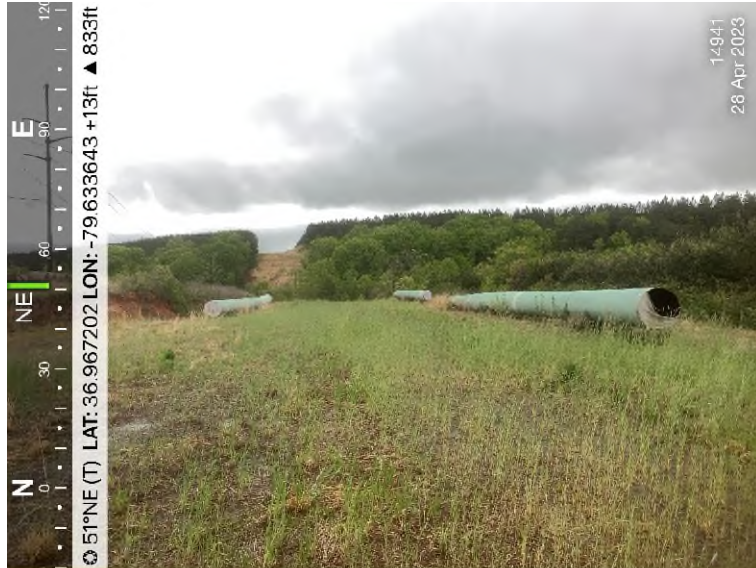
**Figure 1: STA 14941+00 – Controls in place and functioning properly.**

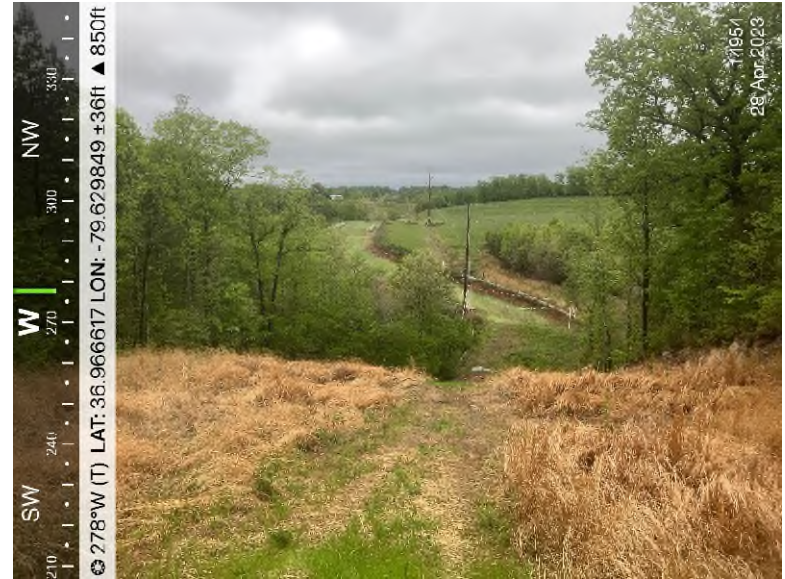
**Figure 2: STA 14954+00 – Controls in place and functioning properly.**

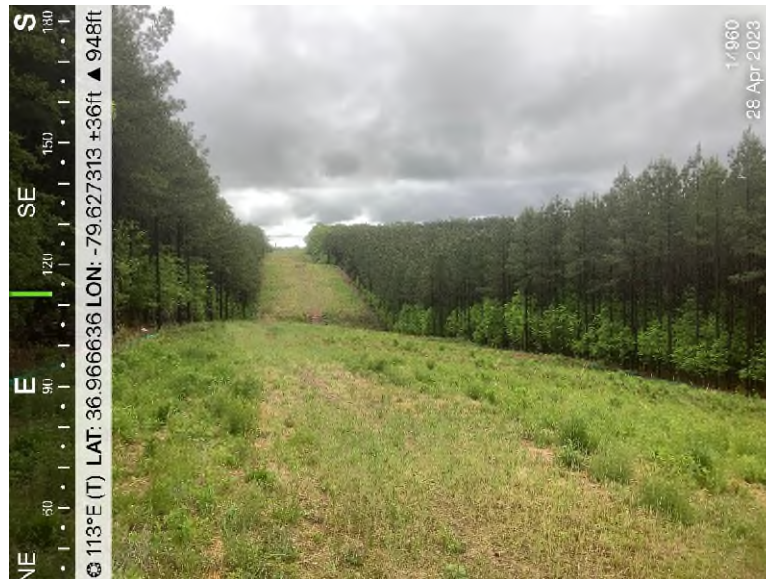
**Figure 3: STA 14960+00 – Controls in place and functioning properly.**

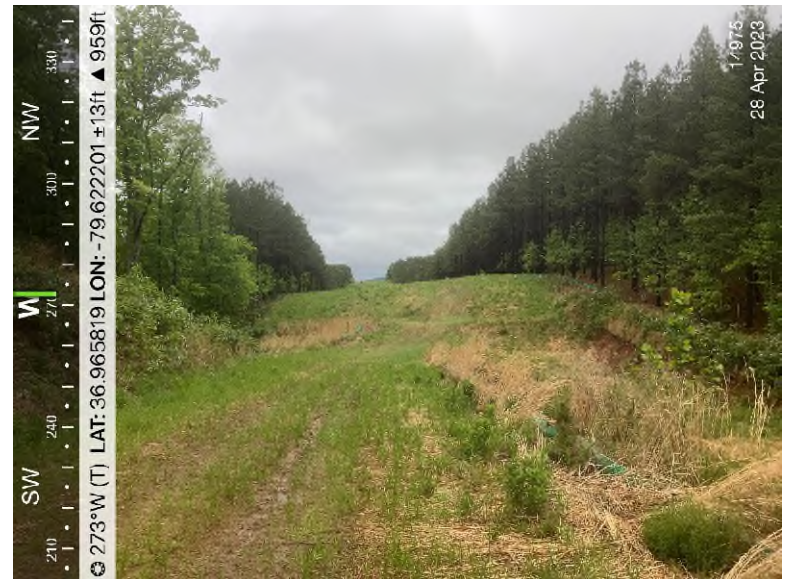
**Figure 4: STA 14975+00 – Controls in place and functioning properly.**
