FIELD INSPECTION REPORT

Project Name:	Mountain Valley Pipeline	Inspector:	Marshall Willis
Inspection Date:	Thursday, April 20, 2023	Project Contact:	Brian Clauto, Cory Chalmers
Spread I: Franklin County	STA 13892+45 – 13940+00 MVP-FR-305	Weather:	Dry

FIELD INSPECTION PHOTO LOG

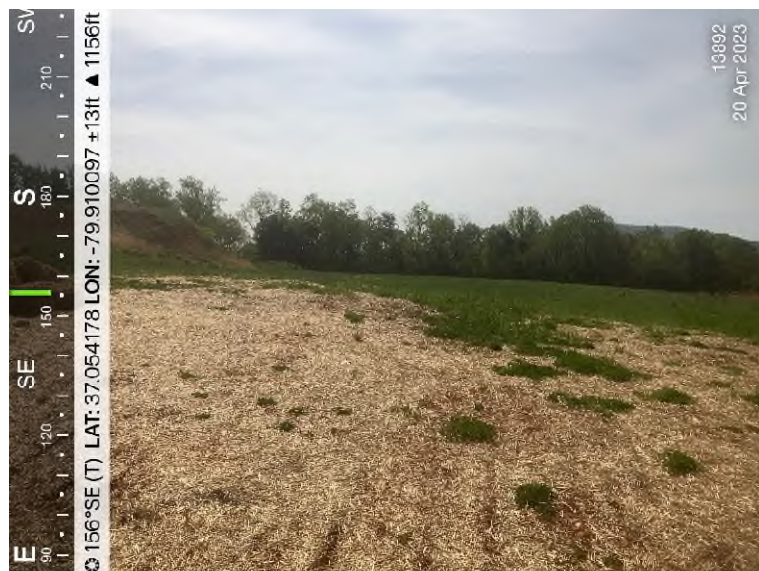
Figure 1: STA 13892+00 – Controls in place and functioning properly.

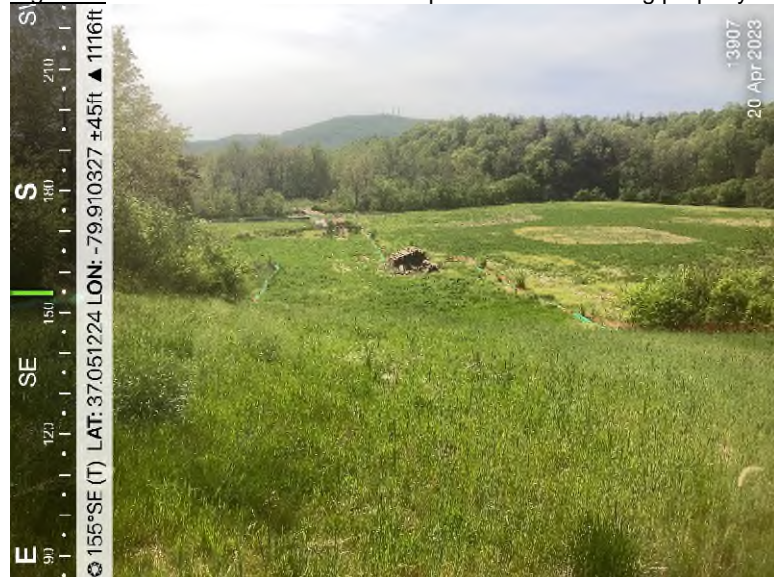
Figure 2: STA 13907+00 – Controls in place and functioning properly.

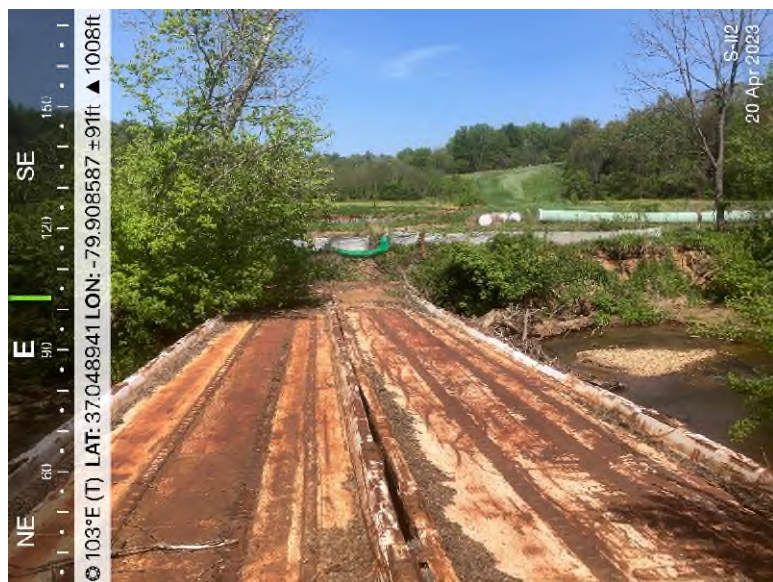
Figure 3: Stream S-II2 – Controls in place and functioning properly.

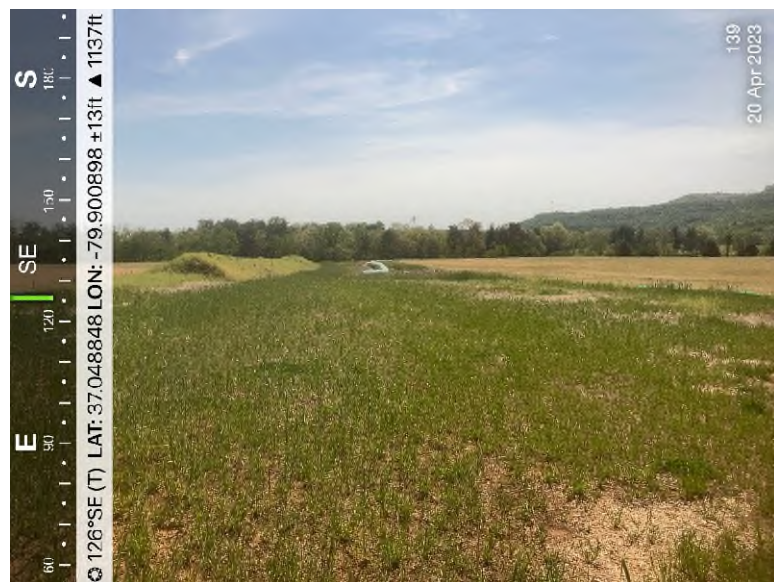
Figure 4: STA 13940+00 – Controls in place and functioning properly.
