## FIELD INSPECTION REPORT

| Project Name: | Mountain Valley Pipeline | Inspector: | Marshall Willis |
| Inspection Date: | Tuesday, April 25, 2023 | Project Contact: | Brian Clauto, Cory Chalmers |
| Spread H:<br>Franklin County | STA 12994+02 – 13061+44<br>MVP-FR-290 | Weather: | Dry |

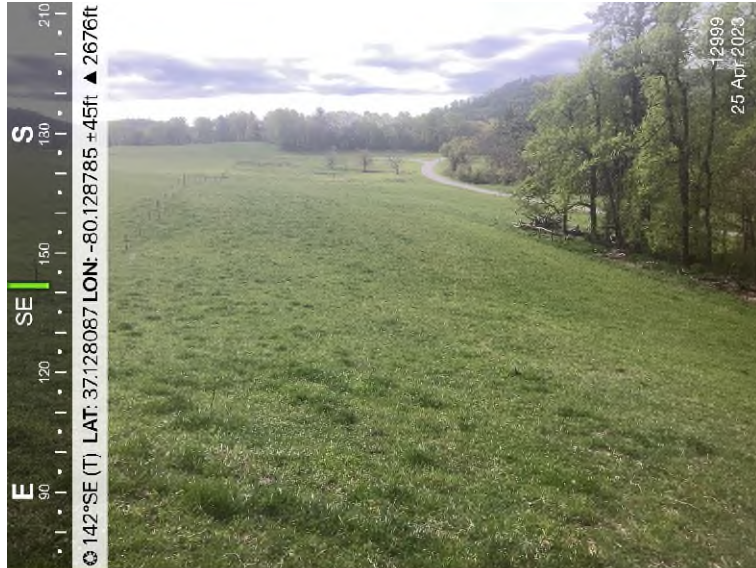
**Figure 1: STA 12999+00** – Controls in place and functioning properly.

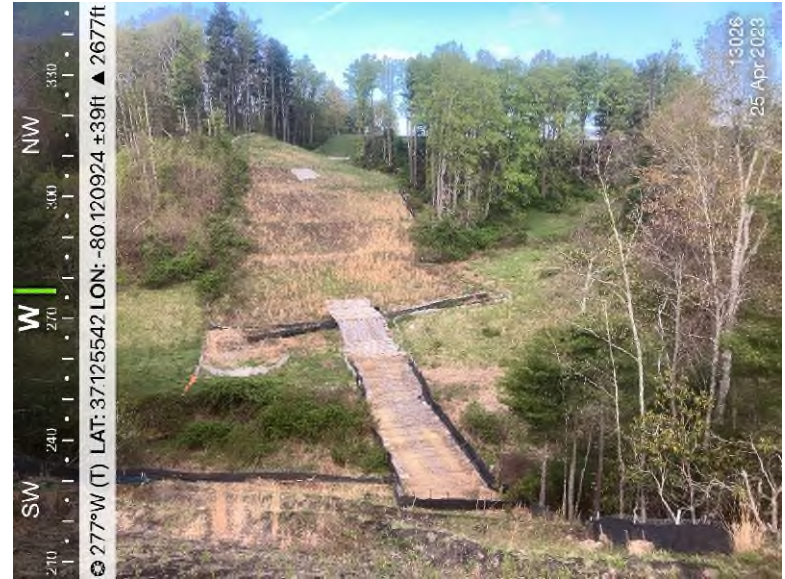
**Figure 2: STA 13026+00** – Controls in place and functioning properly.

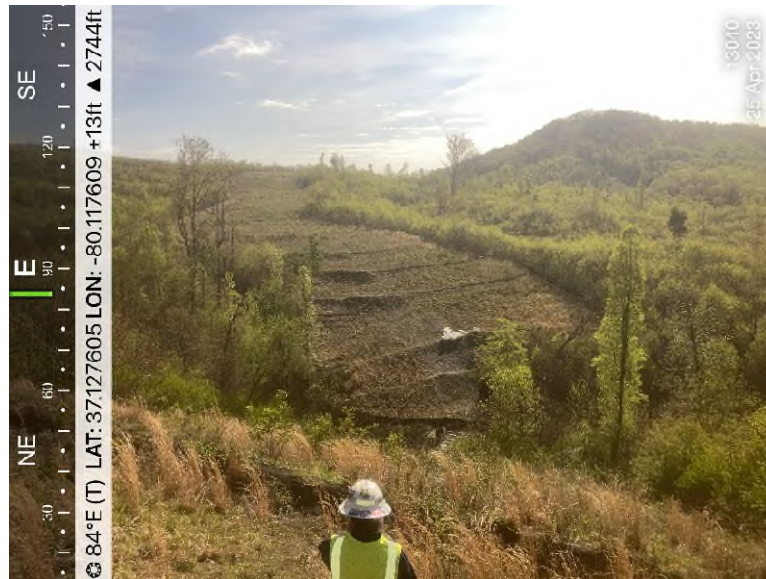
**Figure 3: STA 13040+00** – Controls in place and functioning properly.

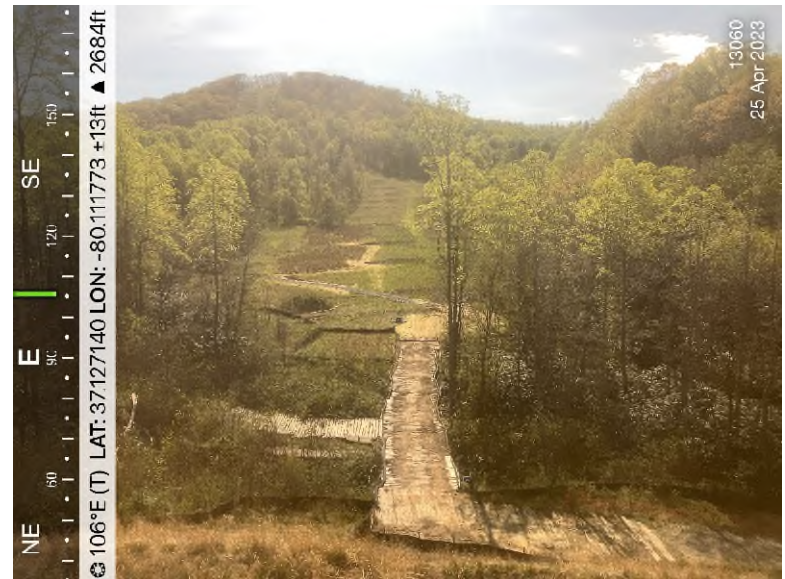
**Figure 4: STA 13060+00** – Controls in place and functioning properly.
