## FIELD INSPECTION REPORT

| Project Name: | Mountain Valley Pipeline | Inspector: | Marshall Willis |
| Inspection Date: | Thursday, April 13, 2023 | Project Contact: | Brian Clauto, Cory Chalmers |
| Spread H:<br>Roanoke County | STA 12601+00 – 12637+00<br>MVP-RO-279.01/02 | Weather: | Dry |

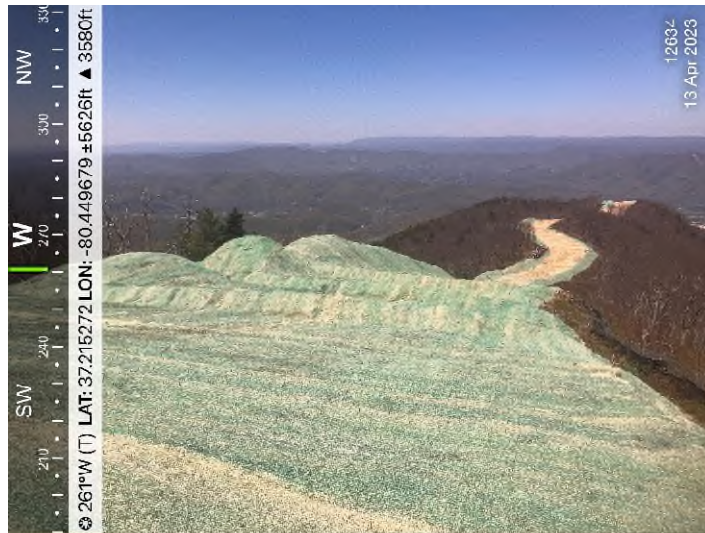
**Figure 1: STA 12634+00** – Controls in place and functioning properly.

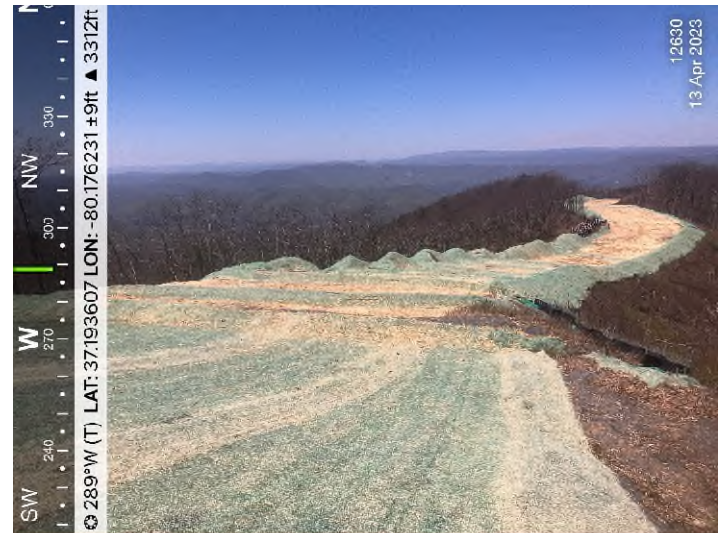
**Figure 2: STA 12630+00** – Controls in place and functioning properly.

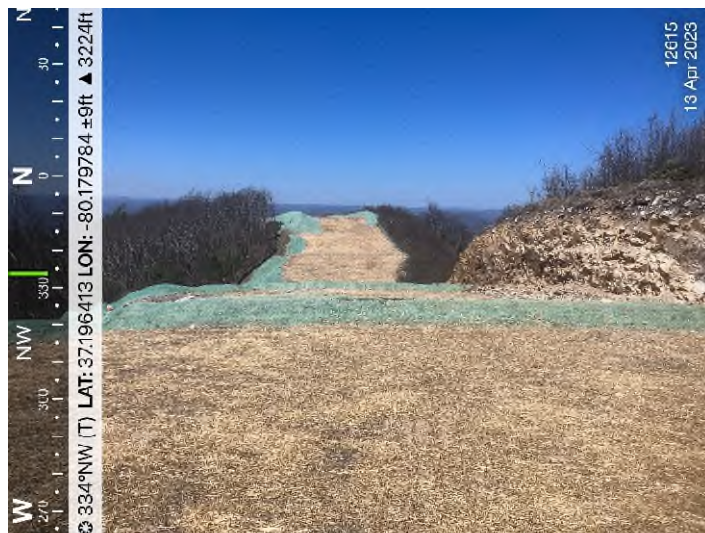
**Figure 3: STA 12615+00** – Controls in place and functioning properly.

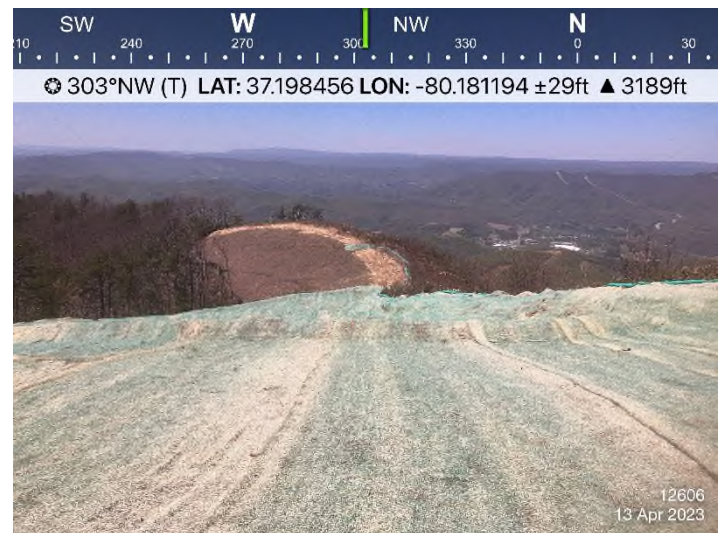
**Figure 4: STA 12606+00** – Controls in place and functioning properly.
