## FIELD INSPECTION REPORT

| <b>Project Name:</b> | Mountain Valley Pipeline | <b>Inspector:</b> | Marshall Willis |
| <b>Spread H:<br/>Montgomery County</b> | STA 12373+28 – 12422+32<br>MVP-MLV-AR-27<br>MVP-MN-279.02 | <b>Weather:</b> | Dry |

## FIELD INSPECTION PHOTO LOG

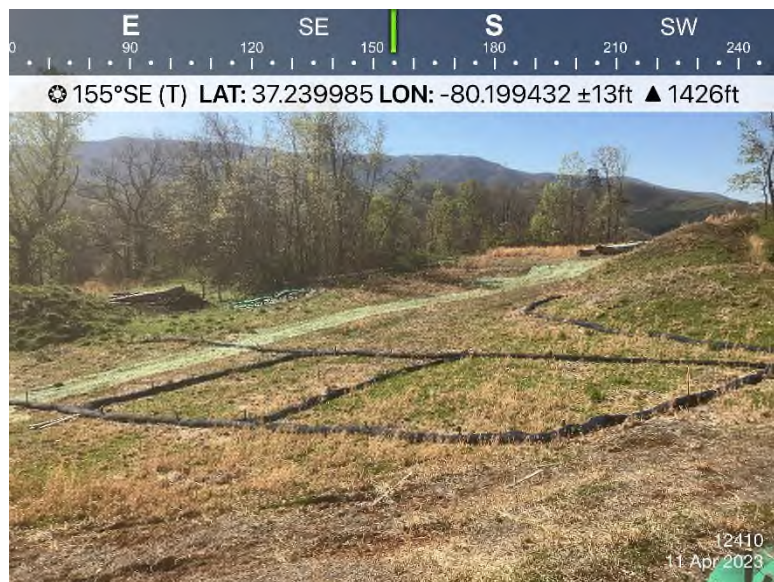
**Figure 1: STA 12410+00** – Controls in place and functioning properly.

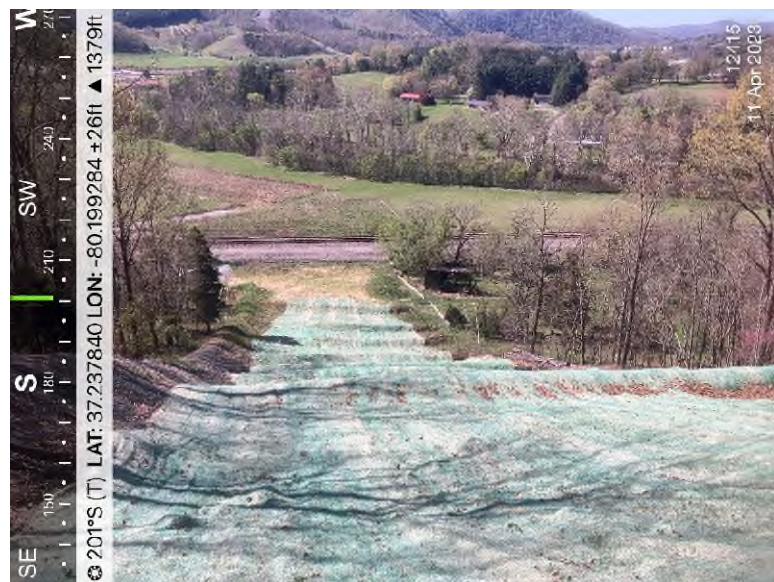
**Figure 2: STA 12415+00** – Controls in place and functioning properly.

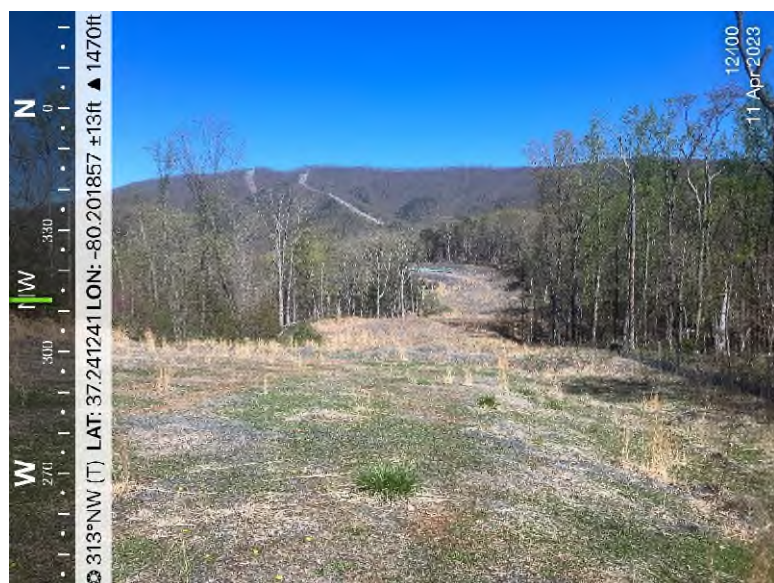
**Figure 3: STA 12400+00** – Controls in place and functioning properly.

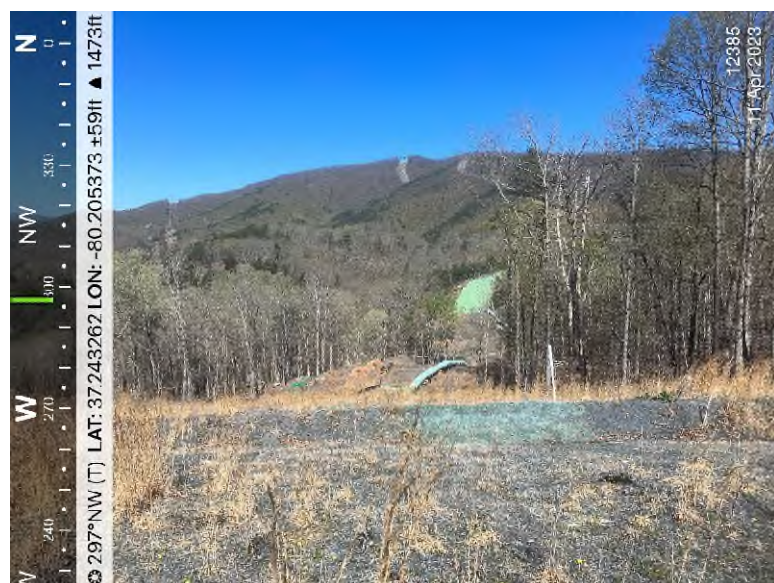
**Figure 4: STA 12385+00** – Controls in place and functioning properly.
