## FIELD INSPECTION REPORT

| Project Name: | Mountain Valley Pipeline | Inspector: | Marshall Willis |
| Spread I:<br>Franklin County | STA 13826+95 – 13892+45<br>MVP-FR-302 | Weather: | Dry |

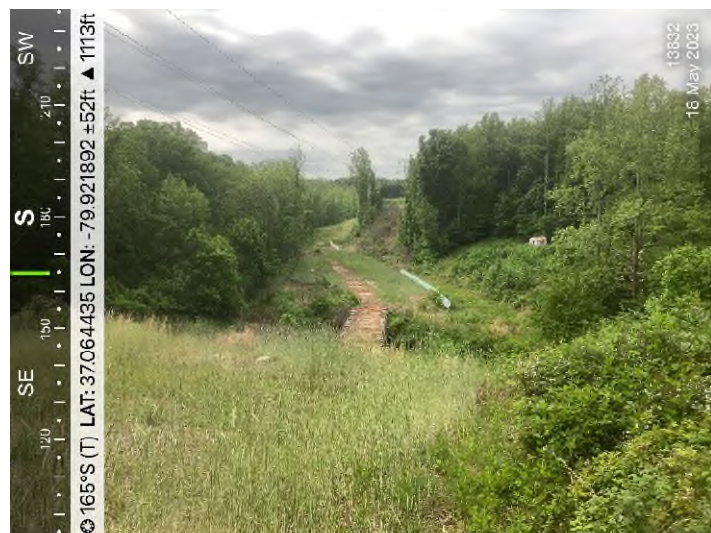
**Figure 1: STA 13832+00** – Controls in place and functioning properly.

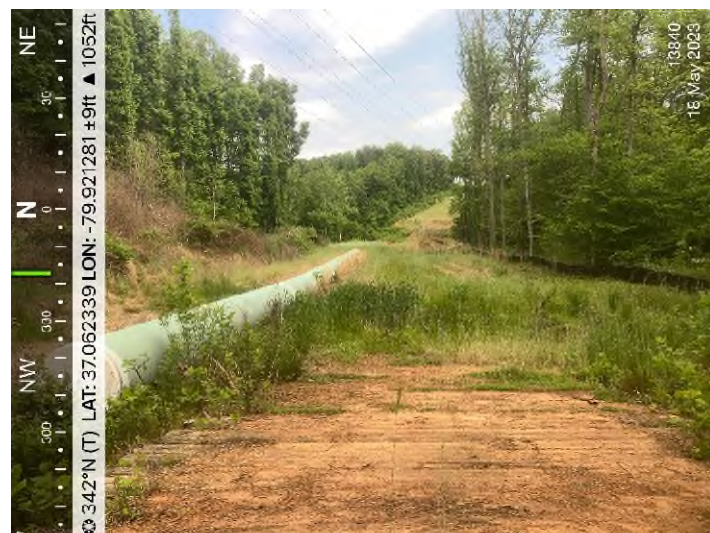
**Figure 2: STA 13840+00** – Controls in place and functioning properly.

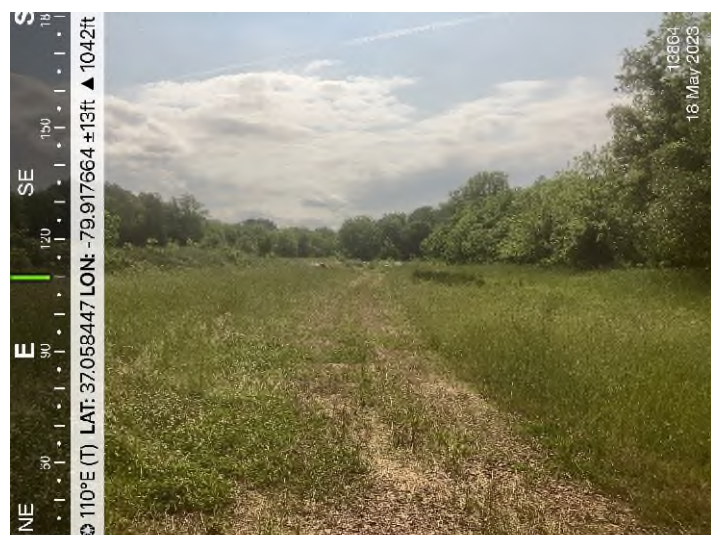
**Figure 3: STA 13864+00** – Controls in place and functioning properly.

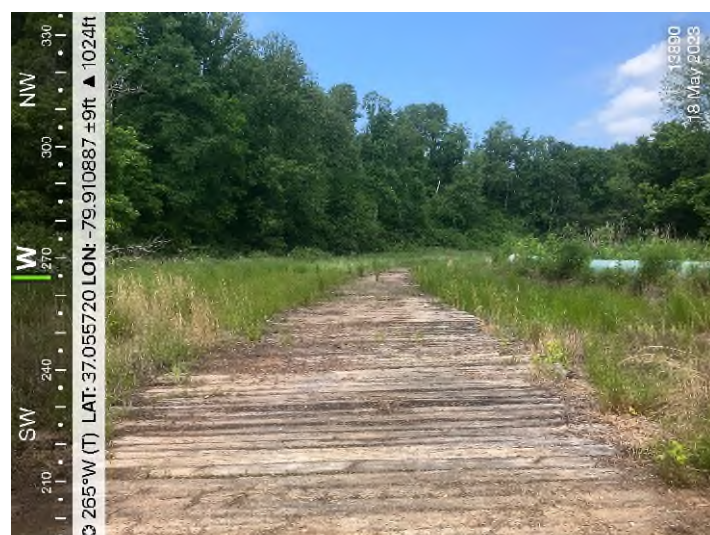
**Figure 4: STA 13890+00** – Controls in place and functioning properly.
