## FIELD INSPECTION REPORT

| Project Name: | Mountain Valley Pipeline | Inspector: | Marshall Willis |
| Spread I:<br>Franklin County | STA 13644+82 – 13690+91 | Weather: | Dry |

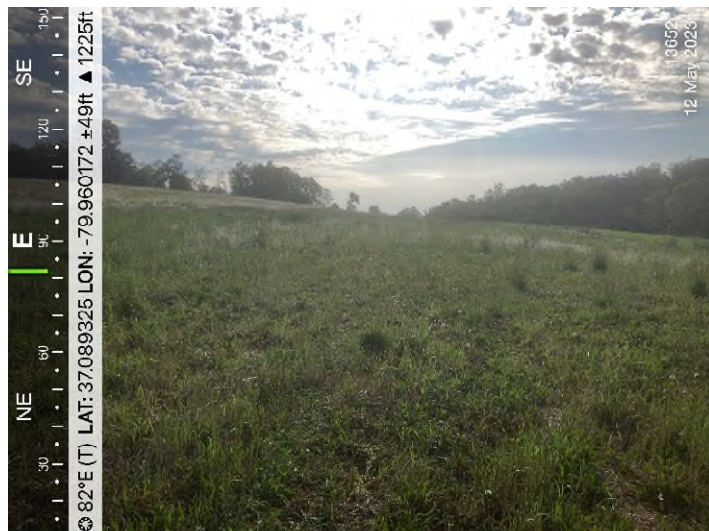
**Figure 1: STA 13652+00** – Controls in place and functioning properly.

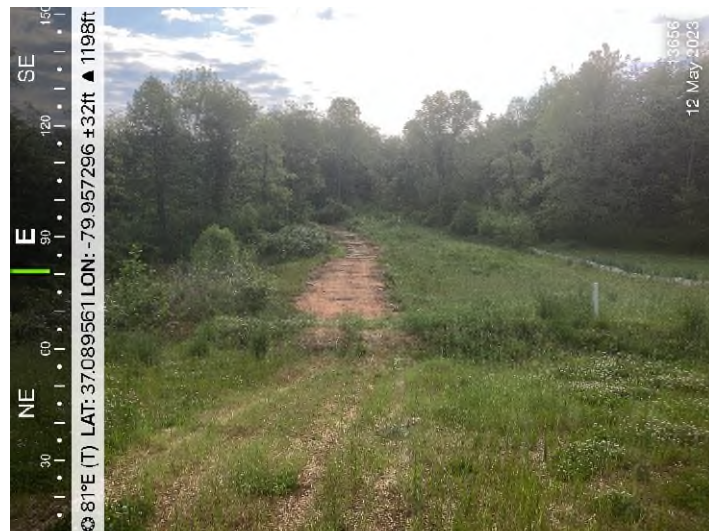
**Figure 2: STA 13656+00** – Controls in place and functioning properly.

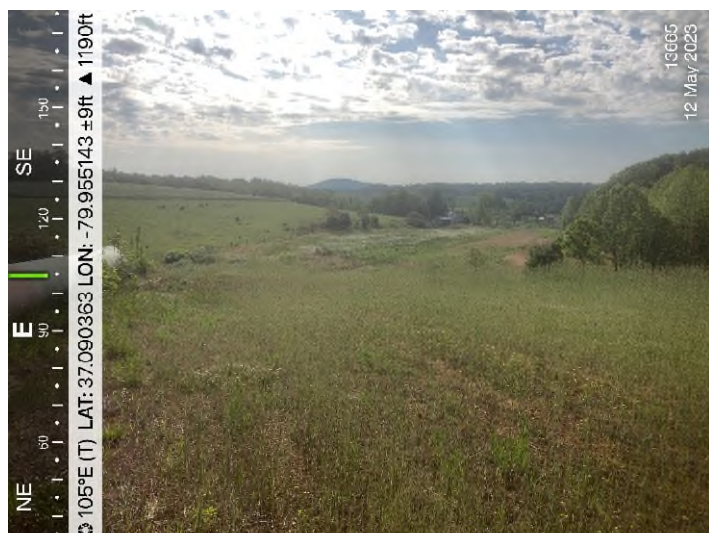
**Figure 3: STA 13665+00** – Controls in place and functioning properly.

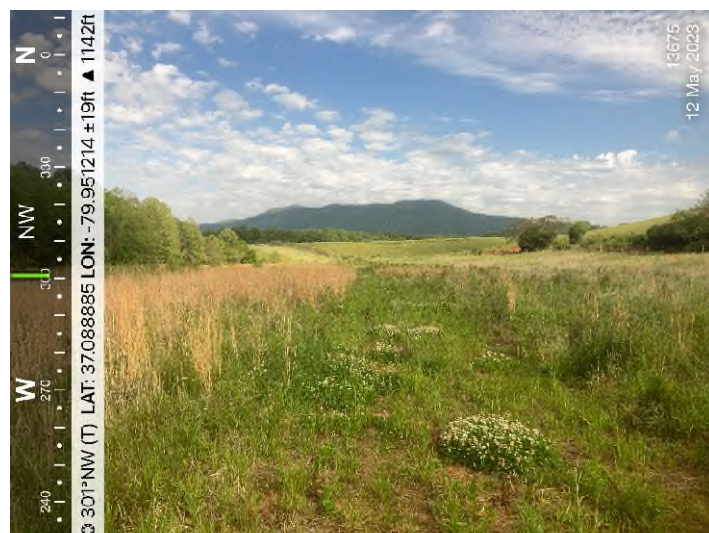
**Figure 4: STA 13675+00** – Controls in place and functioning properly.
