## FIELD INSPECTION REPORT

| Project Name: | Mountain Valley Pipeline | Inspector: | Marshall Willis |
| Inspection Date: | Wednesday, May 17, 2023 | Project Contact: | Brian Clauto, Cory Chalmers |
| Spread H:<br>Franklin County | STA 13061+44 – 13116+87<br>MVP-FR-290/291 | Weather: | Dry |

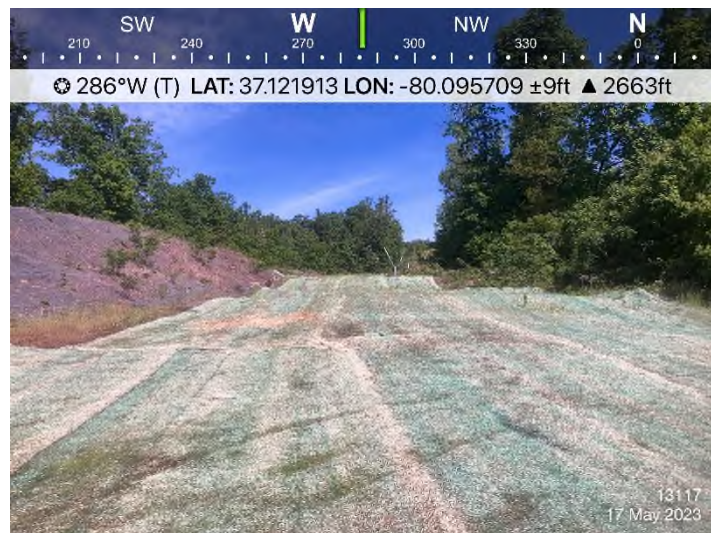
**Figure 1: STA 13117+00** – Controls in place and functioning properly.

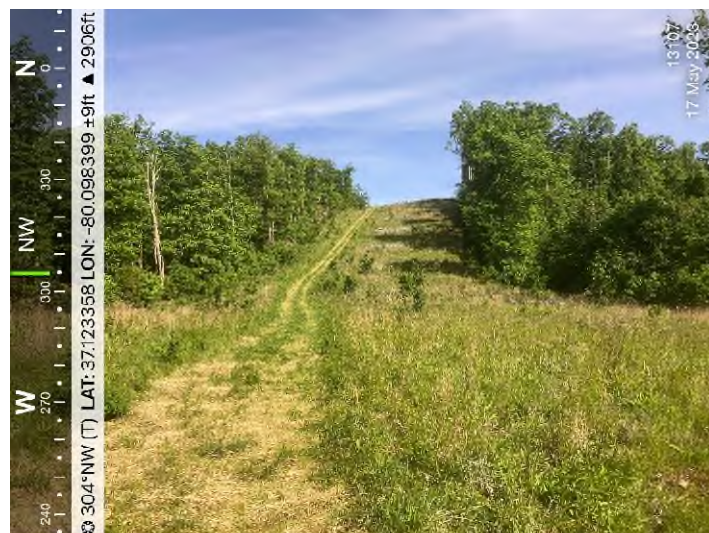
**Figure 2: STA 13107+00** – Controls in place and functioning properly.

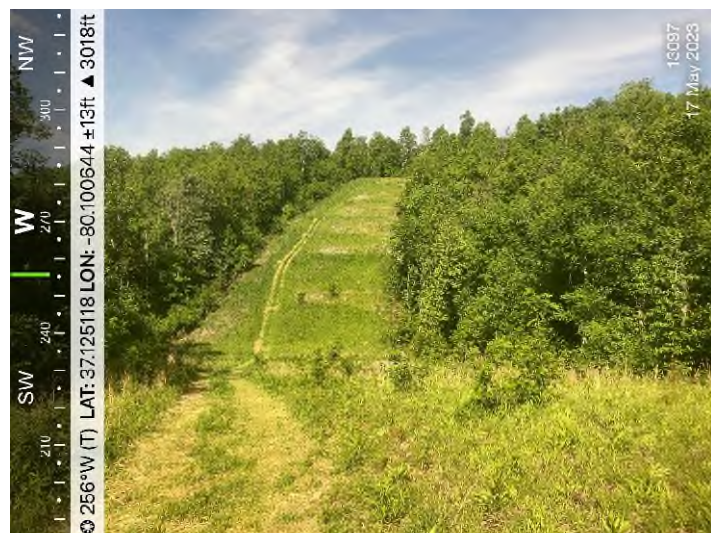
**Figure 3: STA 13097+00** – Controls in place and functioning properly.

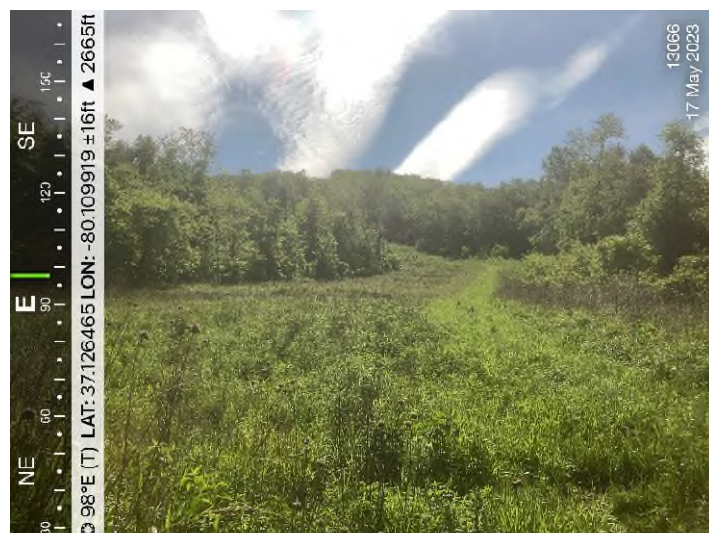
**Figure 4: STA 13066+00** – Controls in place and functioning properly.
