## FIELD INSPECTION REPORT

| <b>Project Name:</b> | Mountain Valley Pipeline | <b>Inspector:</b> | Marshall Willis |
| <b>Spread H:<br/>Roanoke County</b> | STA 12690+43 – 12729+12<br>MVP-RO-281<br>MVP-RO-280 | <b>Weather:</b> | Dry |

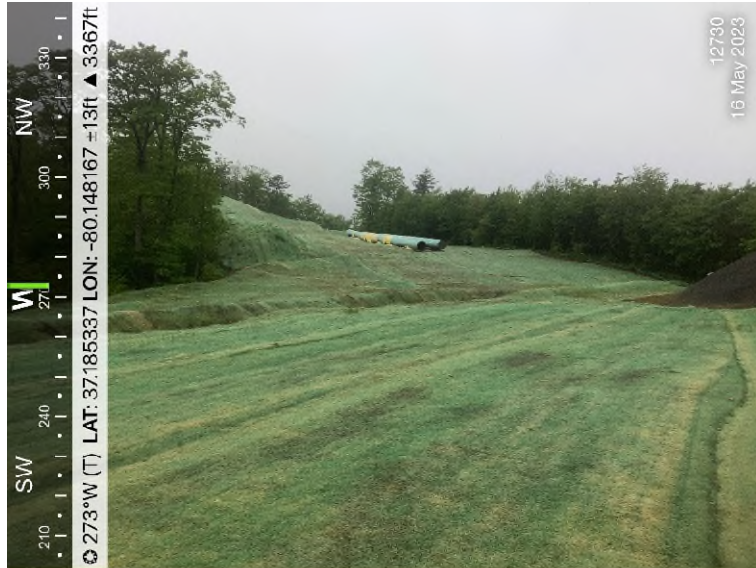
**Figure 1: STA 12730+00 – Controls in place and functioning properly.**

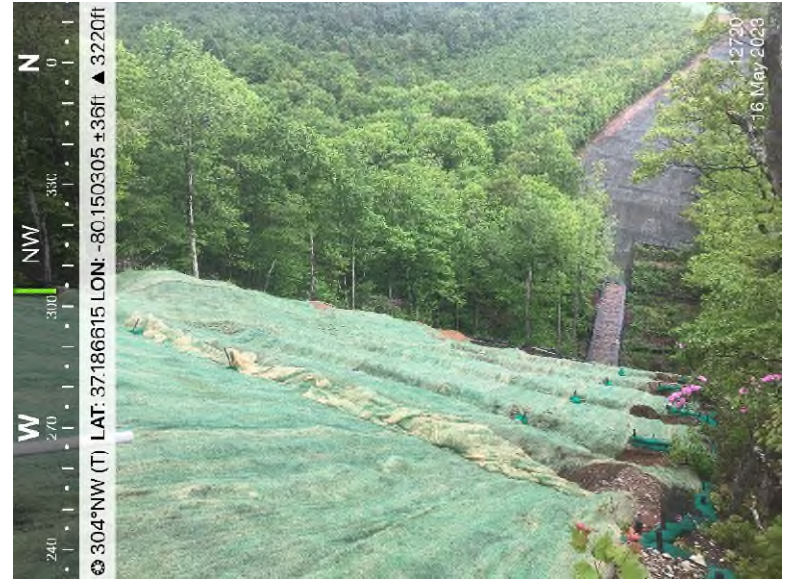
**Figure 2: STA 12720+00 – Controls in place and functioning properly.**

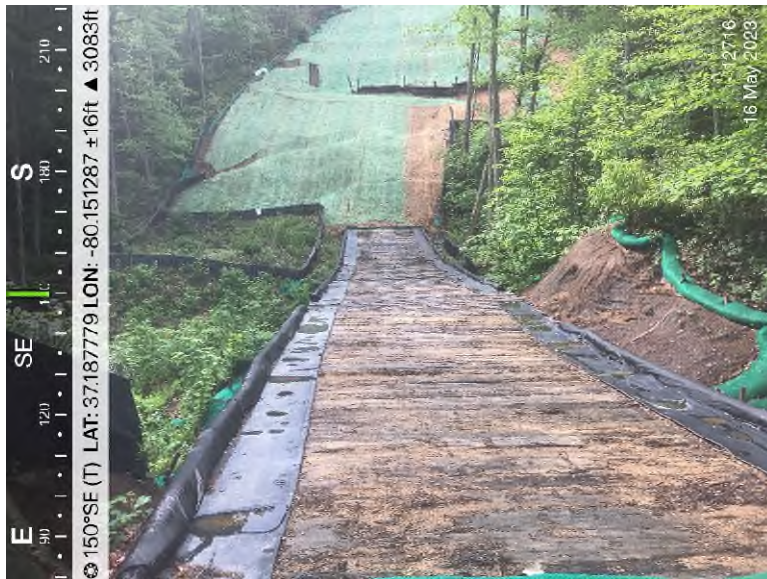
**Figure 3: STA 12716+00 – Controls in place and functioning properly.**

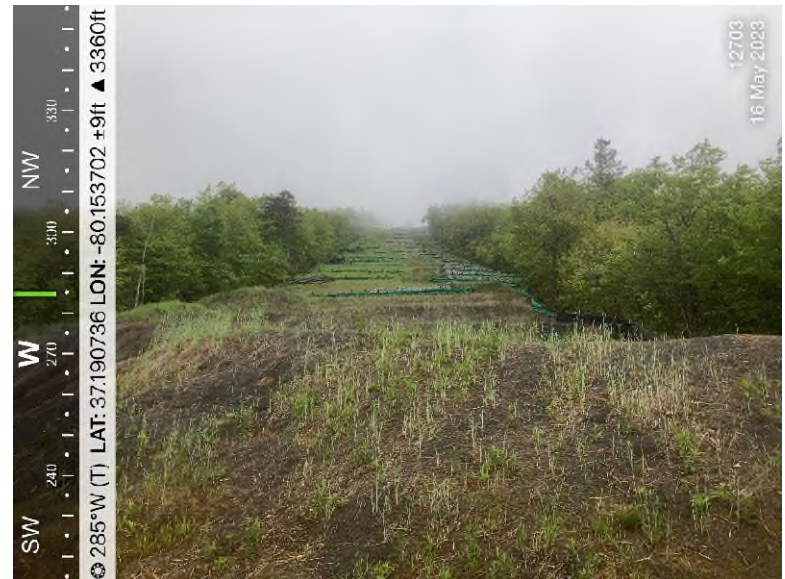
**Figure 4: STA 12703+00 – Controls in place and functioning properly.**
