## FIELD INSPECTION REPORT

| <b>Project Name:</b> | Mountain Valley Pipeline | <b>Inspector:</b> | Marshall Willis |
| <b>Spread H:<br/>Roanoke County</b> | STA 12945+00 – 12982+00<br>MVP-RO-287<br>MVP-RO-288 | <b>Weather:</b> | Dry |

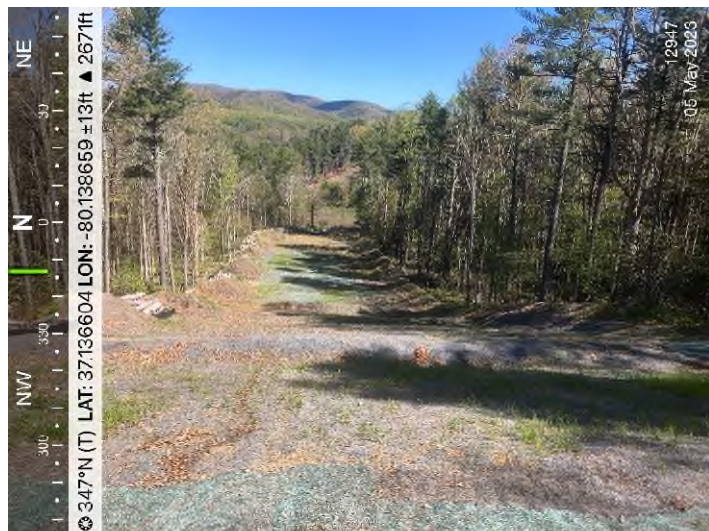
**Figure 1: STA 12947+00** – Controls in place and functioning properly.

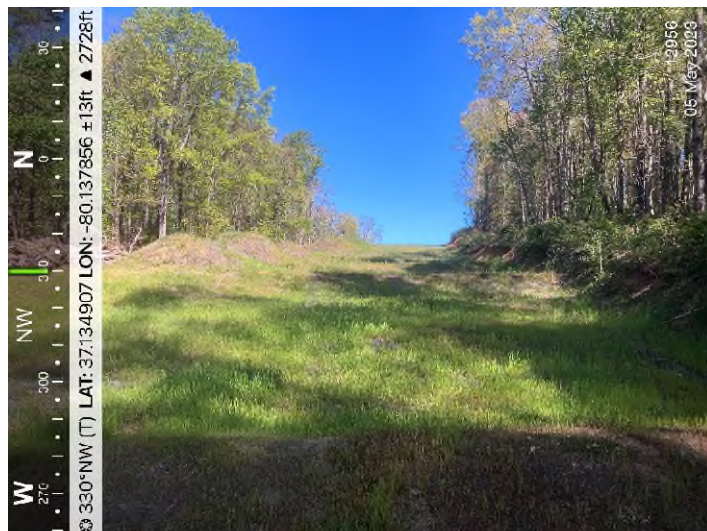
**Figure 2: STA 12956+00** – Controls in place and functioning properly.

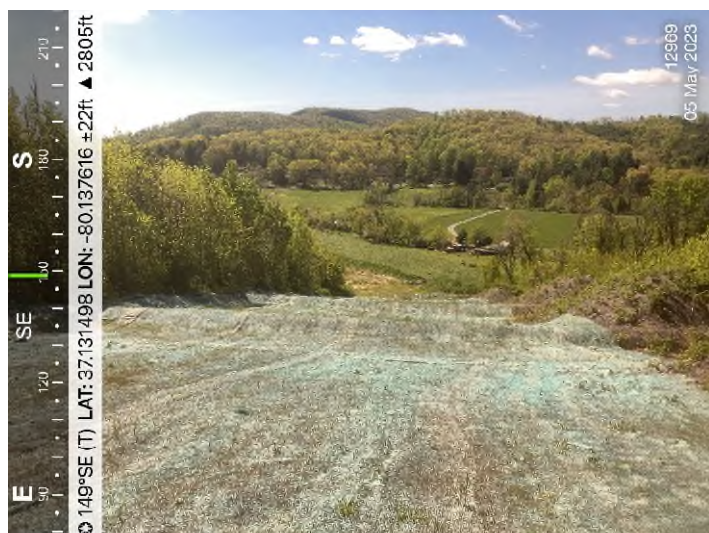
**Figure 3: STA 12969+00** – Controls in place and functioning properly.

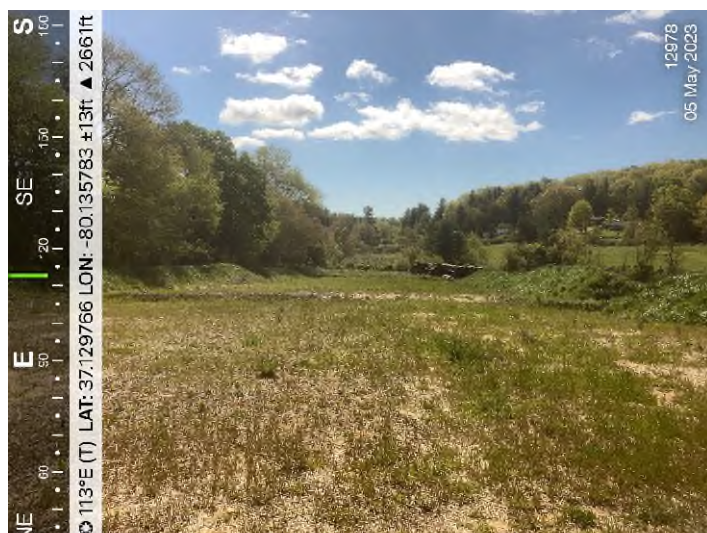
**Figure 4: STA 12978+00** – Controls in place and functioning properly.
