## FIELD INSPECTION REPORT

| Project Name: | Mountain Valley Pipeline | Inspector: | Marshall Willis |
| Spread H:<br>Montgomery County | STA 12298+39 – 12371+23<br>MVP-MN-276.03 | Weather: | Dry |

# FIELD INSPECTION PHOTO LOG

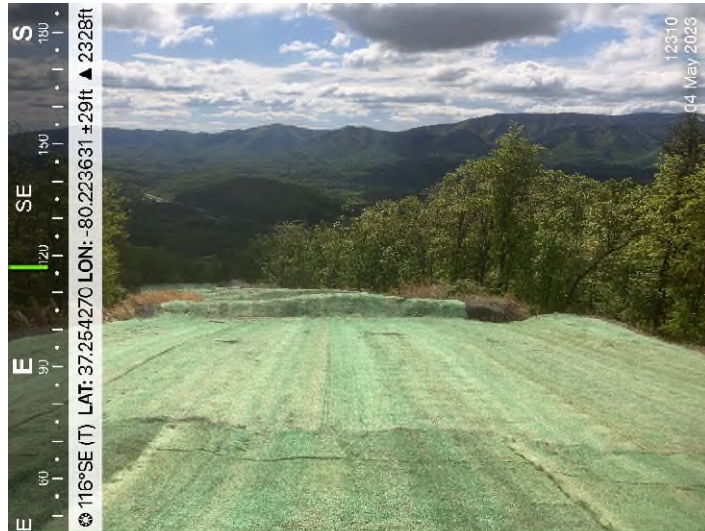
**Figure 1: STA 12310+00** – Controls in place and functioning properly.

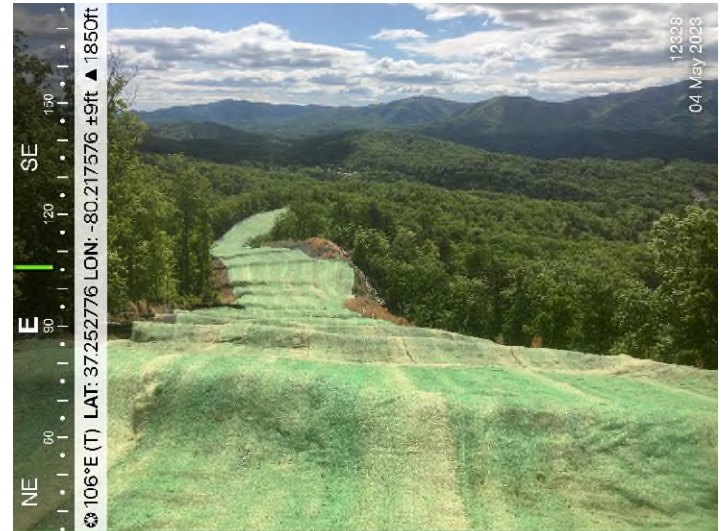
**Figure 2: STA 12328+00** – Controls in place and functioning properly.

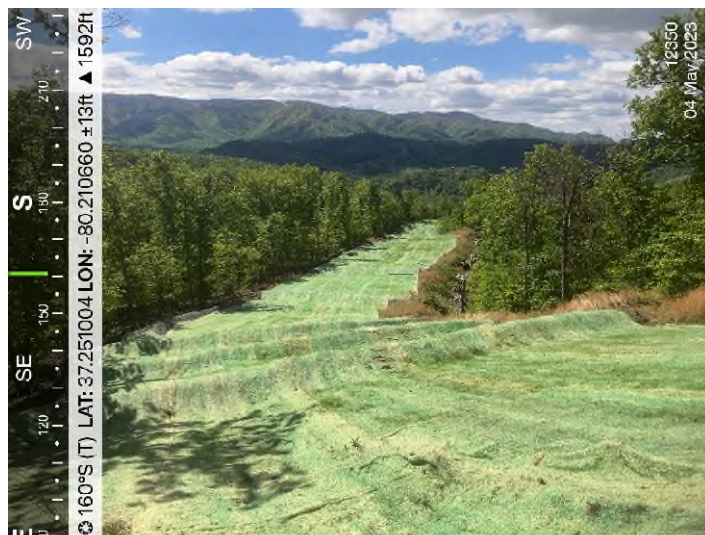
**Figure 3: STA 12350+00** – Controls in place and functioning properly.

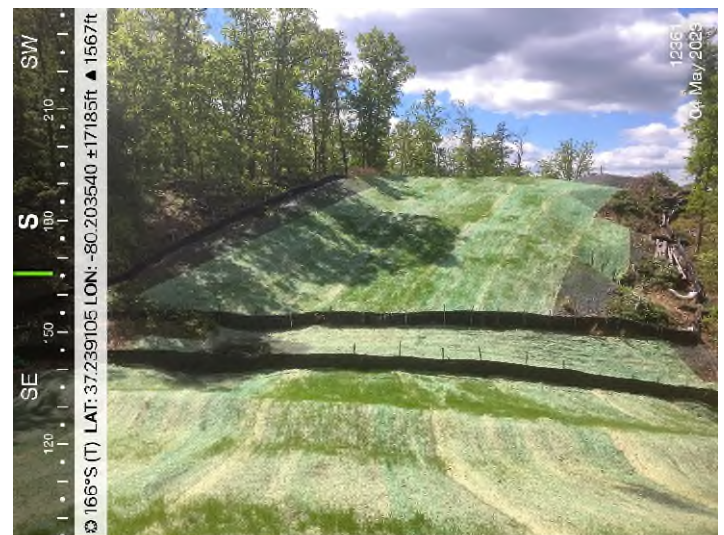
**Figure 4: STA 12361+00** – Controls in place and functioning properly.
