## FIELD INSPECTION REPORT

| Project Name: | Mountain Valley Pipeline | Inspector: | Marshall Willis |
| Inspection Date: | Thursday, June 8, 2023 | Project Contact: | Brian Clauto, Cory Chalmers |
| Spread I:<br>Franklin County | STA 14928+52 – 14981+55 | Weather: | Dry |

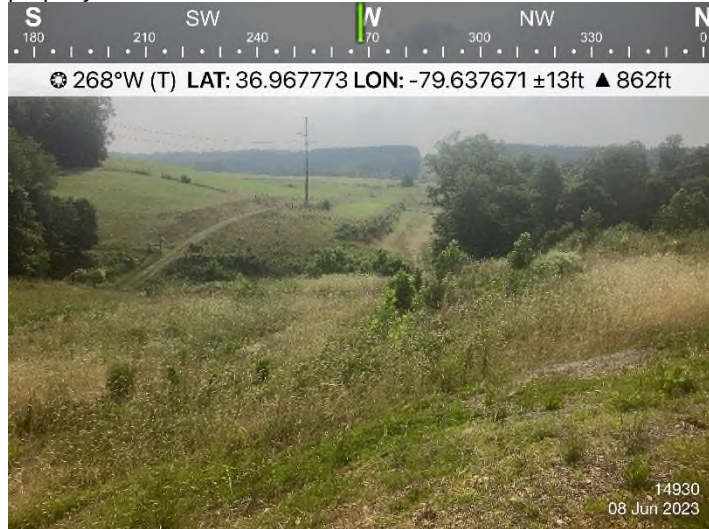
**Figure 1: STA 14930+00** – Controls in place and functioning properly.

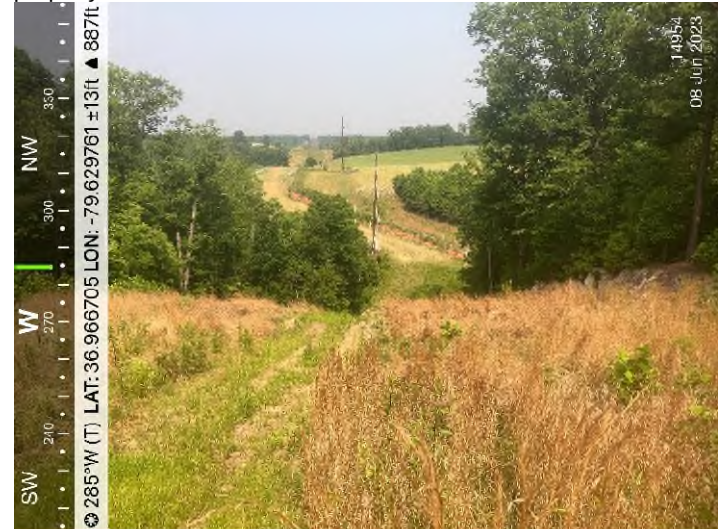
**Figure 2: STA 14954+00** – Controls in place and functioning properly.

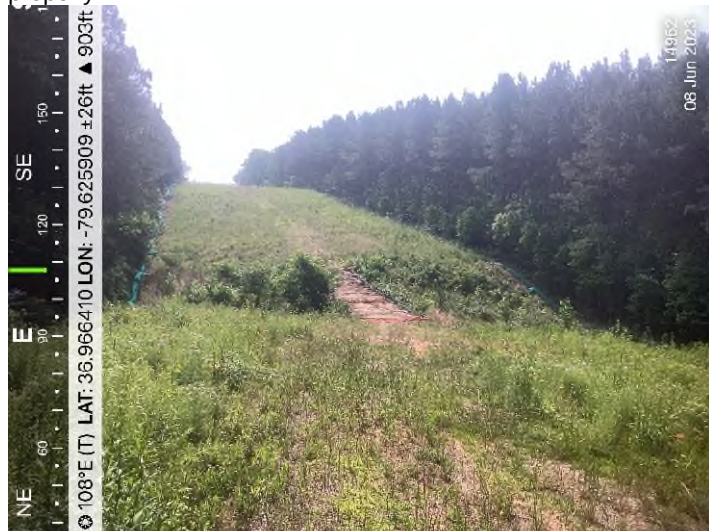
**Figure 3: STA 14962+00** – Controls in place and functioning properly.

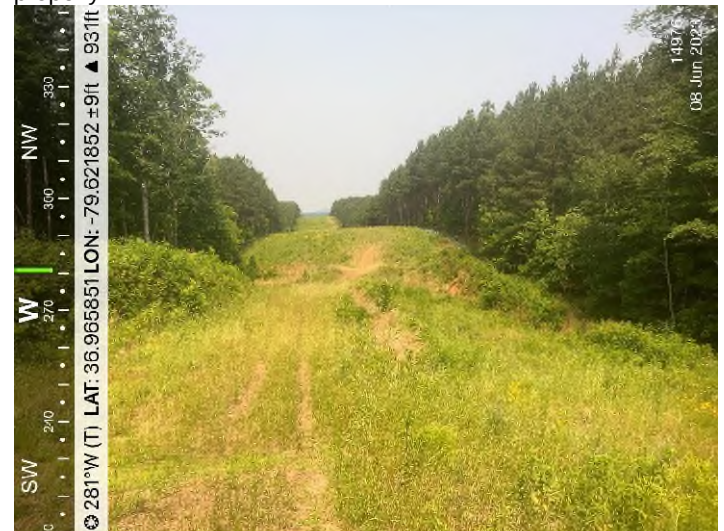
**Figure 4: STA 14978+00** – Controls in place and functioning properly.
