## FIELD INSPECTION REPORT

| Project Name: | Mountain Valley Pipeline | Inspector: | Marshall Willis |
| Inspection Date: | Wednesday, June 7, 2023 | Project Contact: | Brian Clauto, Cory Chalmers |
| Spread I:<br>Franklin County | STA 14758+16 – 14845+68 | Weather: | Dry |

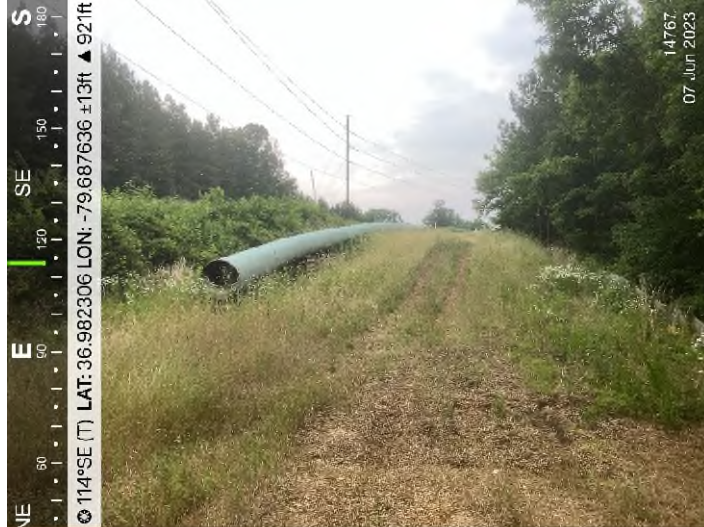
**Figure 1: STA 14767+00 – Controls in place and functioning properly.**

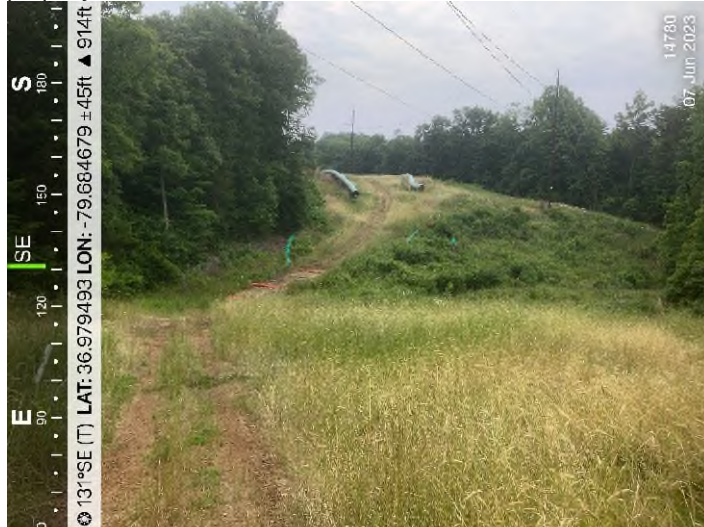
**Figure 3: STA 14780+00 – Controls in place and functioning properly.**

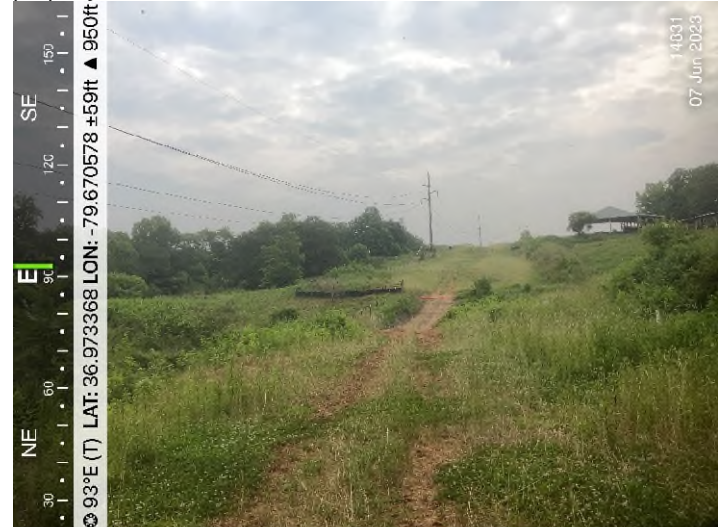
**Figure 4: STA 14831+00 – Controls in place and functioning properly.**
