FIELD INSPECTION REPORT

Project Name:	Mountain Valley Pipeline	Inspector:	Marshall Willis			
Inspection Date:	Wednesday, May 24, 2023	Project Contact:	Brian Clauto, Cory Chalmers			
Spread I: Franklin County	STA 14062+17 - 14171+36 MVP-FR-309.05/309.06	Weather:	Dry

FIELD INSPECTION PHOTO LOG

Project Name: Mountain Valley Pipeline

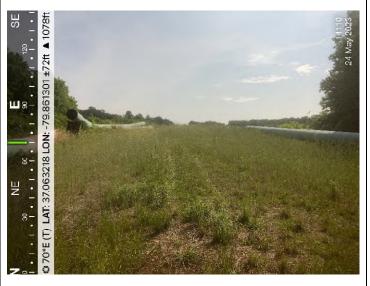
Figure 2: STA 14110+00 – Controls in place and functioning properly.

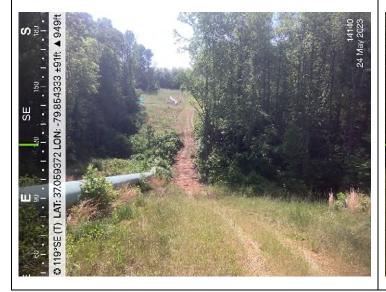
<u>Figure 3</u>: **STA 14140+00** – Controls in place and functioning properly.

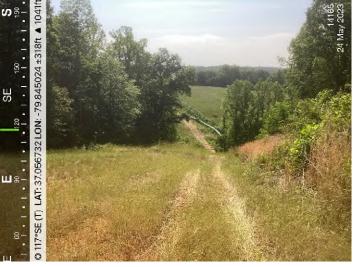
<u>Figure 4</u>: **STA 14165+00** – Controls in place and functioning properly.
