## FIELD INSPECTION REPORT

| Project Name: | Mountain Valley Pipeline | Inspector: | Marshall Willis |
| Spread H:<br>Montgomery County | Pipeyard 006 | Weather: | Dry |

## FIELD INSPECTION PHOTO LOG

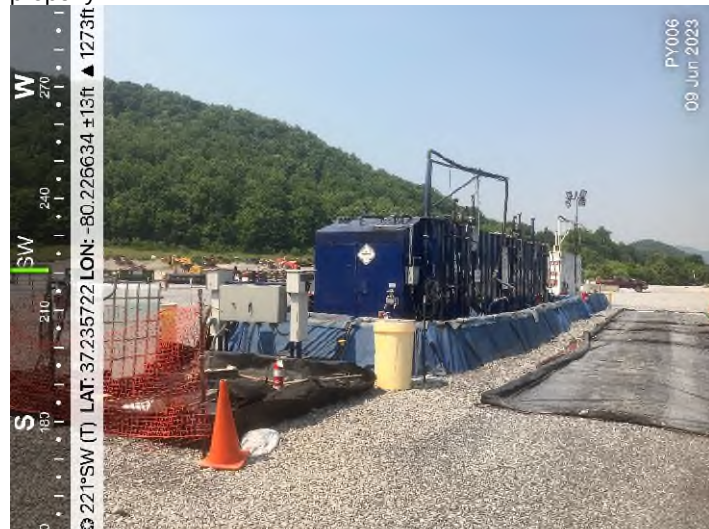
**Figure 1: Pipeyard 006 – Controls in place and functioning properly.**

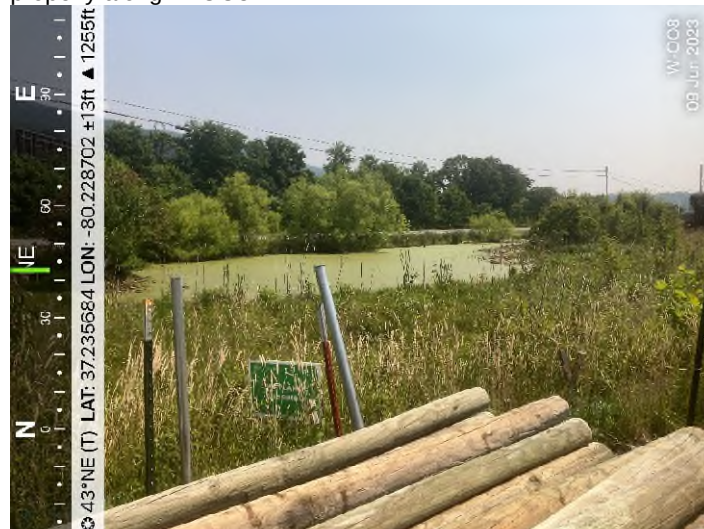
**Figure 2: Pipeyard 006 – Controls in place and functioning properly along W-008.**

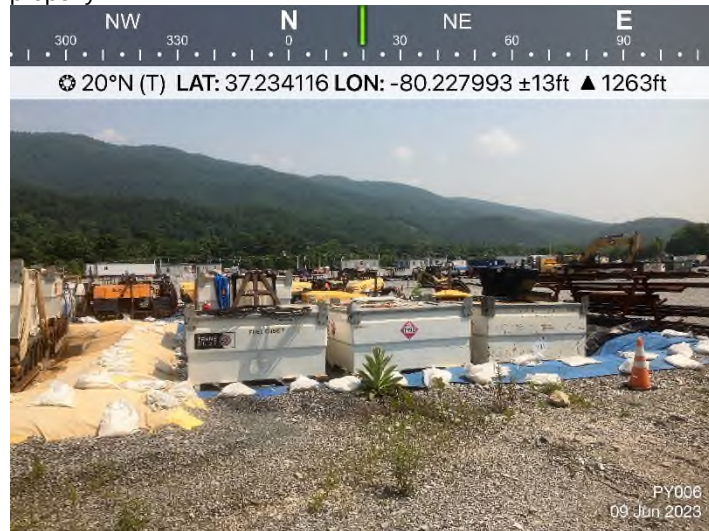
**Figure 3: Pipeyard 006 – Controls in place and functioning properly.**

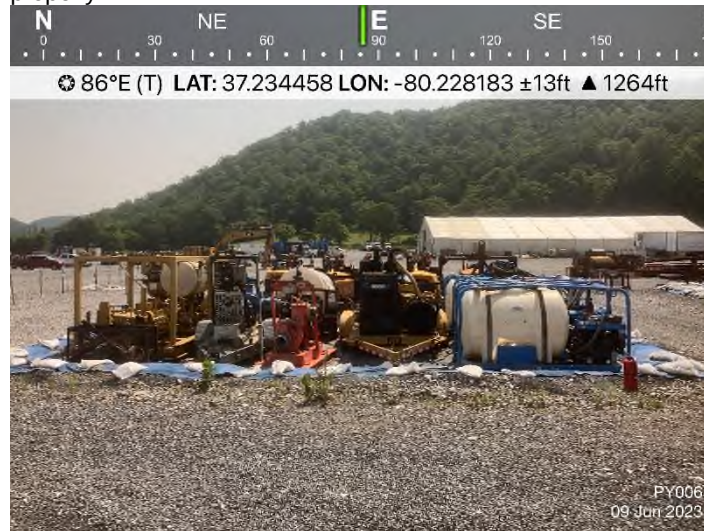
**Figure 4: Pipeyard 006 – Controls in place and functioning properly.**
