FIELD INSPECTION REPORT

Project Name:	Mountain Valley Pipeline	Inspector:	Marshall Willis
Inspection Date:	Friday, May 26, 2023	Project Contact:	Brian Clauto, Cory Chalmers
Spread H: Montgomery County	STA 12119+17 – 12190+85 MVP-MN-274	Weather:	Dry

FIELD INSPECTION PHOTO LOG

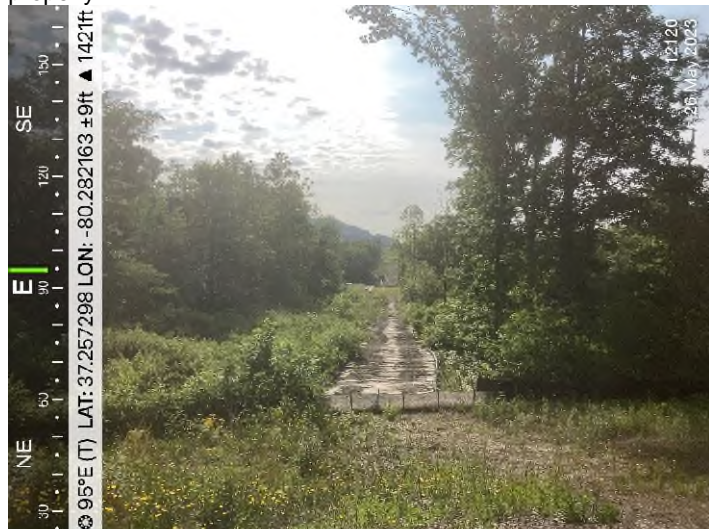
Figure 1: STA 12120+00 – Controls in place and functioning properly.

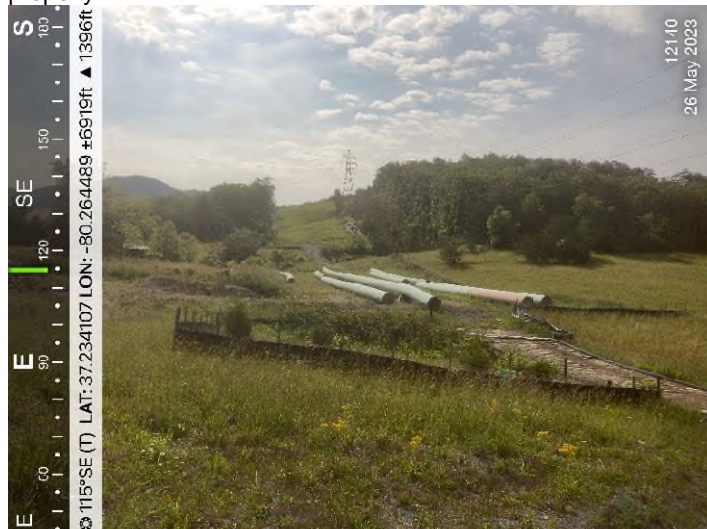
Figure 2: STA 12140+00 – Controls in place and functioning properly.

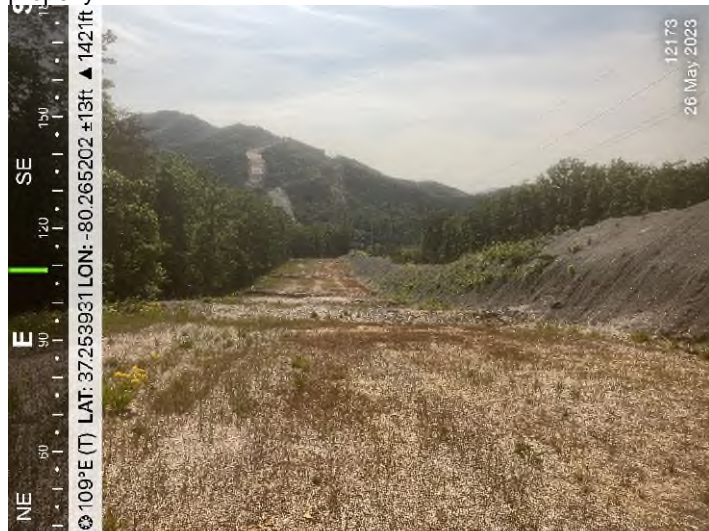
Figure 3: STA 12173+00 – Controls in place and functioning properly.

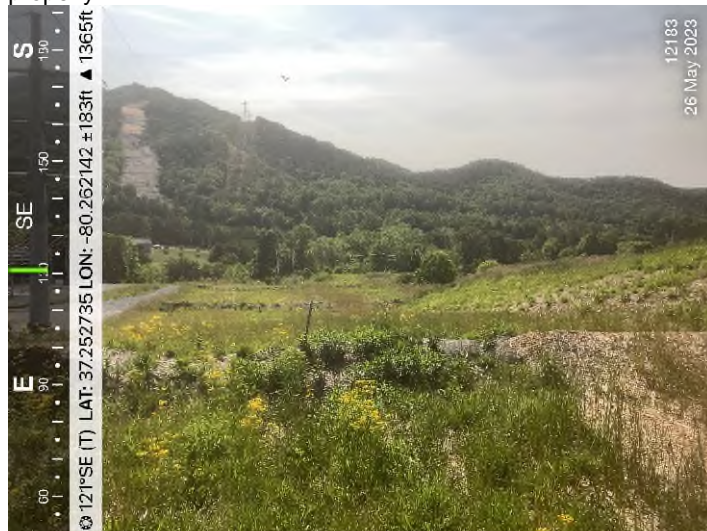
Figure 4: STA 12183+00 – Controls in place and functioning properly.
