FIELD INSPECTION REPORT

Project Name:	Mountain Valley Pipeline	Inspector:	Marshall Willis
Inspection Date:	Friday, June 30, 2023	Project Contact:	Brian Clauto, Cory Chalmers
Spread H: Montgomery County	STA 12119+17 - 12155+00 MVP-MN-273	Weather:	Dry

FIELD INSPECTION PHOTO LOG

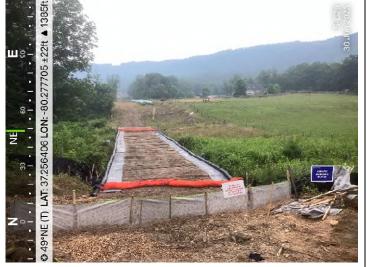
<u>Figure 3</u>: **Stream S-C29**— Controls in place and functioning properly. Recently replaced timber mat crossing and perimeter controls.

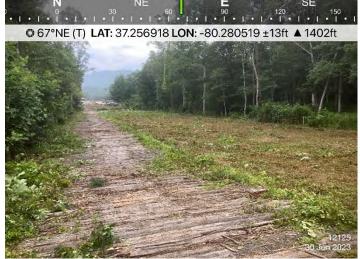
<u>Figure 4</u>: **STA 12125+00** – Crews clearing brush, installing new timber mats and CFS.
