FIELD INSPECTION REPORT

Project Name:	Mountain Valley Pipeline	Inspector:	Marshall Willis
Inspection Date:	Tuesday, June 20, 2023	Project Contact:	Brian Clauto, Cory Chalmers
Spread H: Roanoke County Franklin County	MVP-FR-293.01 MVP-FR-292 MVP-RO-281/281.01/281.02	Weather:	Rainy

FIELD INSPECTION PHOTO LOG

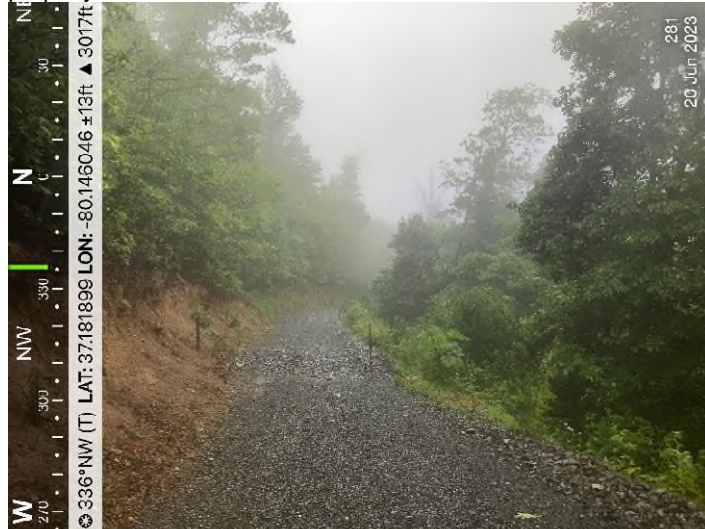
Figure 1: MVP-RO-281 – Controls in place and functioning properly.

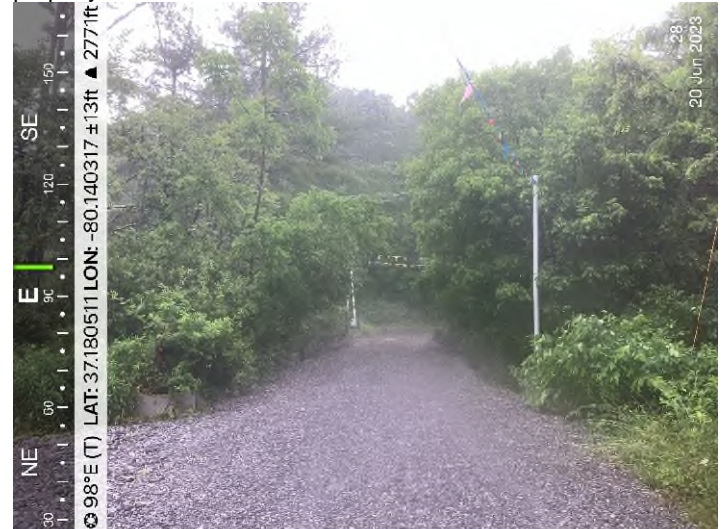
Figure 2: MVP-RO-281 – Controls in place and functioning properly.

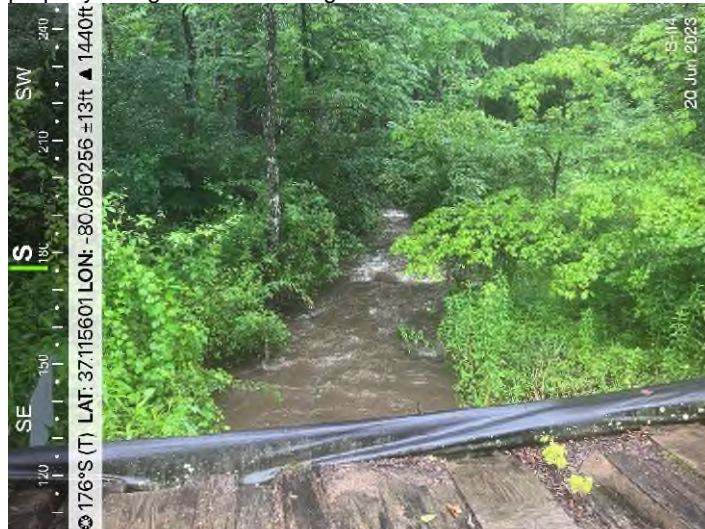
Figure 3: Stream S-II4 – Controls in place and functioning properly along stream crossing.

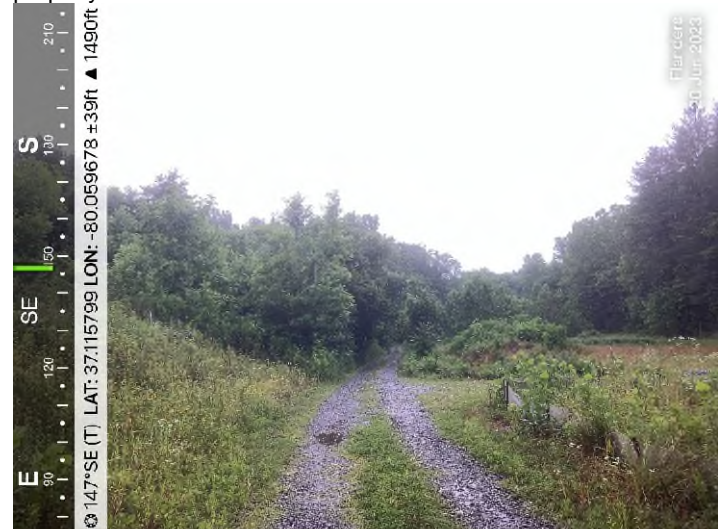
Figure 4: MVP-FR-293.01 – Controls in place and functioning properly.
