## FIELD INSPECTION REPORT

| <b>Project Name:</b> | Mountain Valley Pipeline | <b>Inspector:</b> | Marshall Willis |
| <b>Spread H:<br/>Franklin County</b> | STA 13033+59 – 13061+44<br>MVP-FR-289<br>MVP-FR-290 | <b>Weather:</b> | Dry |

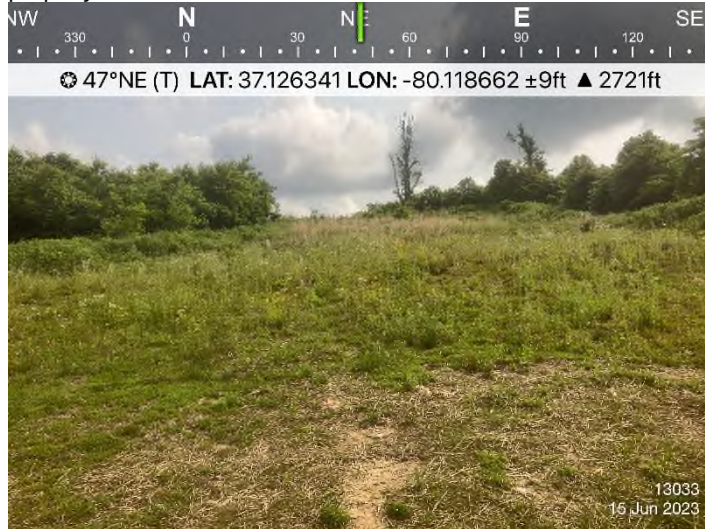
**Figure 1: STA 13033+00** – Controls in place and functioning properly.

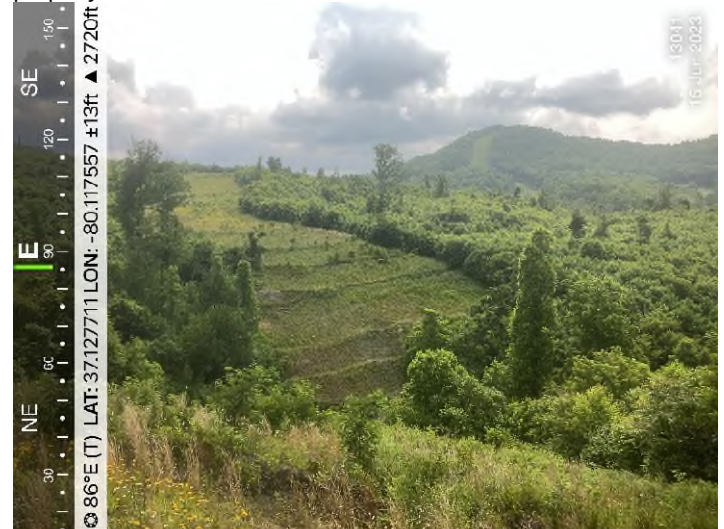
**Figure 2: STA 13041+00** – Controls in place and functioning properly.

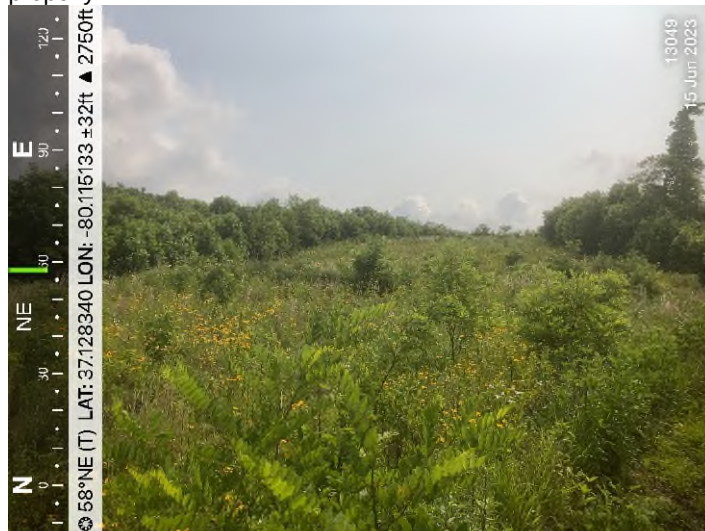
**Figure 3: STA 13049+00** – Controls in place and functioning properly.

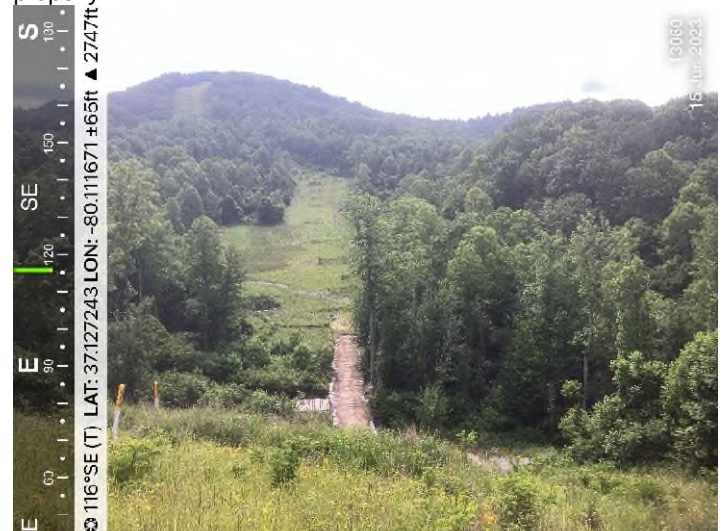
**Figure 4: STA 13060+00** – Controls in place and functioning properly.
