## FIELD INSPECTION REPORT

| Project Name: | Mountain Valley Pipeline | Inspector: | Marshall Willis |
| Spread I:<br>Franklin County | STA 14270+00 – 14311+57<br>MVP-FR-313 | Weather: | Dry |

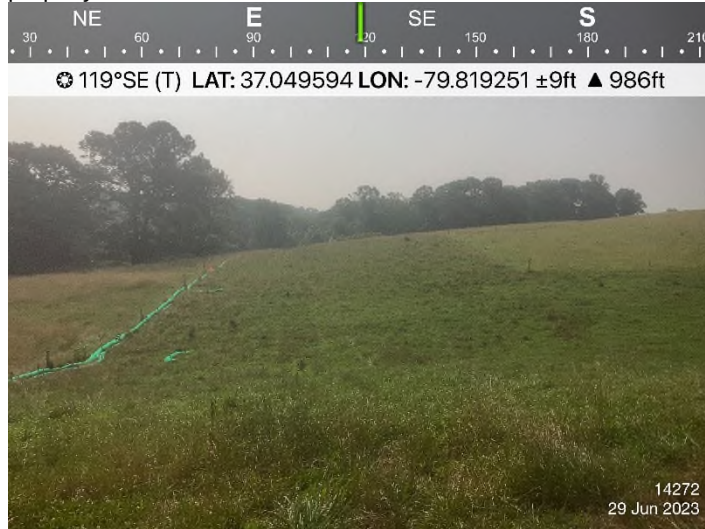
**Figure 1: STA 14272+00** – Controls in place and functioning properly.

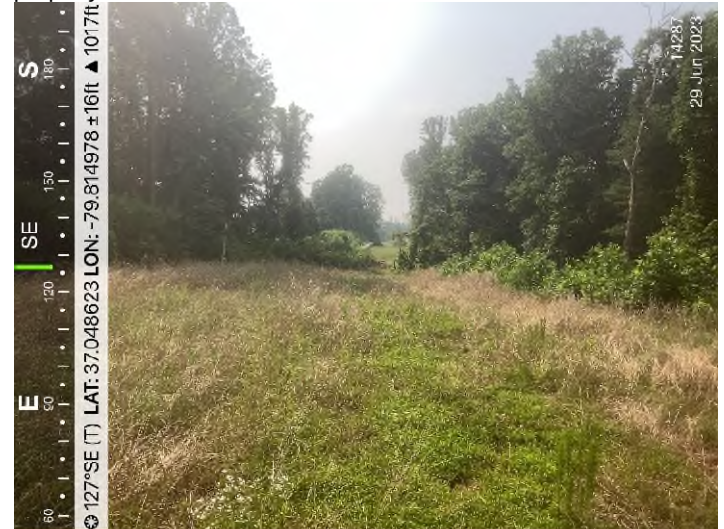
**Figure 2: STA 14287+00** – Controls in place and functioning properly.

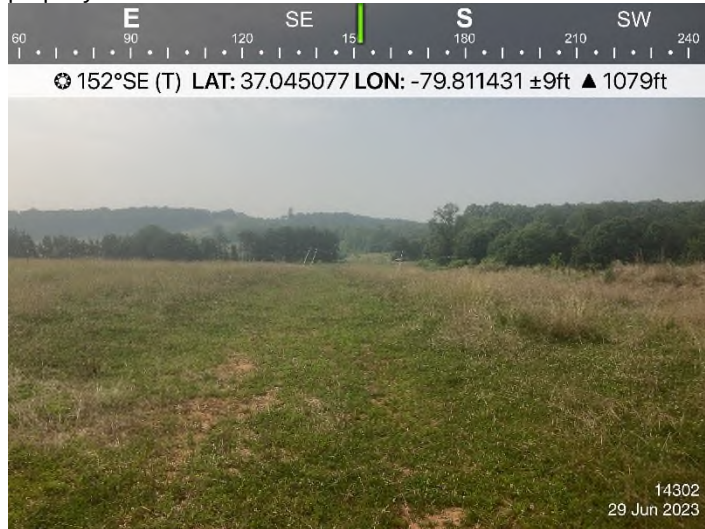
**Figure 3: STA 14302+00** – Controls in place and functioning properly.

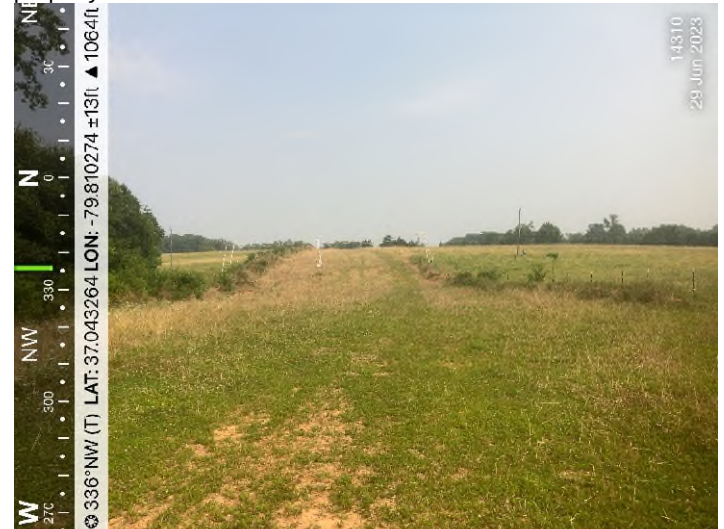
**Figure 4: STA 14310+00** – Controls in place and functioning properly.
