## FIELD INSPECTION REPORT

| <b>Project Name:</b> | Mountain Valley Pipeline | <b>Inspector:</b> | Marshall Willis |
| <b>Inspection Date:</b> | Thursday, June 22, 2023 | <b>Project Contact:</b> | Brian Clauto, Cory Chalmers |

## FIELD INSPECTION PHOTO LOG

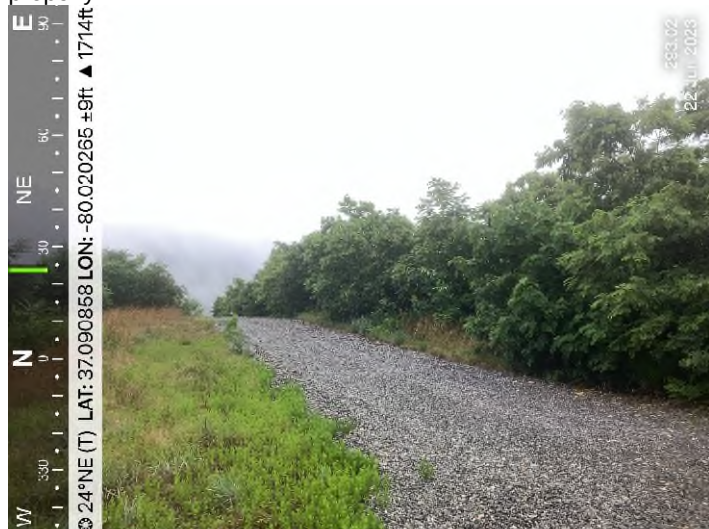
**Figure 1: MVP-FR-293.02** – Controls in place and functioning properly.

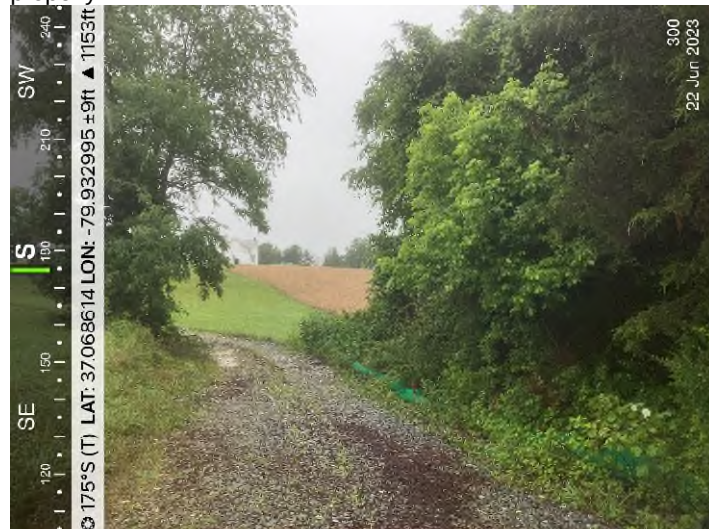
**Figure 2: MVP-FR-300** – Controls in place and functioning properly.

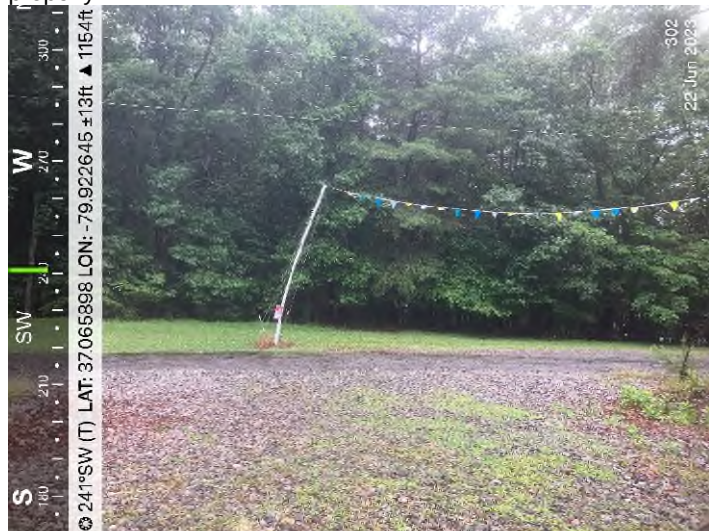
**Figure 3: MVP-FR-302** – Controls in place and functioning properly.

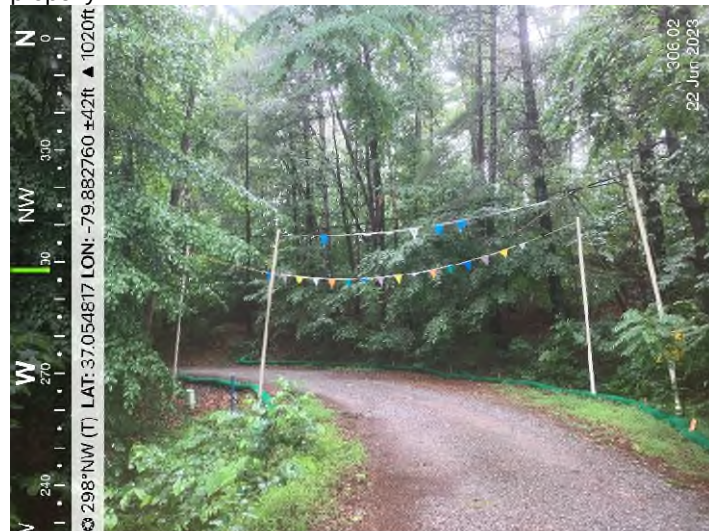
**Figure 4: MVP-FR-306.02** – Controls in place and functioning properly.
