Project Name:	Mountain Valley Pipeline	Inspector:	Matthew Grant
Inspection Date:	Wednesday, June 28, 2023	Project Contact:	Brian Clauto
Spread I: Franklin	Sta 13894-13960 ATWS 697, 698a, 698b, 698c, 1299a	Weather:	Dry

FIELD INSPECTION PHOTO LOG

Project Name: Mountain Valley Pipeline Date: Wednesday, June 28, 2023

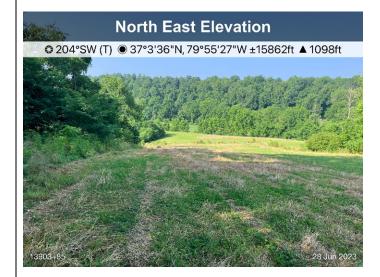
Figure 1: Sta 13903+85, ESC controls are in place.

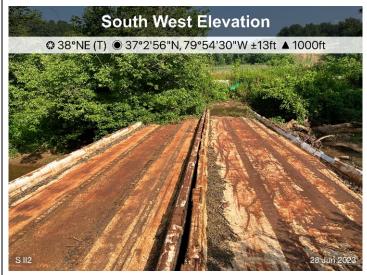
Figure 2: Designated crossing S-II2, ECD's are in place.

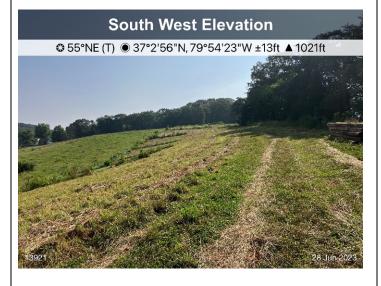
Figure 3: Sta 13921, ECD's and stabilization remains in place.

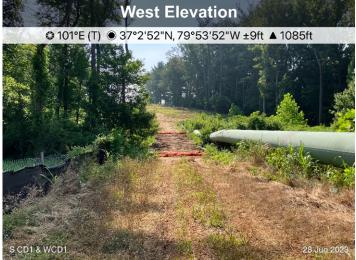
<u>Figure 4</u>: Designated crossing S-CD1 & W-CD1, ECD's are in place.
